Assessing Groundwater Resources and Design of Aquifer
Recharge Systems in Selected 17 Islands of Maldives - L1

BASELINE ASSESSMENT REPORT

Ha Filladhoo, Ha Maarandhoo, Ha Muraidhoo
Ha Uligan, and Ha Molhadhoo

Assignment: Assessing Groundwater Resources and Design of Aquifer Recharge Systems in Selected 17 Islands of Maldives (Lot 1)

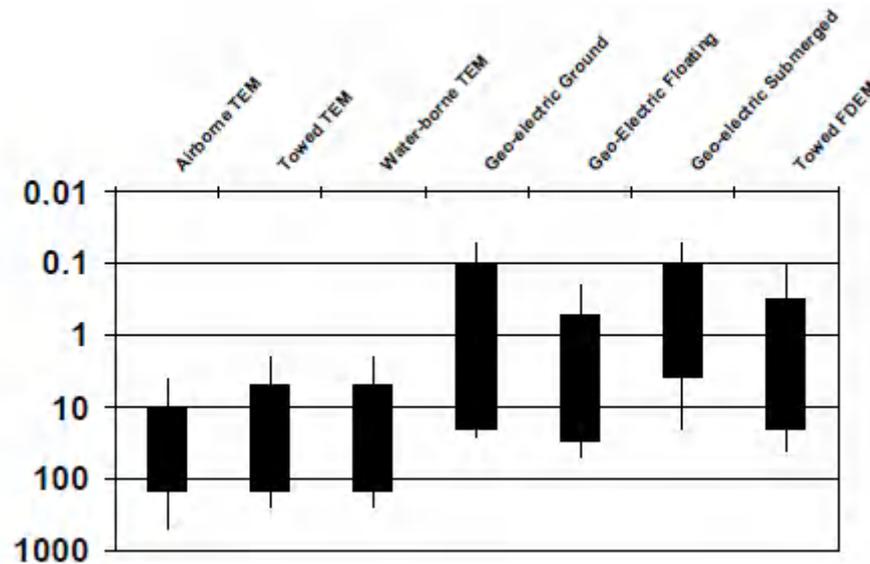
Figure 1-2: Ranges of detectable depths of various ER/EC imaging devices (in metres). Note that airborne FDEM (not shown) has a range similar to but shallower than airborne TEM (Source: Allen, 2007)

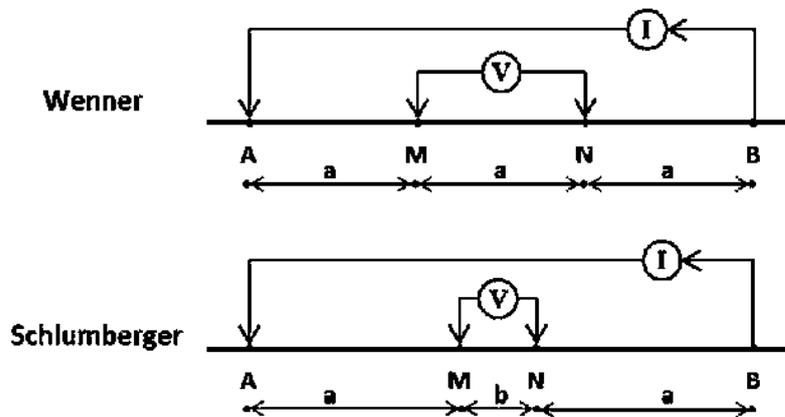
Figure 1-3: Electrode configurations -- Wenner and Schlumberger Arrays (Garofalo, 2014)

There are several standard electrode configurations used in resistivity surveys such as the Wenner array and Schlumberger array. The Wenner array is mostly used for profiling to investigate the lateral resistivity variation whereas the Schlumberger array is used for vertical profiling. Schlumberger array is the method used in this study. Figure 1-3 shows the two different electrode arrays.

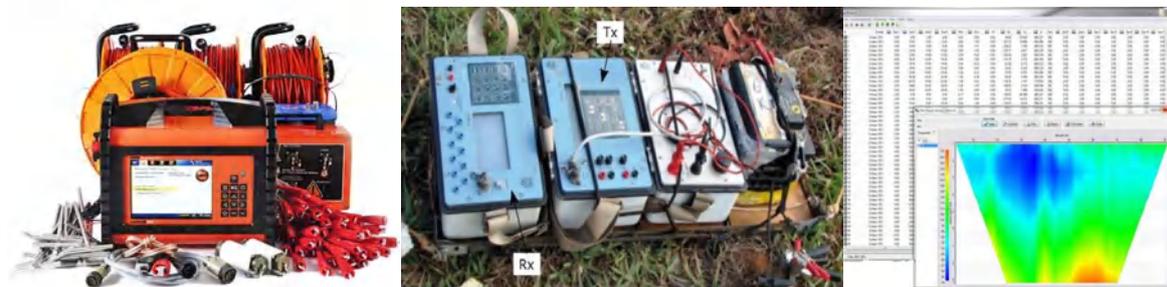
Figure 1-4: Electrical Resistivity (ER) equipment used for the field pilot tests (Sources: Left - ABEM Terrameter LS 2 - User Manual, 2017/ Center, Right - Siqueira Neto & Elis)

An ABEM Terrameter (Model SAS 1000) and an IRIS Resistivity Instrument (Model SYSCAL Pro) were used to carry out the islandwide ER surveys in selected atoll islands.

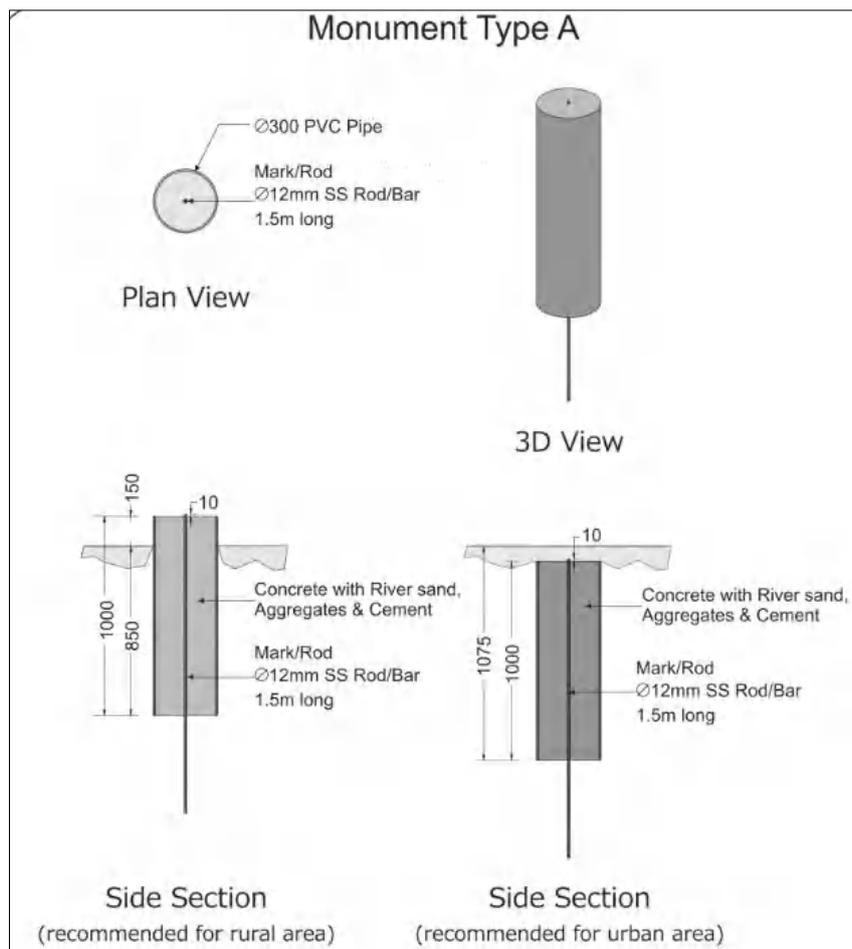
Figure 1-5: Type A PSM design (Source: Maldives Land and Survey Authority, Guideline on the Establishment of Permanent Survey Marks)

The PSMs have been established where necessary (project sites where PSMs are not registered at Maldives Land and Survey Authority - MLSA) as per the MLSA guideline of establishing PSMs. Three PSMs were cast on-site as per MLSA guideline (Type A PSM design), while the PSMs were spaced such that best triangulation is achieved (depending on availability of space). The PSMs were placed 10 cm below ground level as recommended in Control Survey Guidelines by MLSA. The PSMs horizontal coordinates were established using Topcon GNSS receivers using the static survey method with horizontal and vertical error within 10 mm. The data was processed using the Magnate Tools Office (TOPCON Inc., USA) software. The vertical level was established using predicted tidal data of the nearest tide station and established using the difference of ellipsoid height method (Figure 1-5 to Figure 1-7).

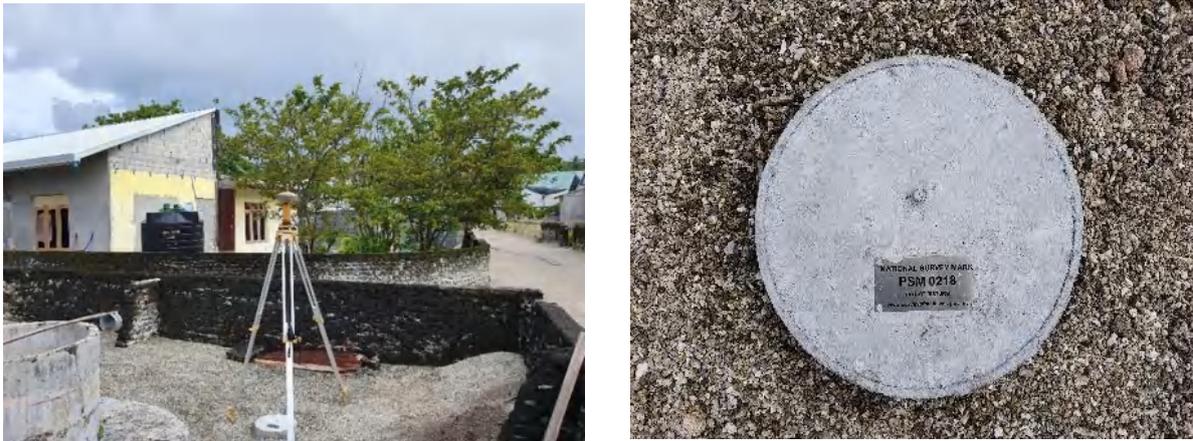
Figure 1-6: Example of PSM

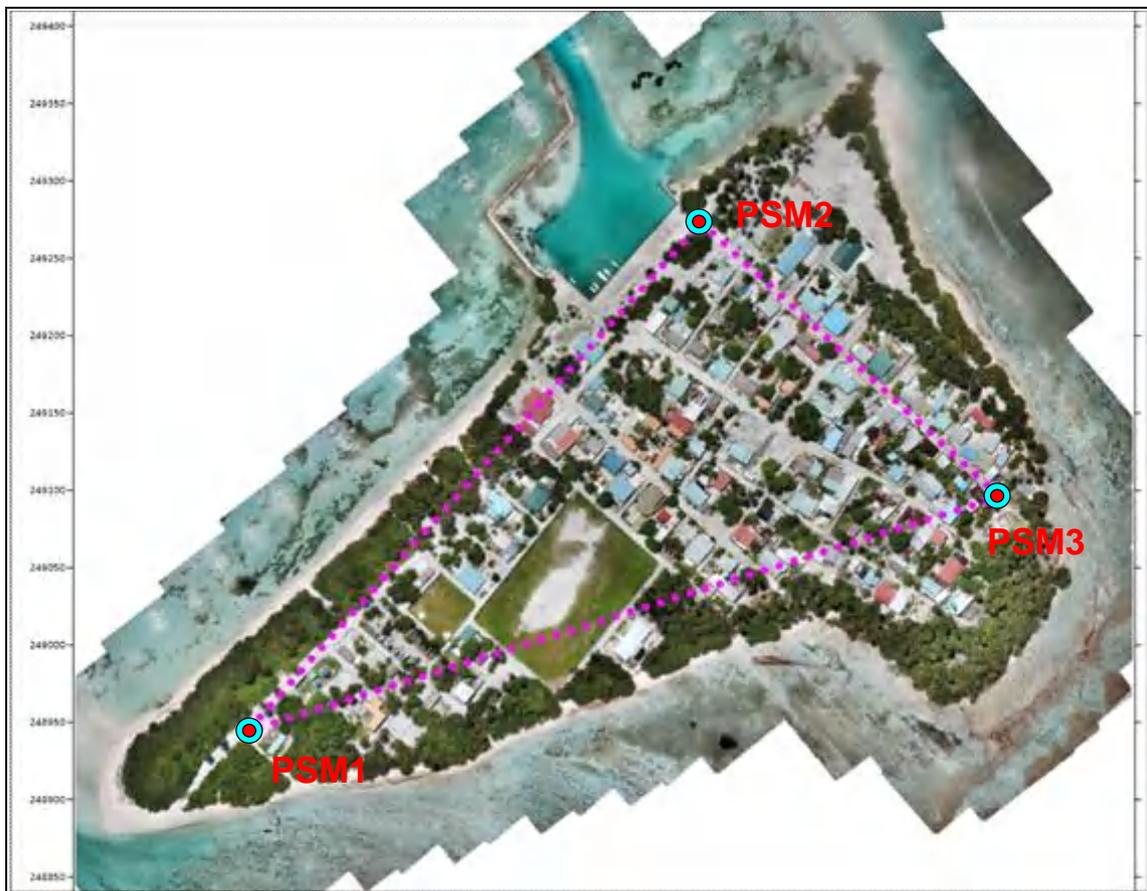
Figure 1-7: Example of spacing of PSMs

Two PSMs were located such that both are intervisible to each other while the 3rd was located at a maximum available distance away from intervisible PSMs (and intervisible to both above) as illustrated in Fig. 1-7.

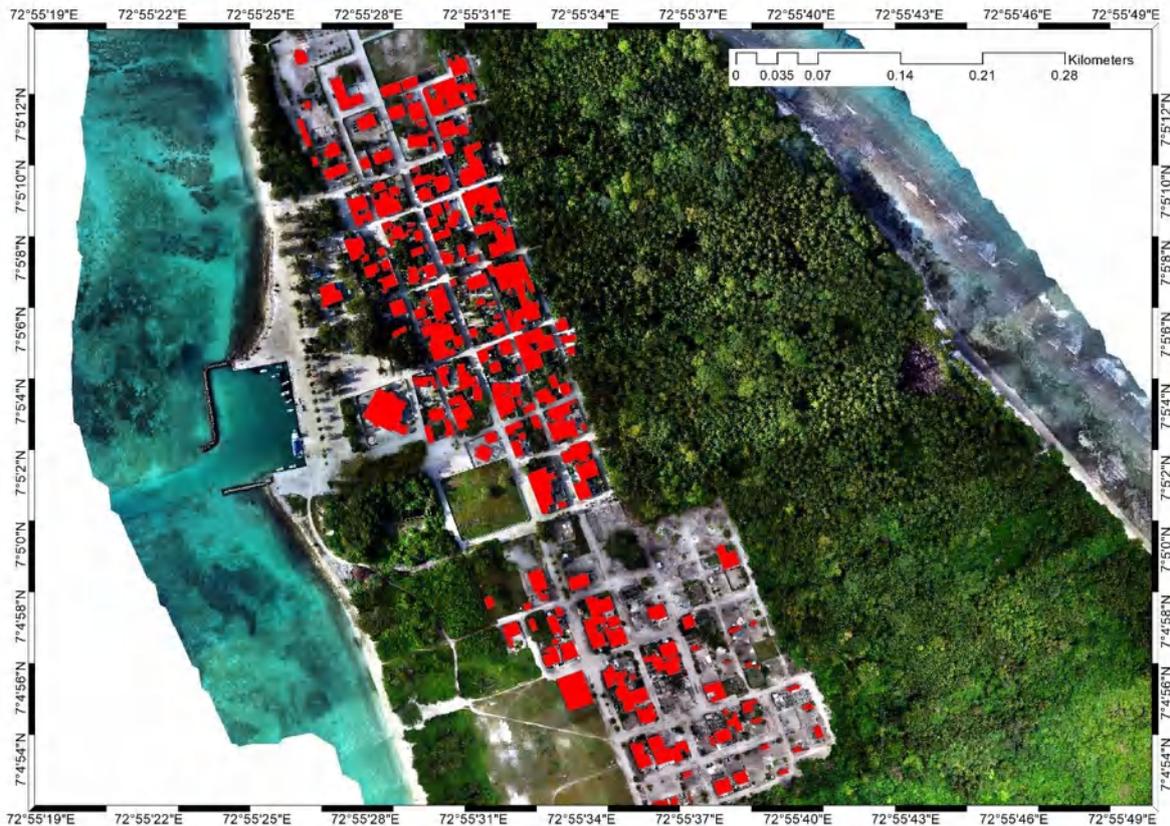
Figure 1-9: Calculation of Roof Cover in an island using UAV survey in the Maldives (Ha. Uligan)

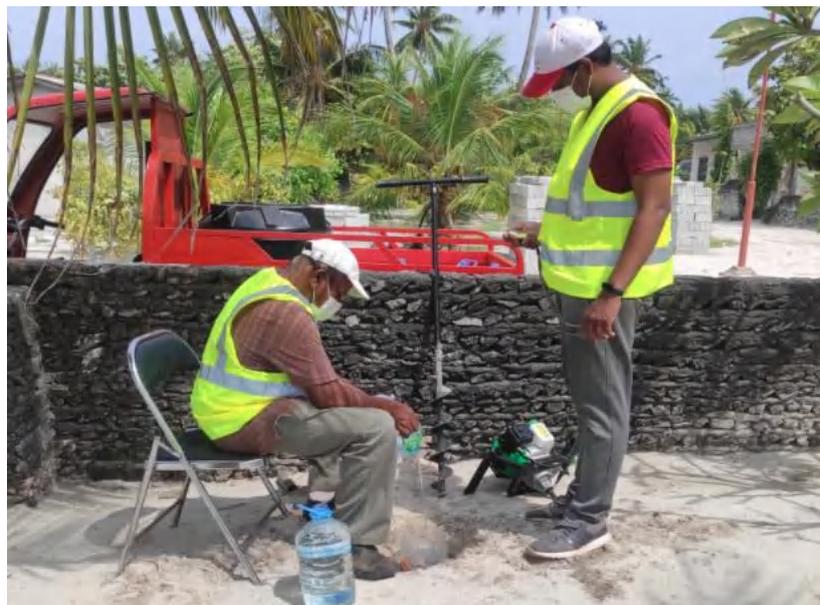
Figure 1-10: Methodology for Constant Head Gravity Permeability Tests

where

- K = coefficient of permeability;
- Q = constant rate of flow into the hole;
- r = internal radius of casing; and
- H = differential head of water = H_1 (gravity head) - H_f (head loss due to friction).

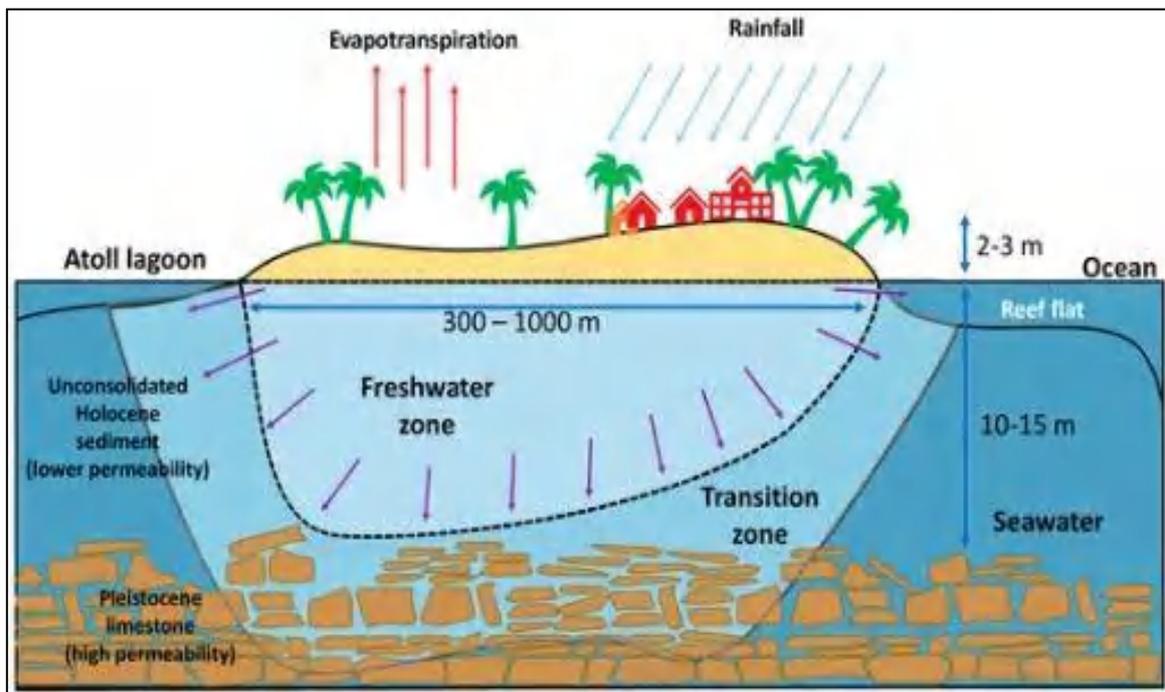
Figure 2-1: Cross section through a small coral island showing main features of a freshwater lens (exaggerated vertical scale) (Source: Jaleel et al., 2020)

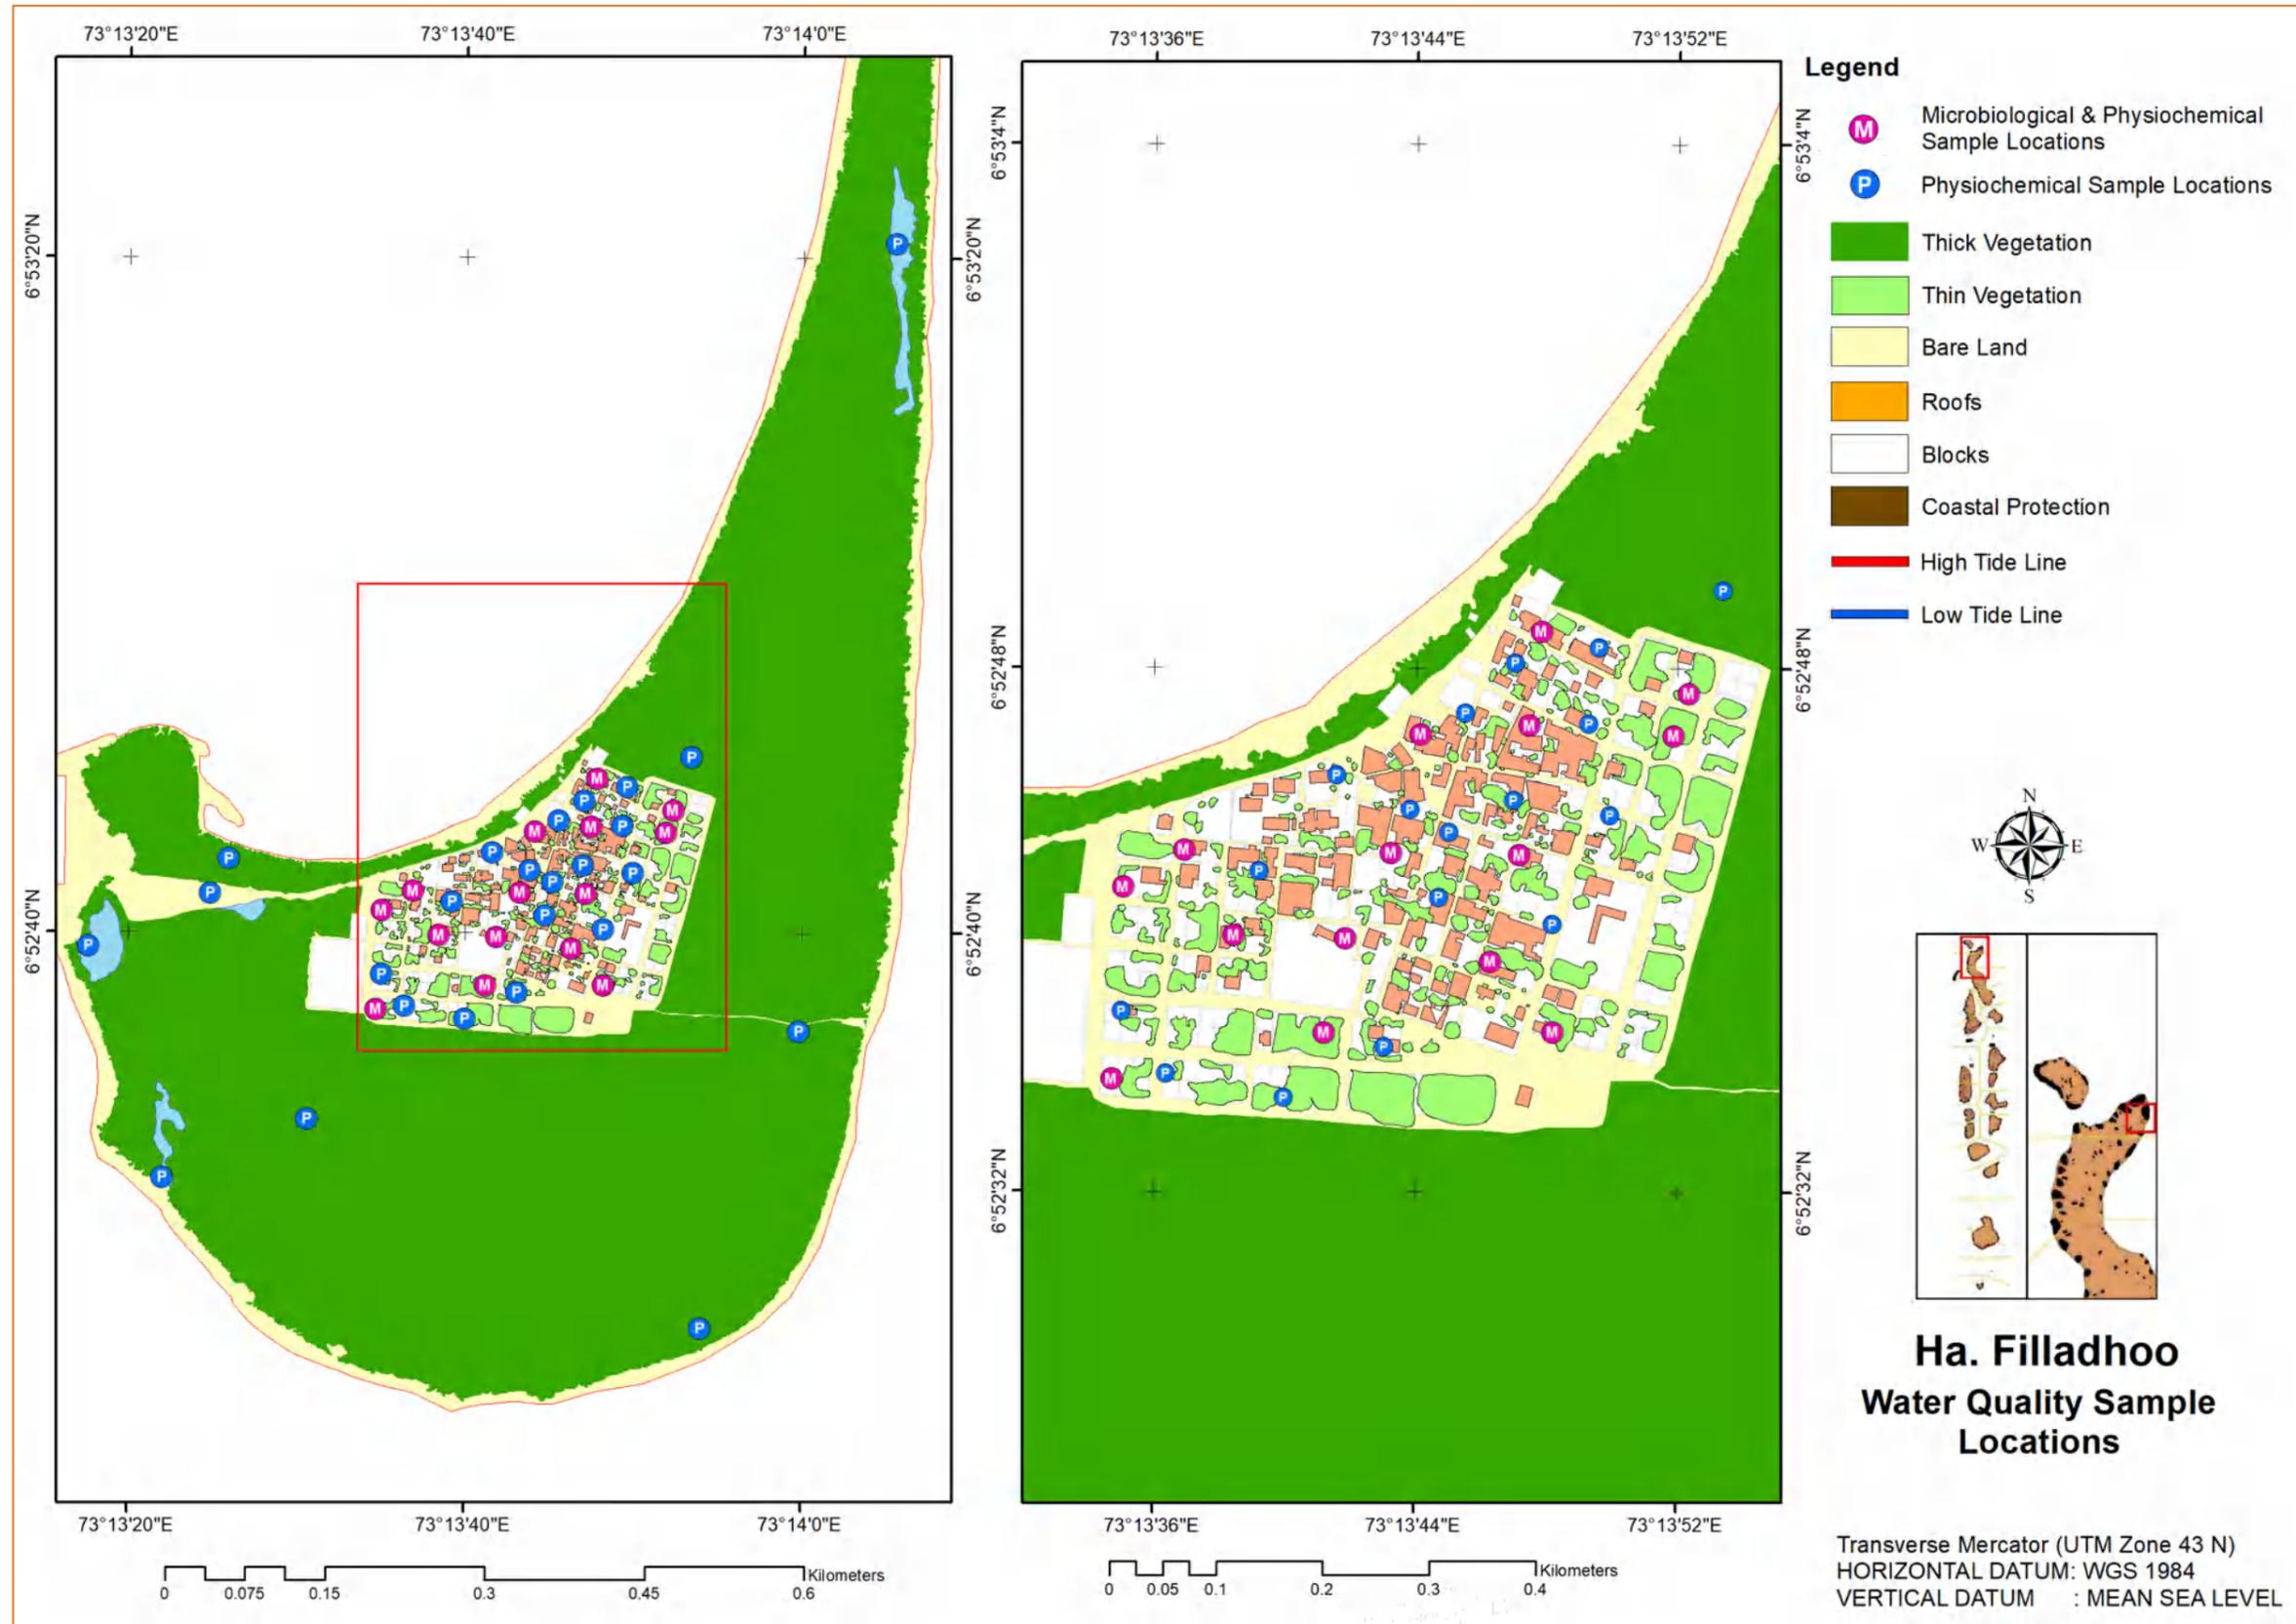
Figure 3-8: Locations of groundwater sampling points in Filladhoo Island

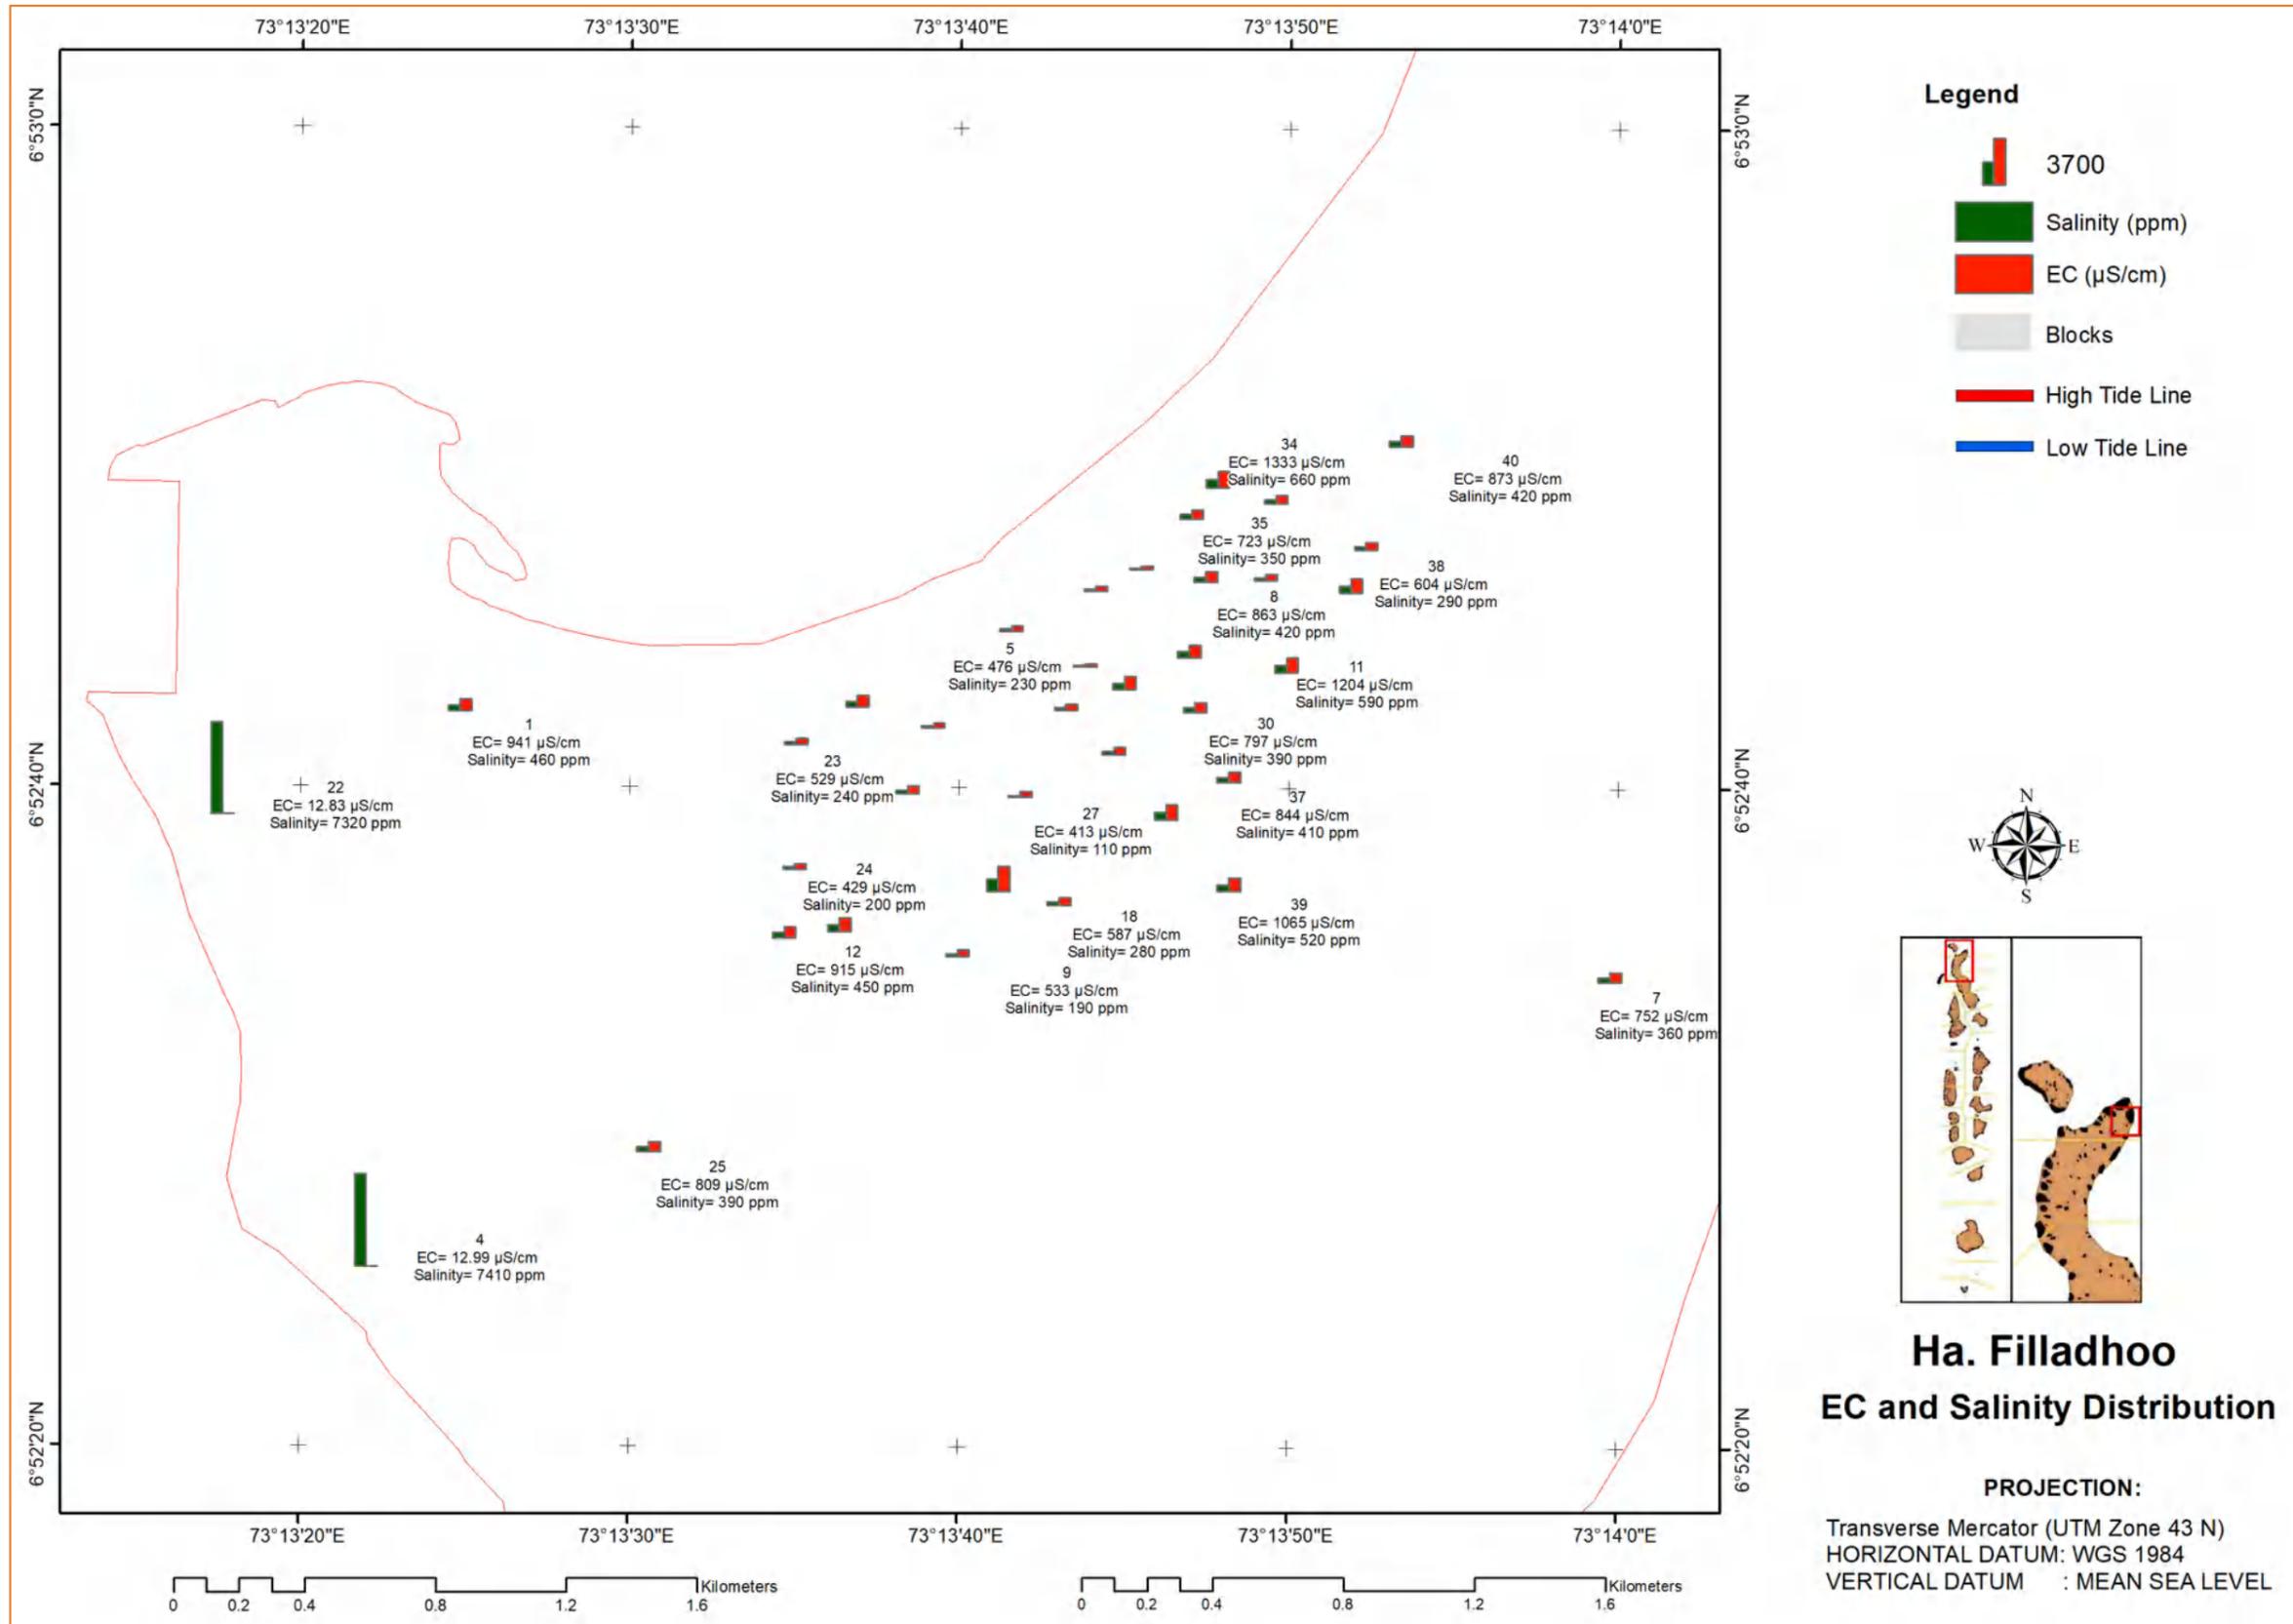
Figure 3-10: EC and Salinity Distribution in Ha. Filladhoo Island

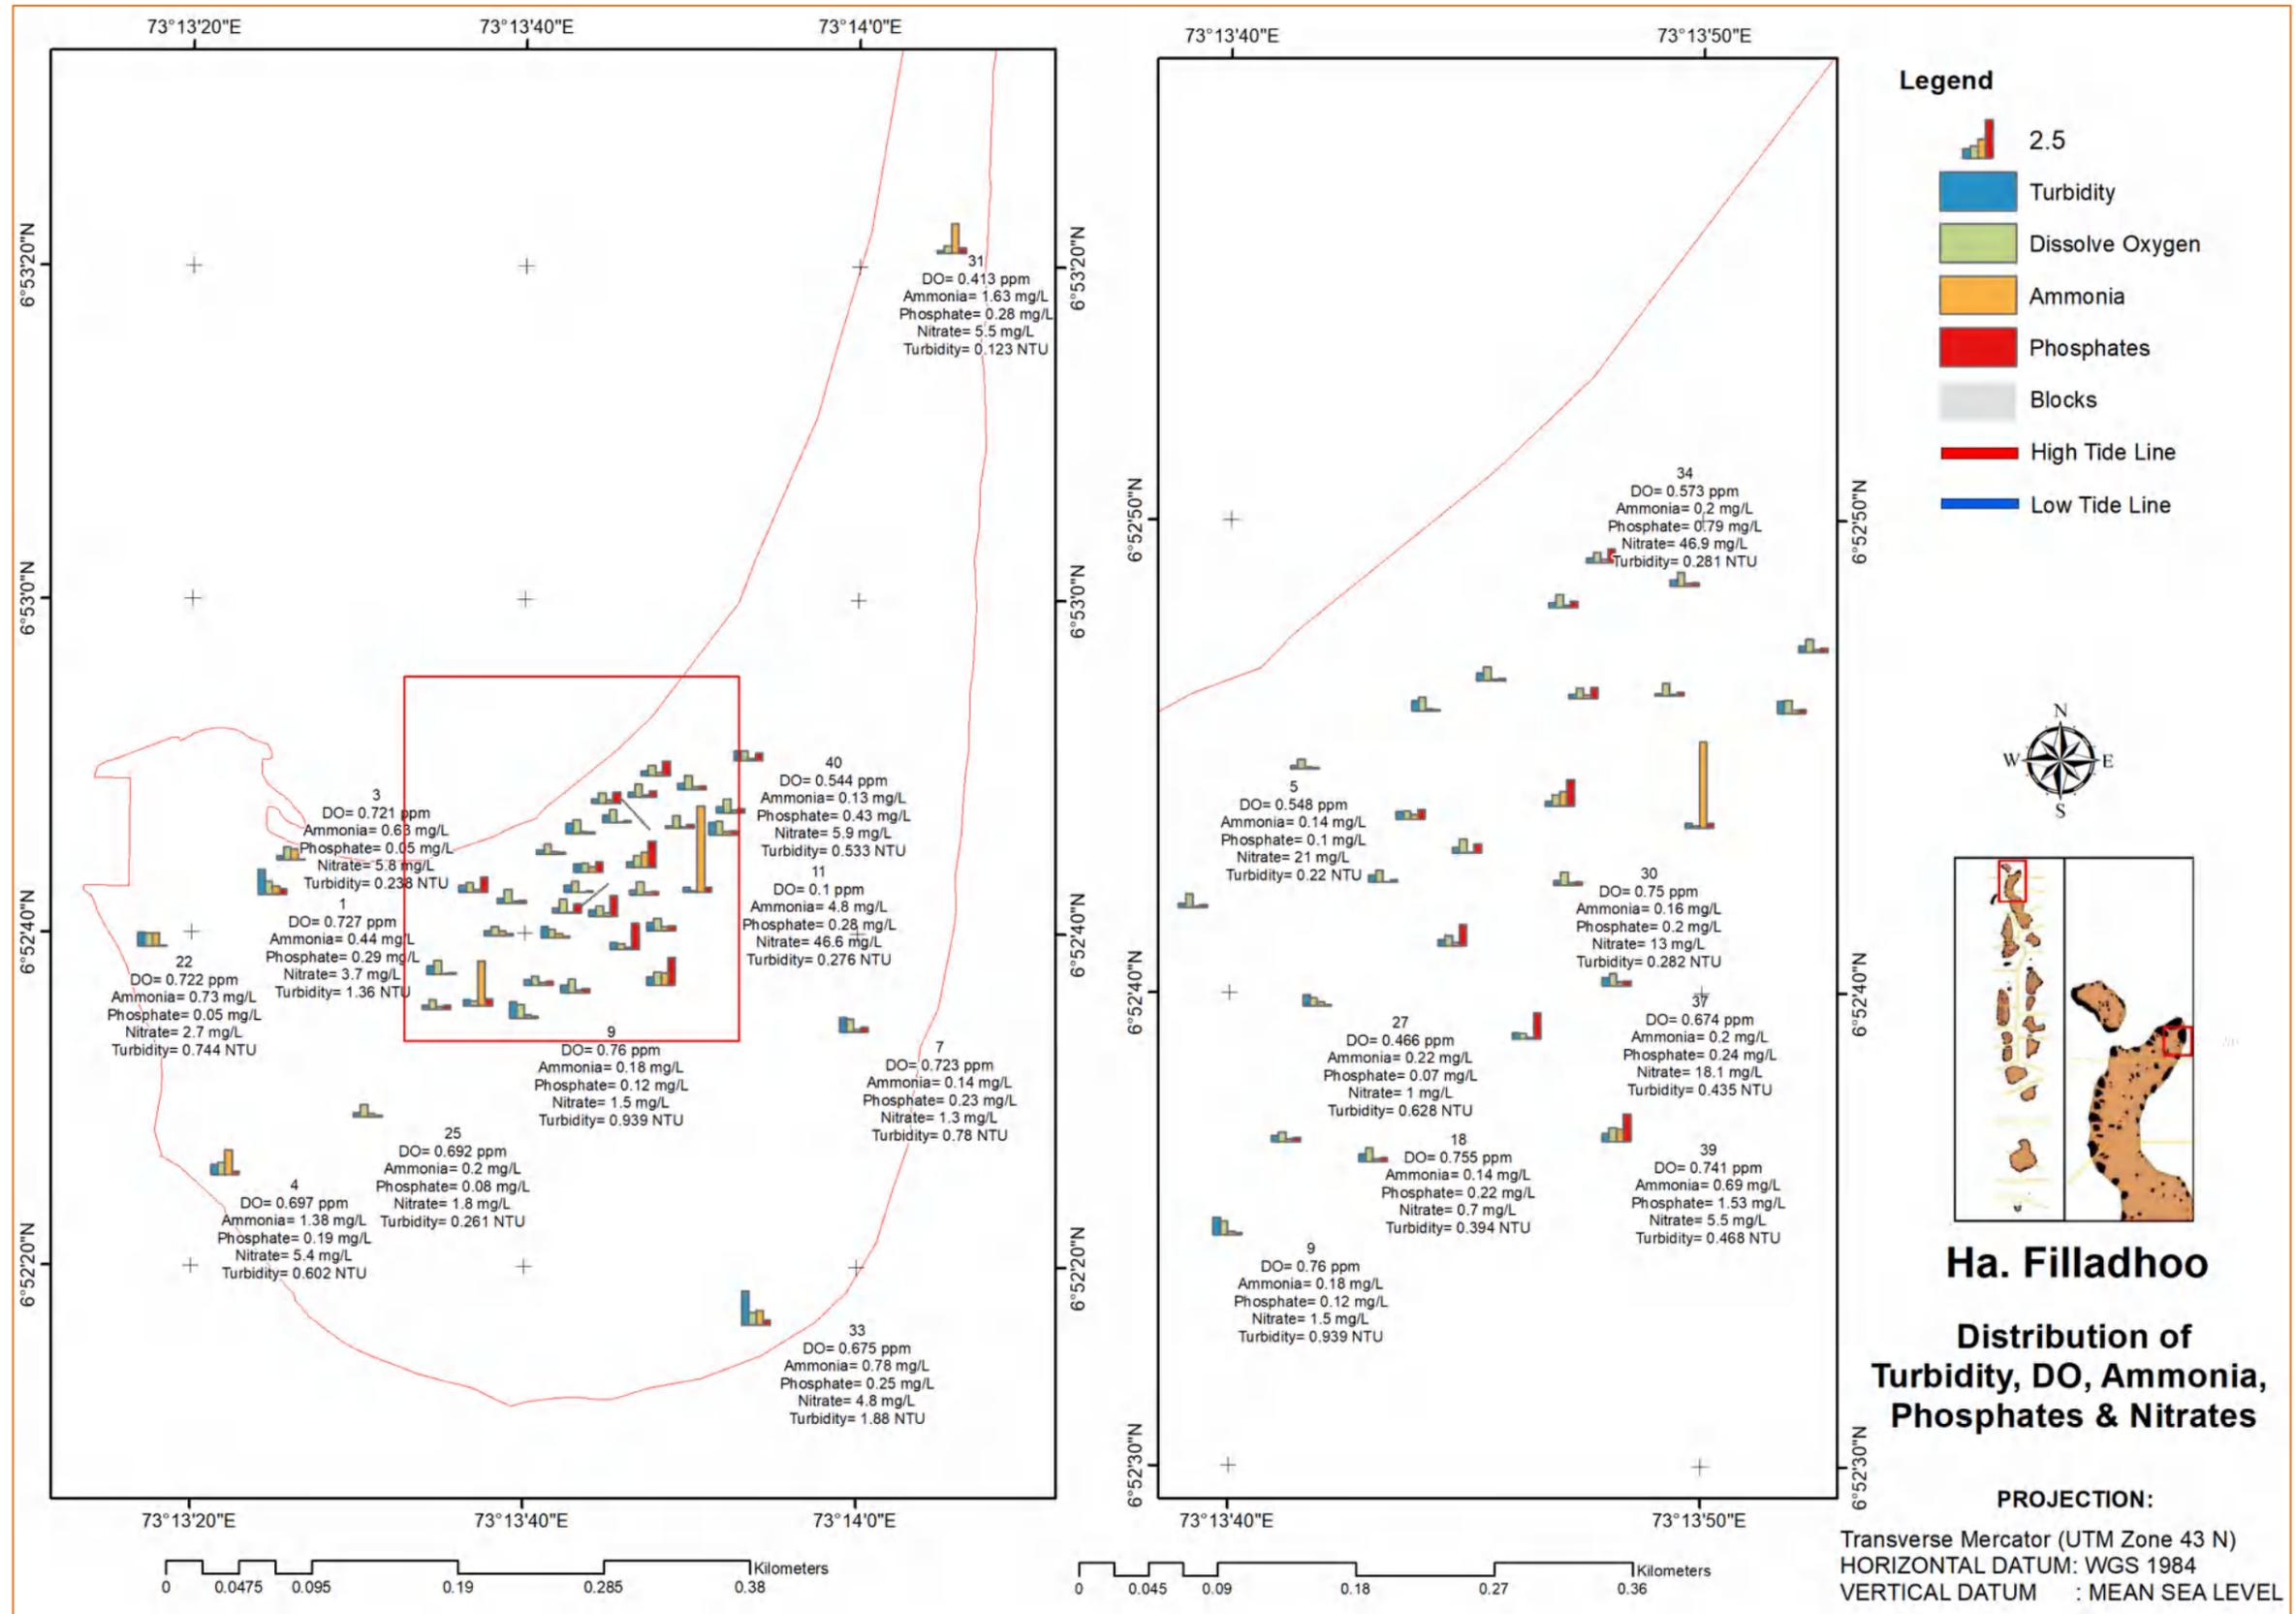
Figure 3-12: Distribution of Turbidity, DO, Ammonia, Phosphates and Nitrates in Ha. Filladhoo Island

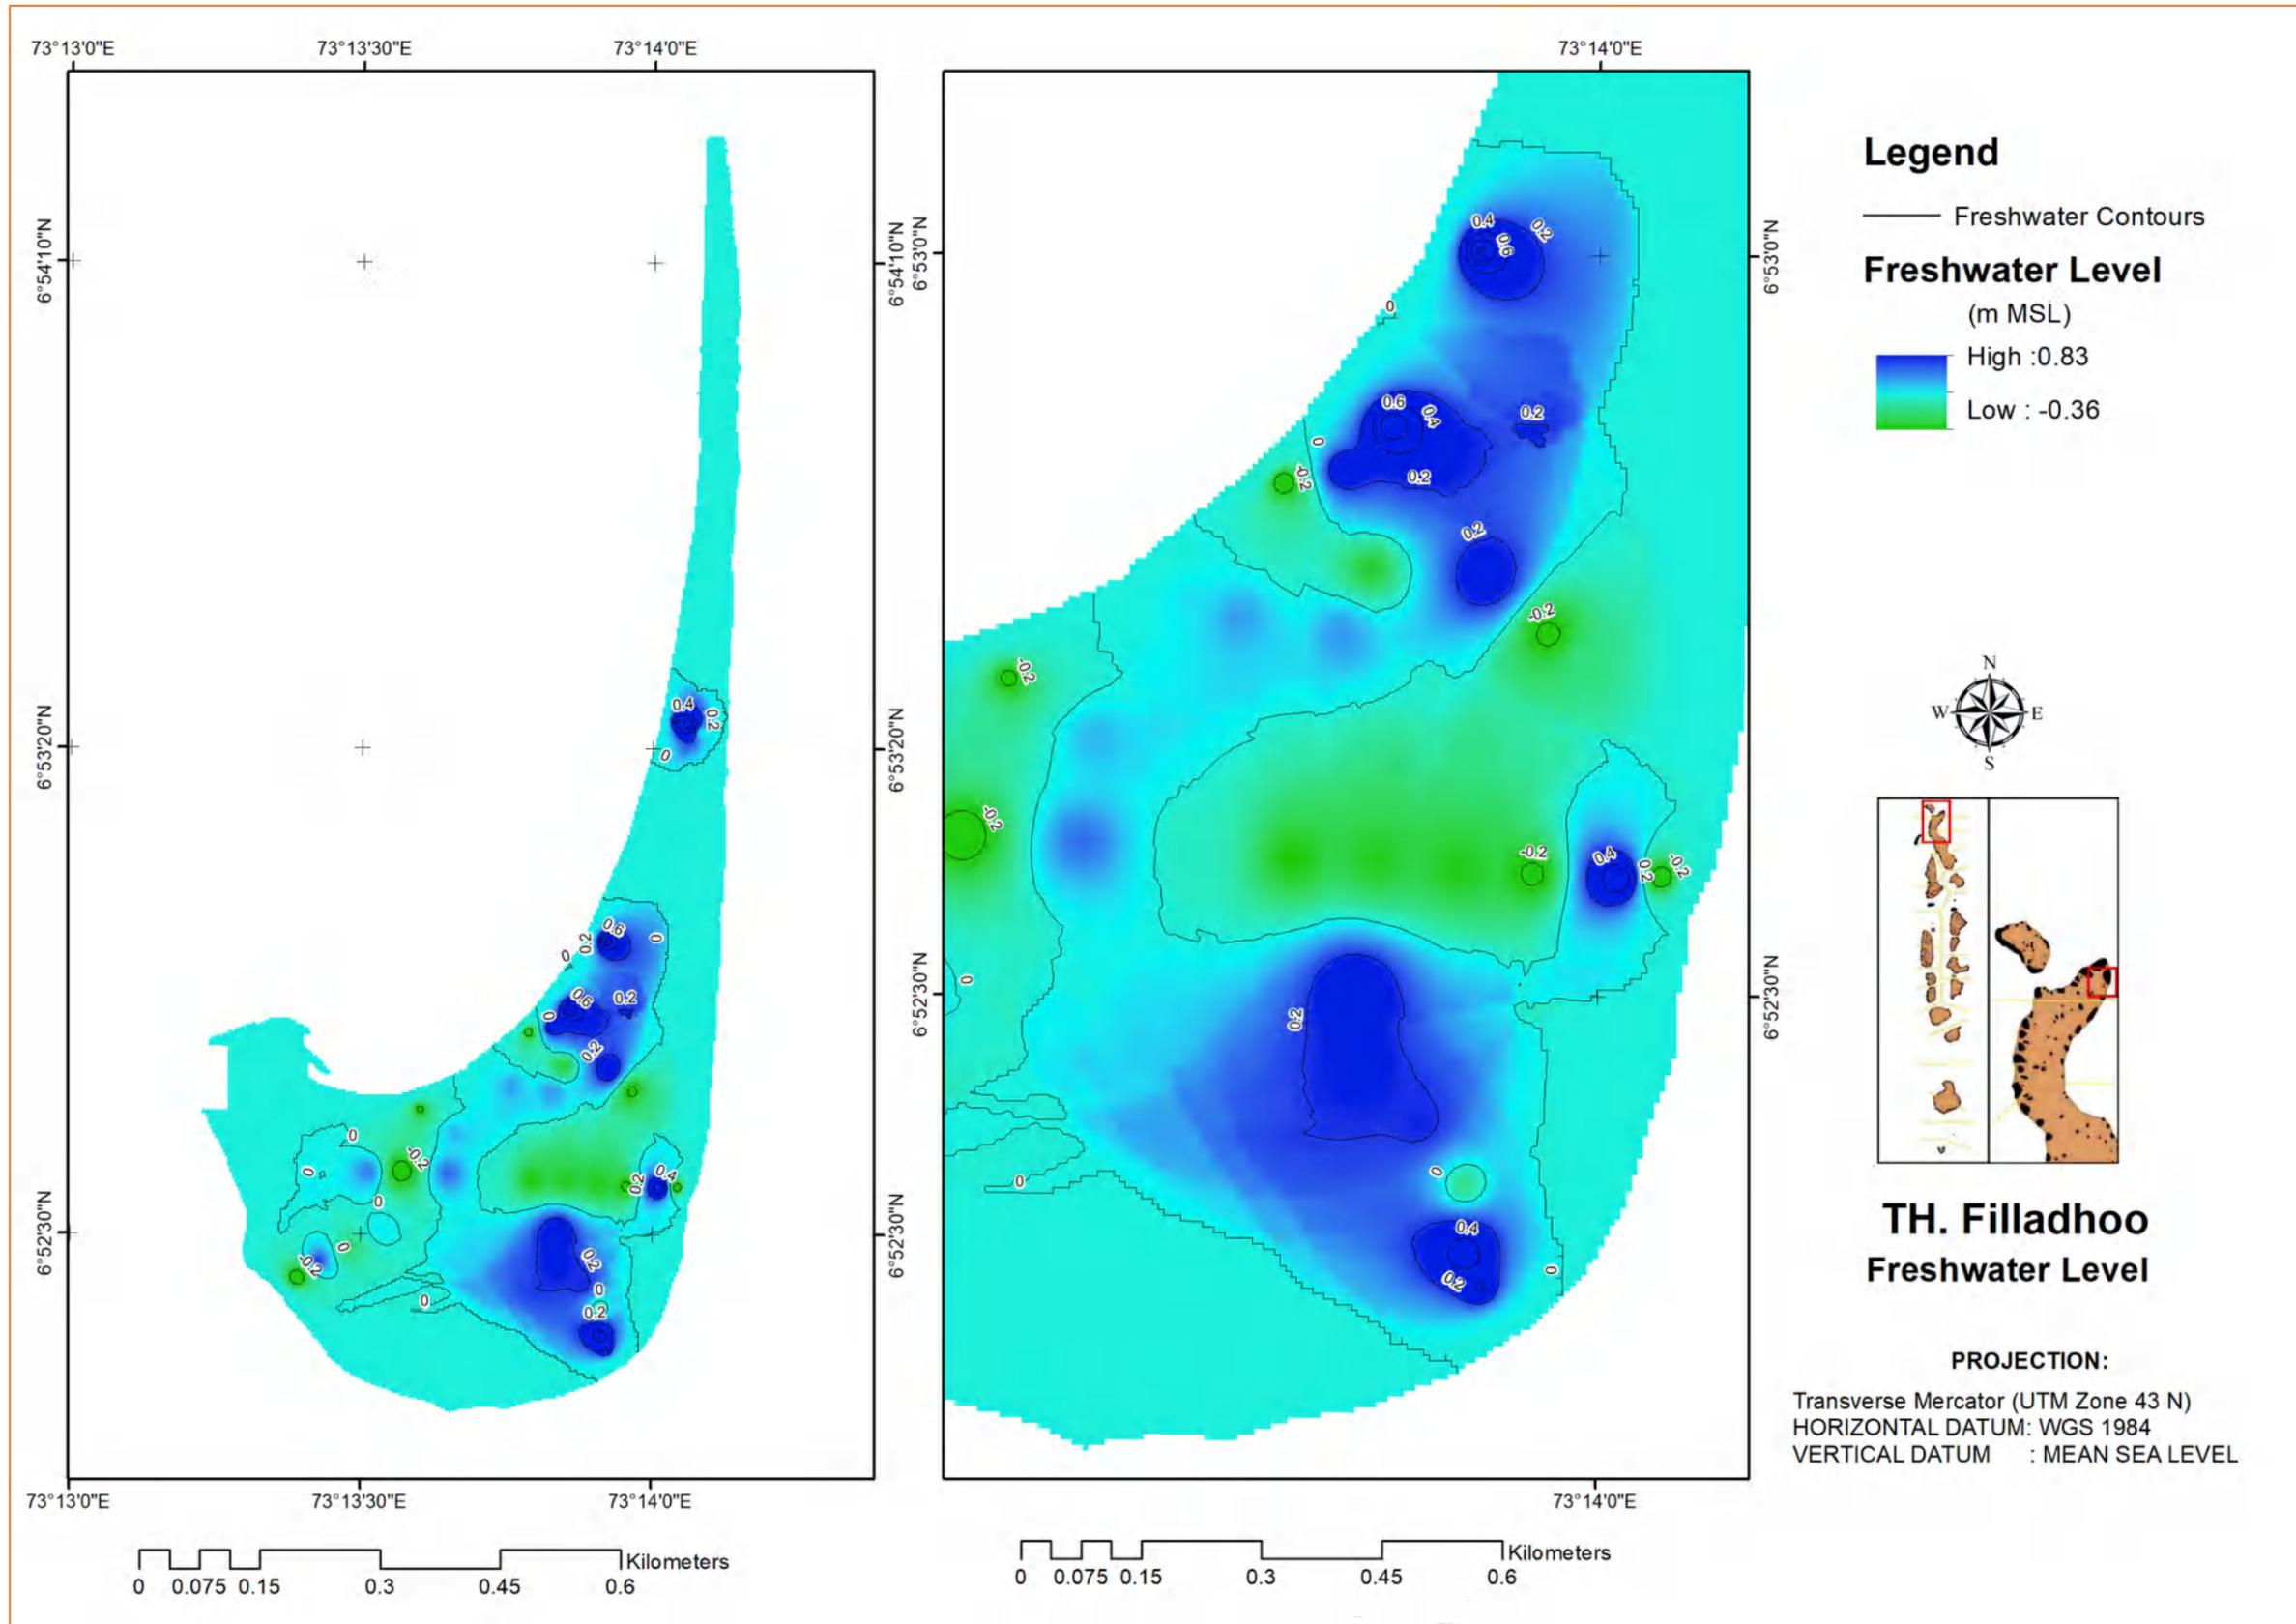
Figure 3-18: Freshwater Level in Filladhoo Island

The 2-D freshwater lens distribution density maps produced with GIS software for visualization of the spatial and volume extents are also presented below in Figure 3-18 to Figure 3-20.
