Assessing Groundwater Resources and Design of Aquifer
Recharge Systems in Selected 17 Islands of Maldives - L1

BASELINE ASSESSMENT REPORT

Ha Filladhoo, Ha Maarandhoo, Ha Muraidhoo
Ha Uligan, and Ha Molhadhoo

Assignment: Assessing Groundwater Resources and Design of Aquifer Recharge Systems in Selected 17 Islands of Maldives (Lot 1)

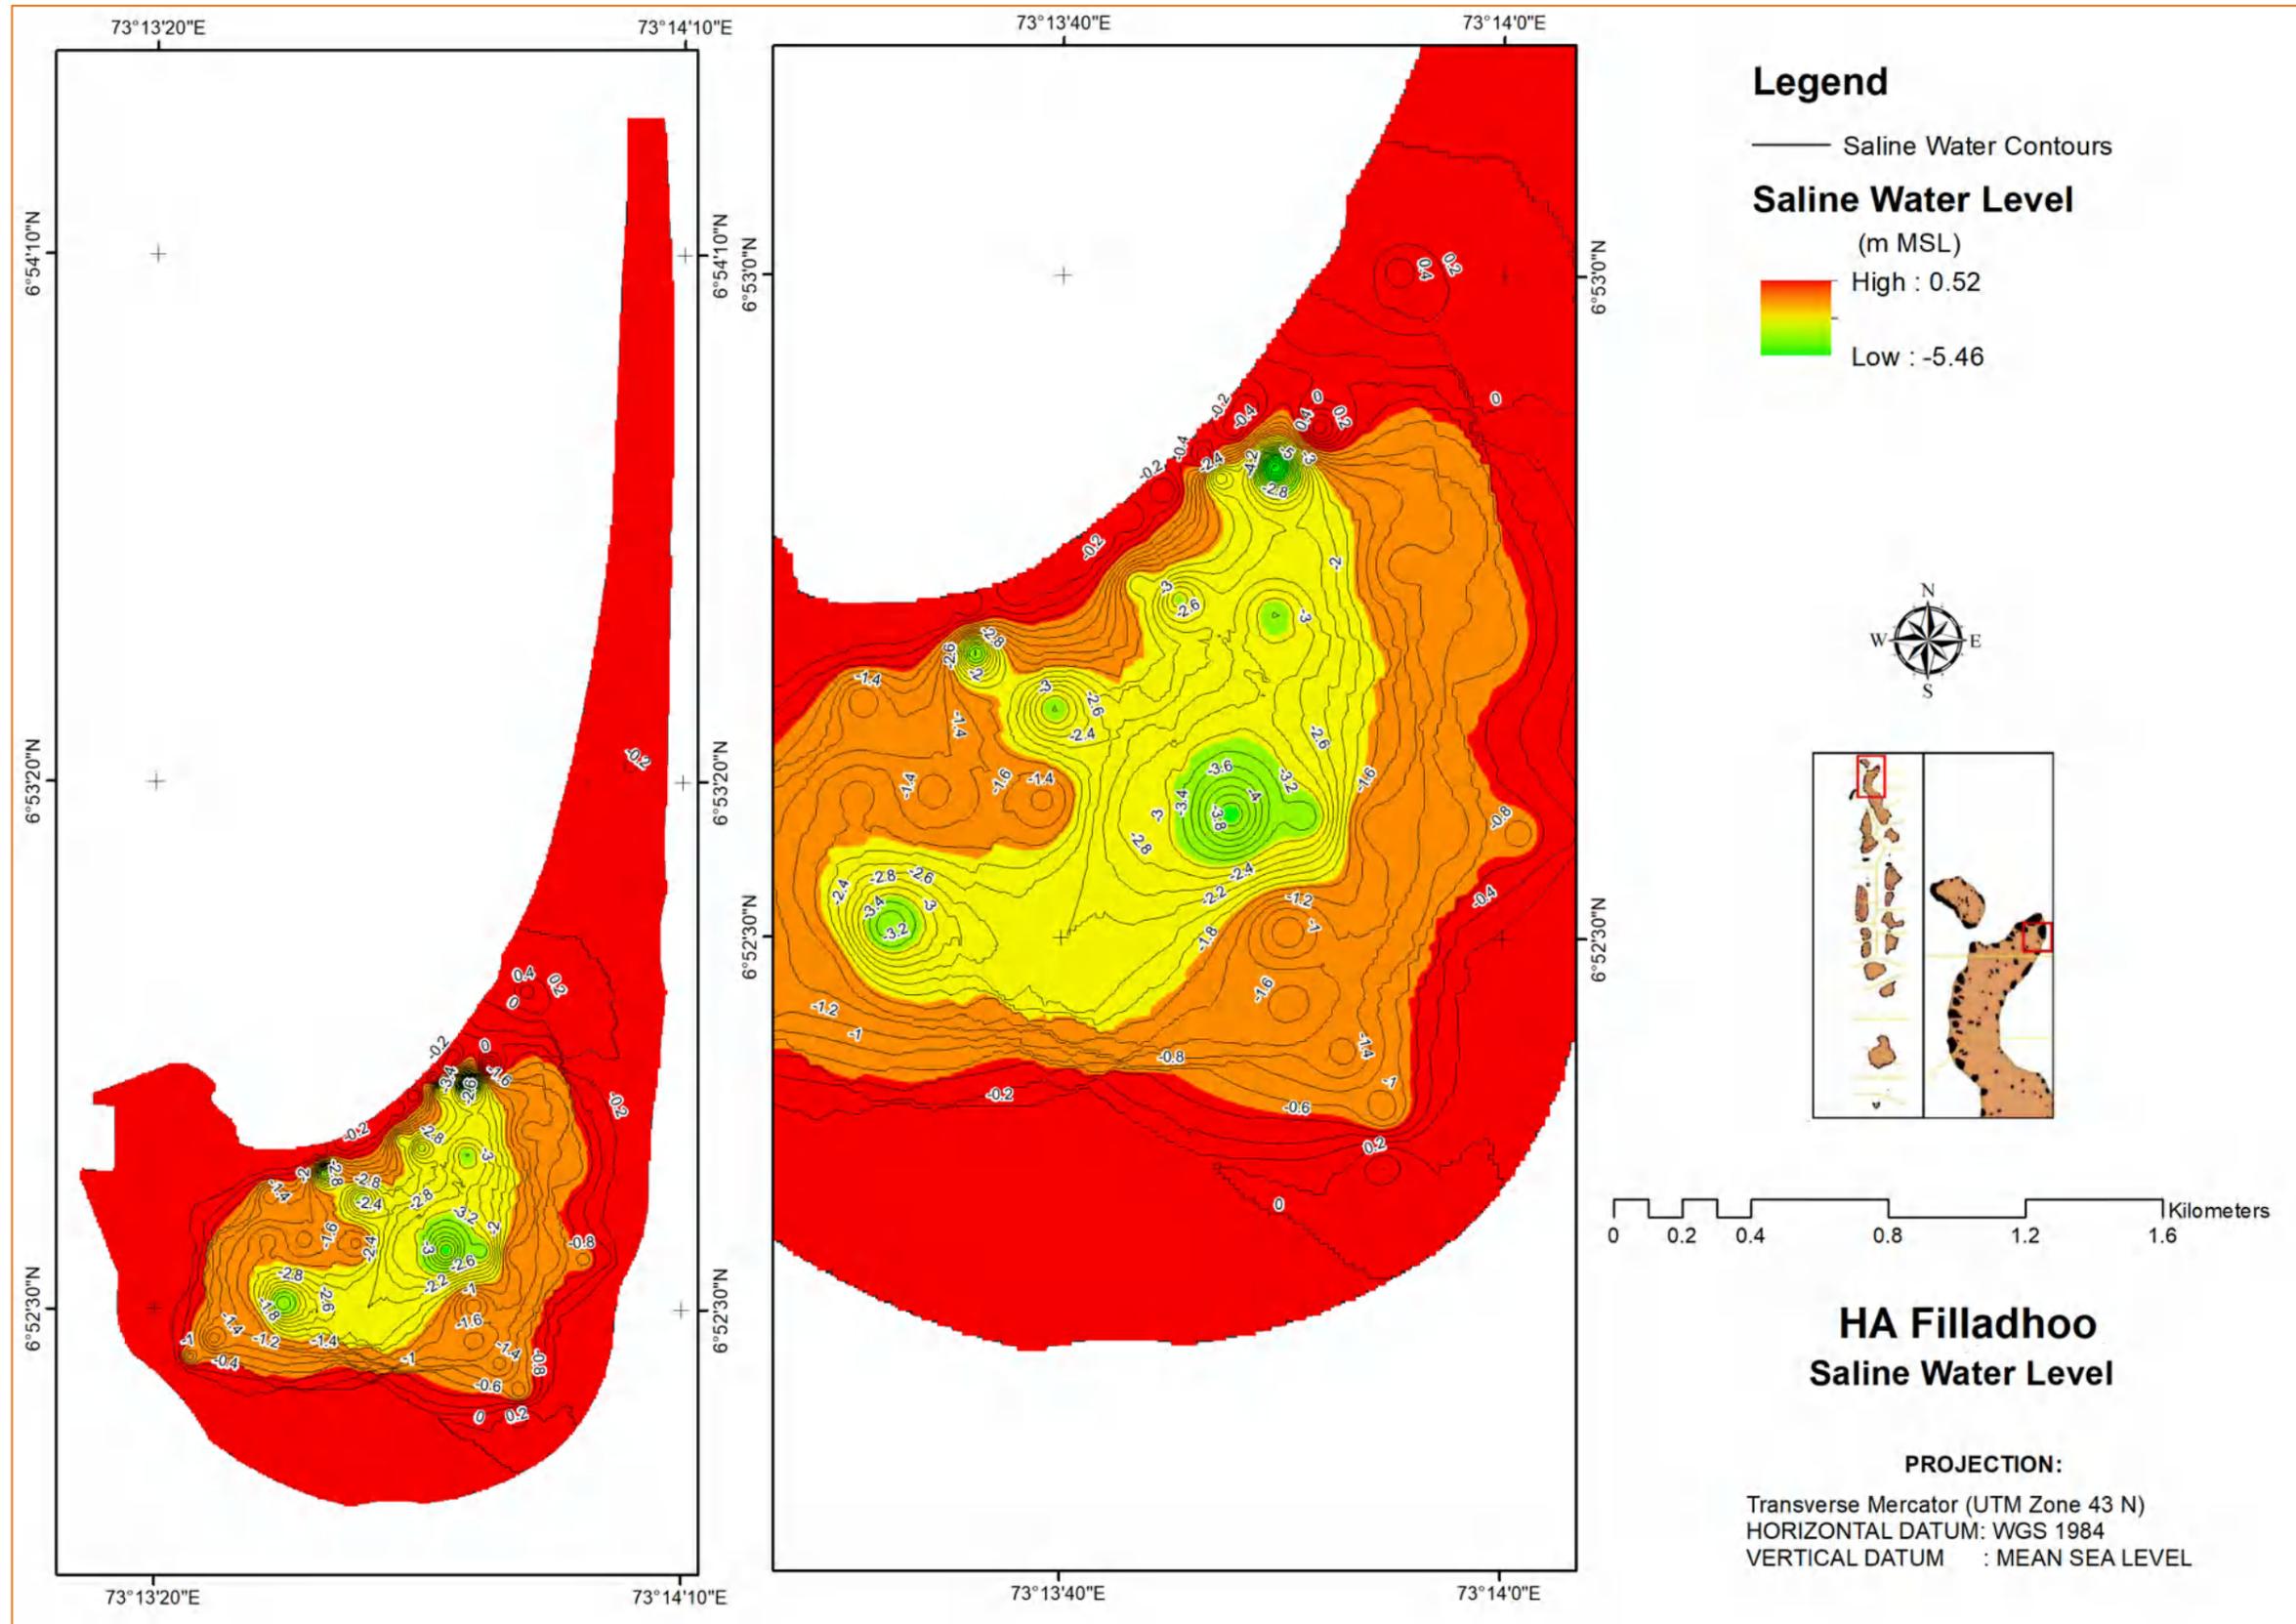
Figure 3-19: Saline water Level in Filladhoo Island

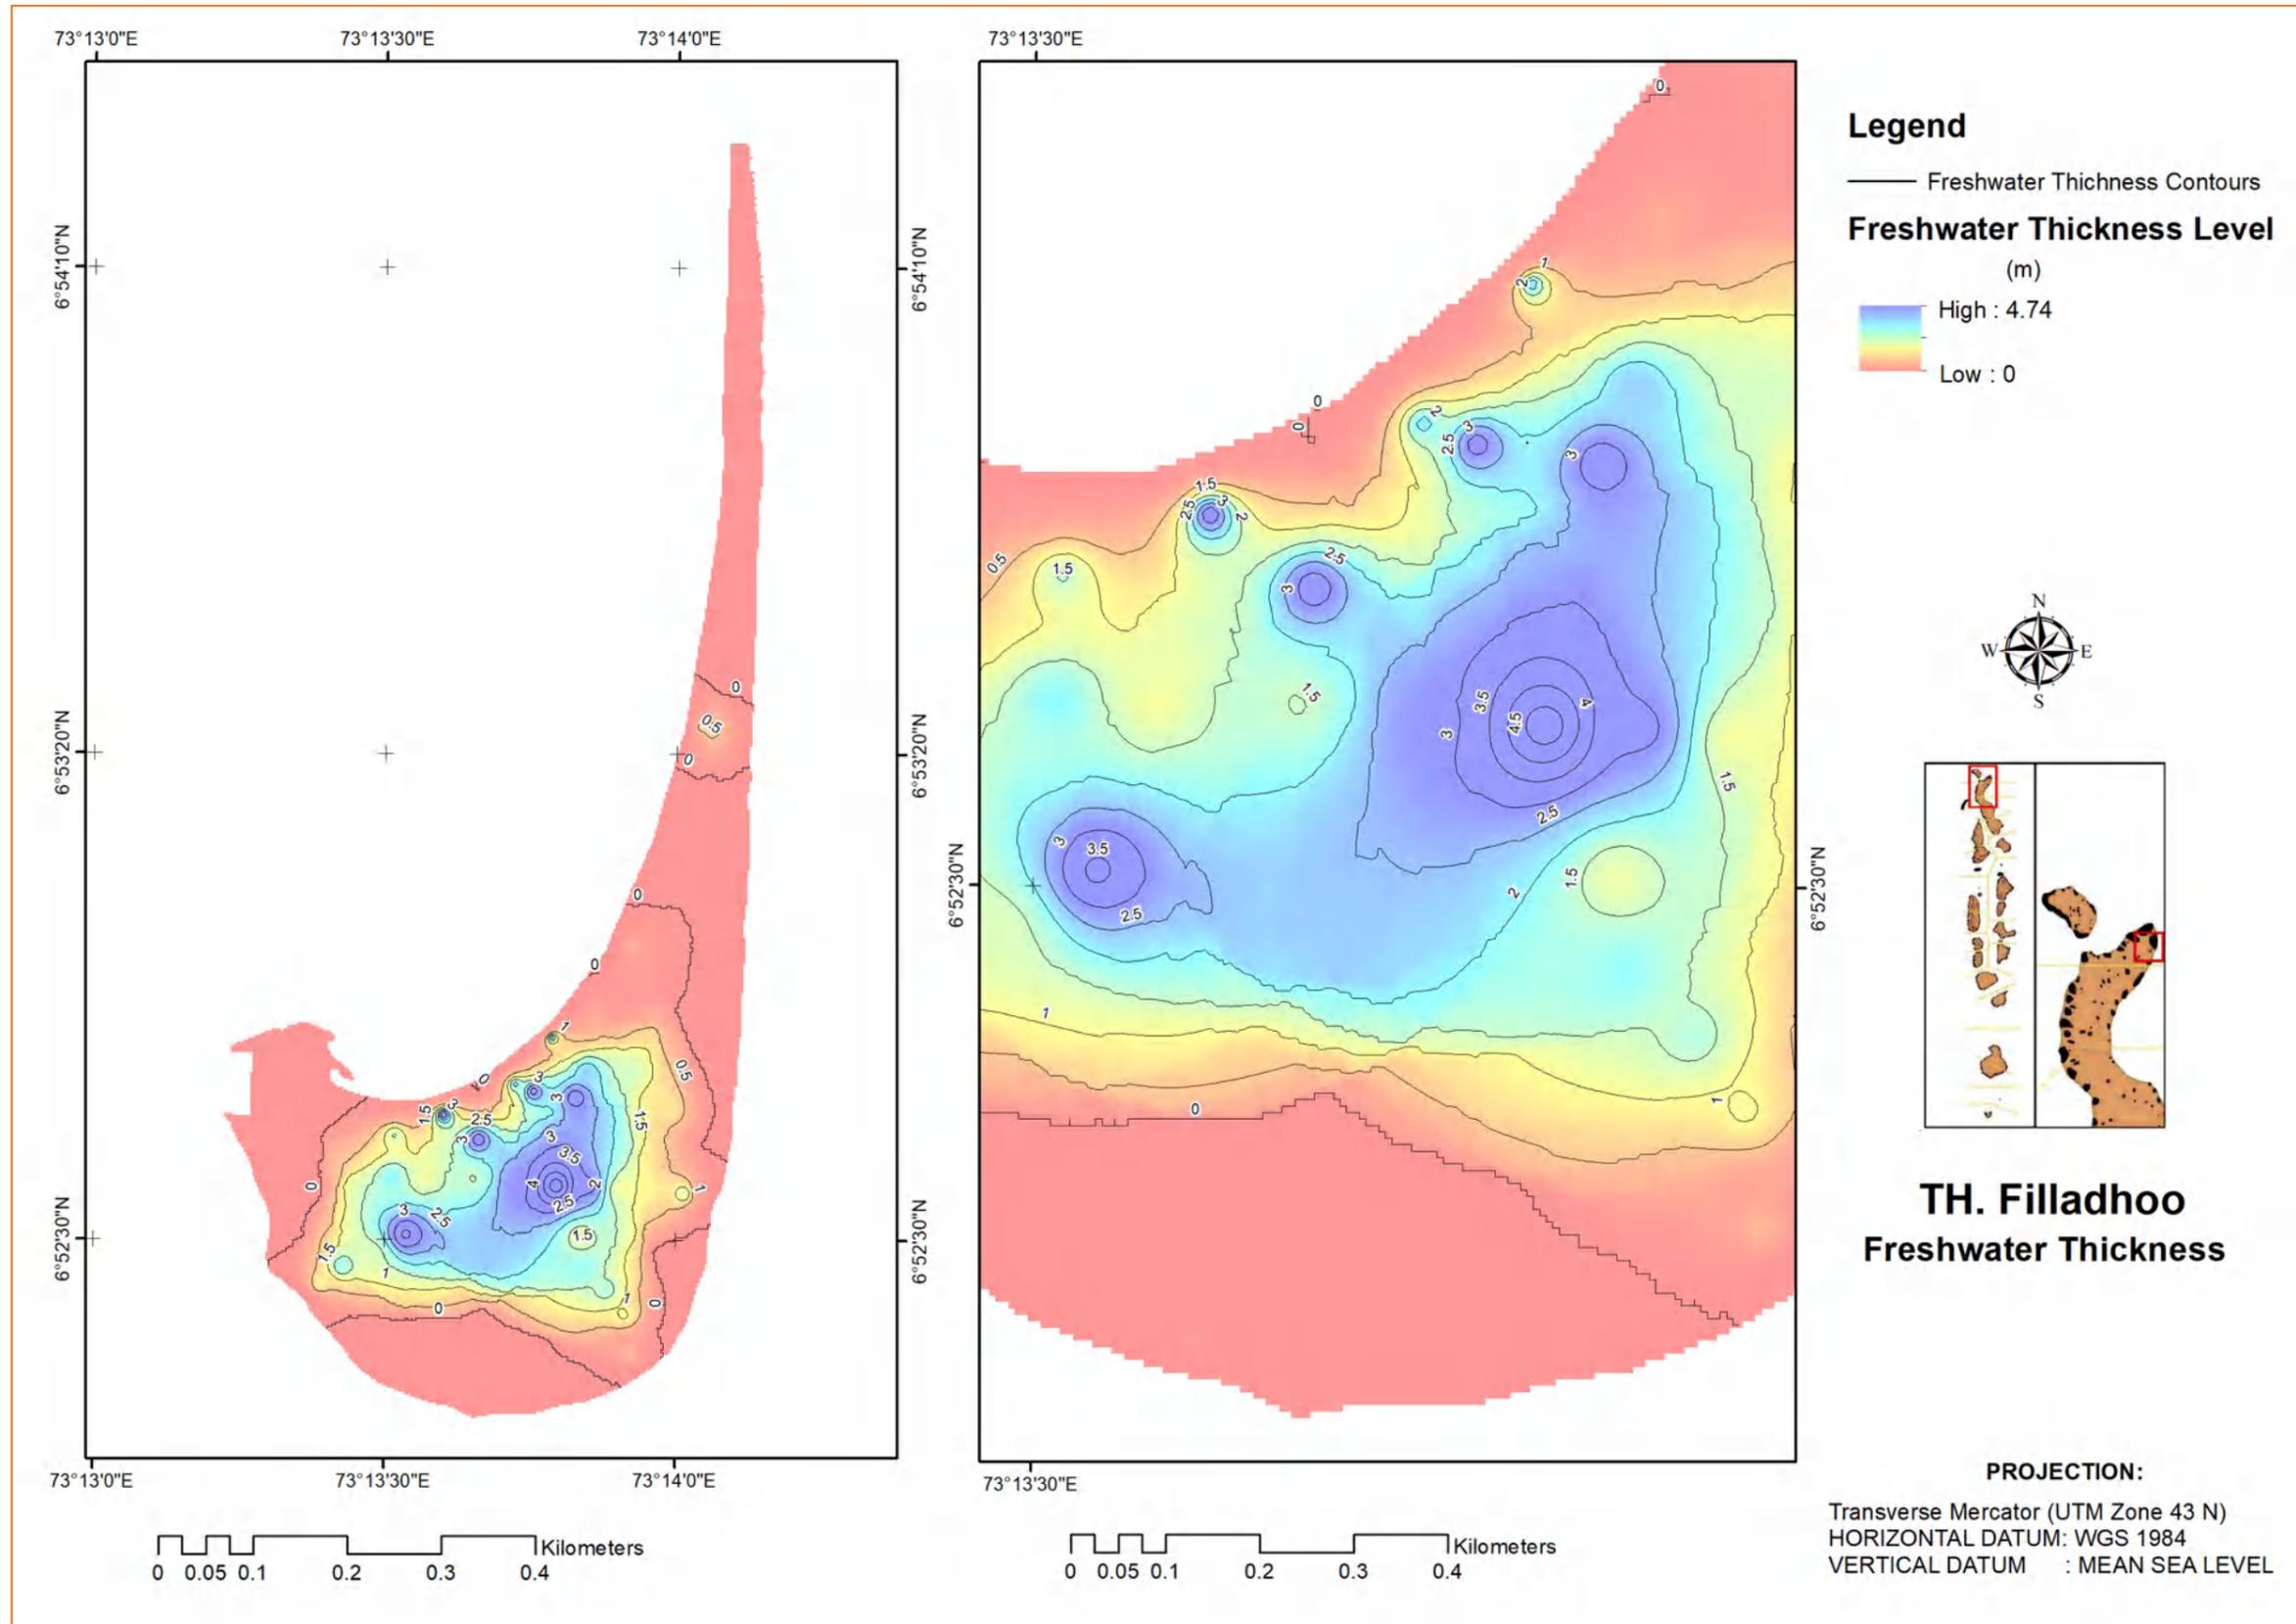
Figure 3-20: Freshwater thickness in Filladhoo Island

The maximum freshwater thickness of the island is 3.99 m (It is noted here that these readings were taken in October, which is the wet season and the with a reasonably higher number of wet days per month of the year).

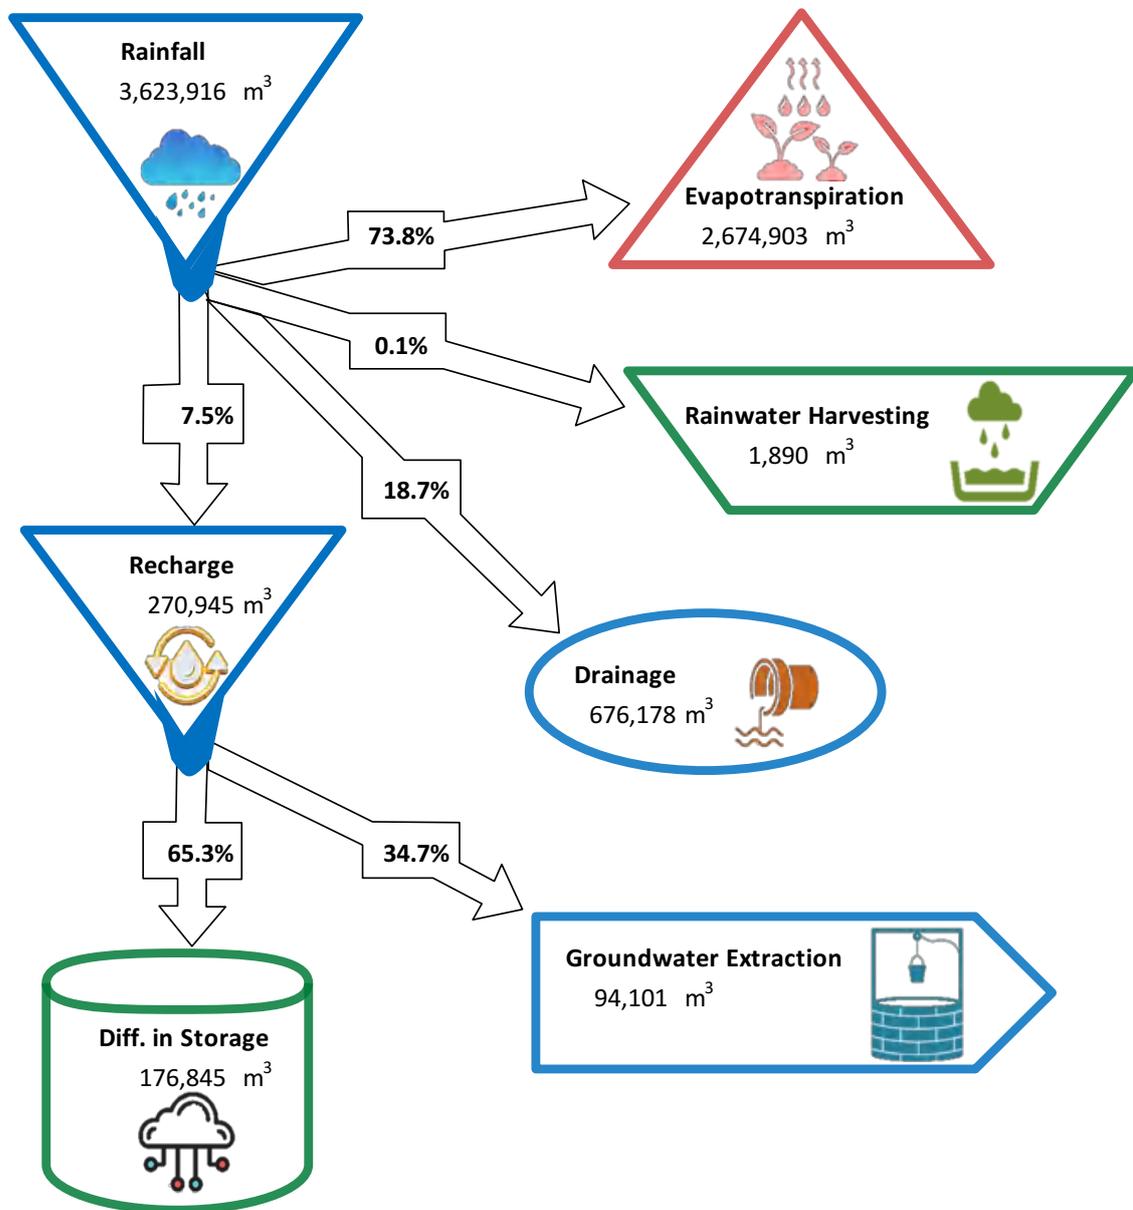
Figure 3-21: Schematic of water balance in Filladhoo Island

An annual estimation is carried out based on the water balance method (Falkland, 2000). Rainwater harvesting is calculated using the number of rainwater harvesting units on the island. According to the spatial mean annual rainfall of the Maldives, the annual average rainfall of Filladhoo Island is reported as 1,750 mm/year. Evapotranspiration was estimated using crop water requirements for different land use. Then, the rainfall was subtracted from rainwater harvesting, evapotranspiration, and drainage to get the recharge volume. Drainage or the surface runoff was calculated by considering an aggregate runoff coefficient for the island based on the land usage (roof cover, bare land, farmland, roads, playgrounds, wetlands). The groundwater extractions were estimated from the amount of water usage in different sectors (residential, resorts, restaurants, agriculture and farming). The difference between recharge and groundwater extraction is taken to estimate the difference in storage.

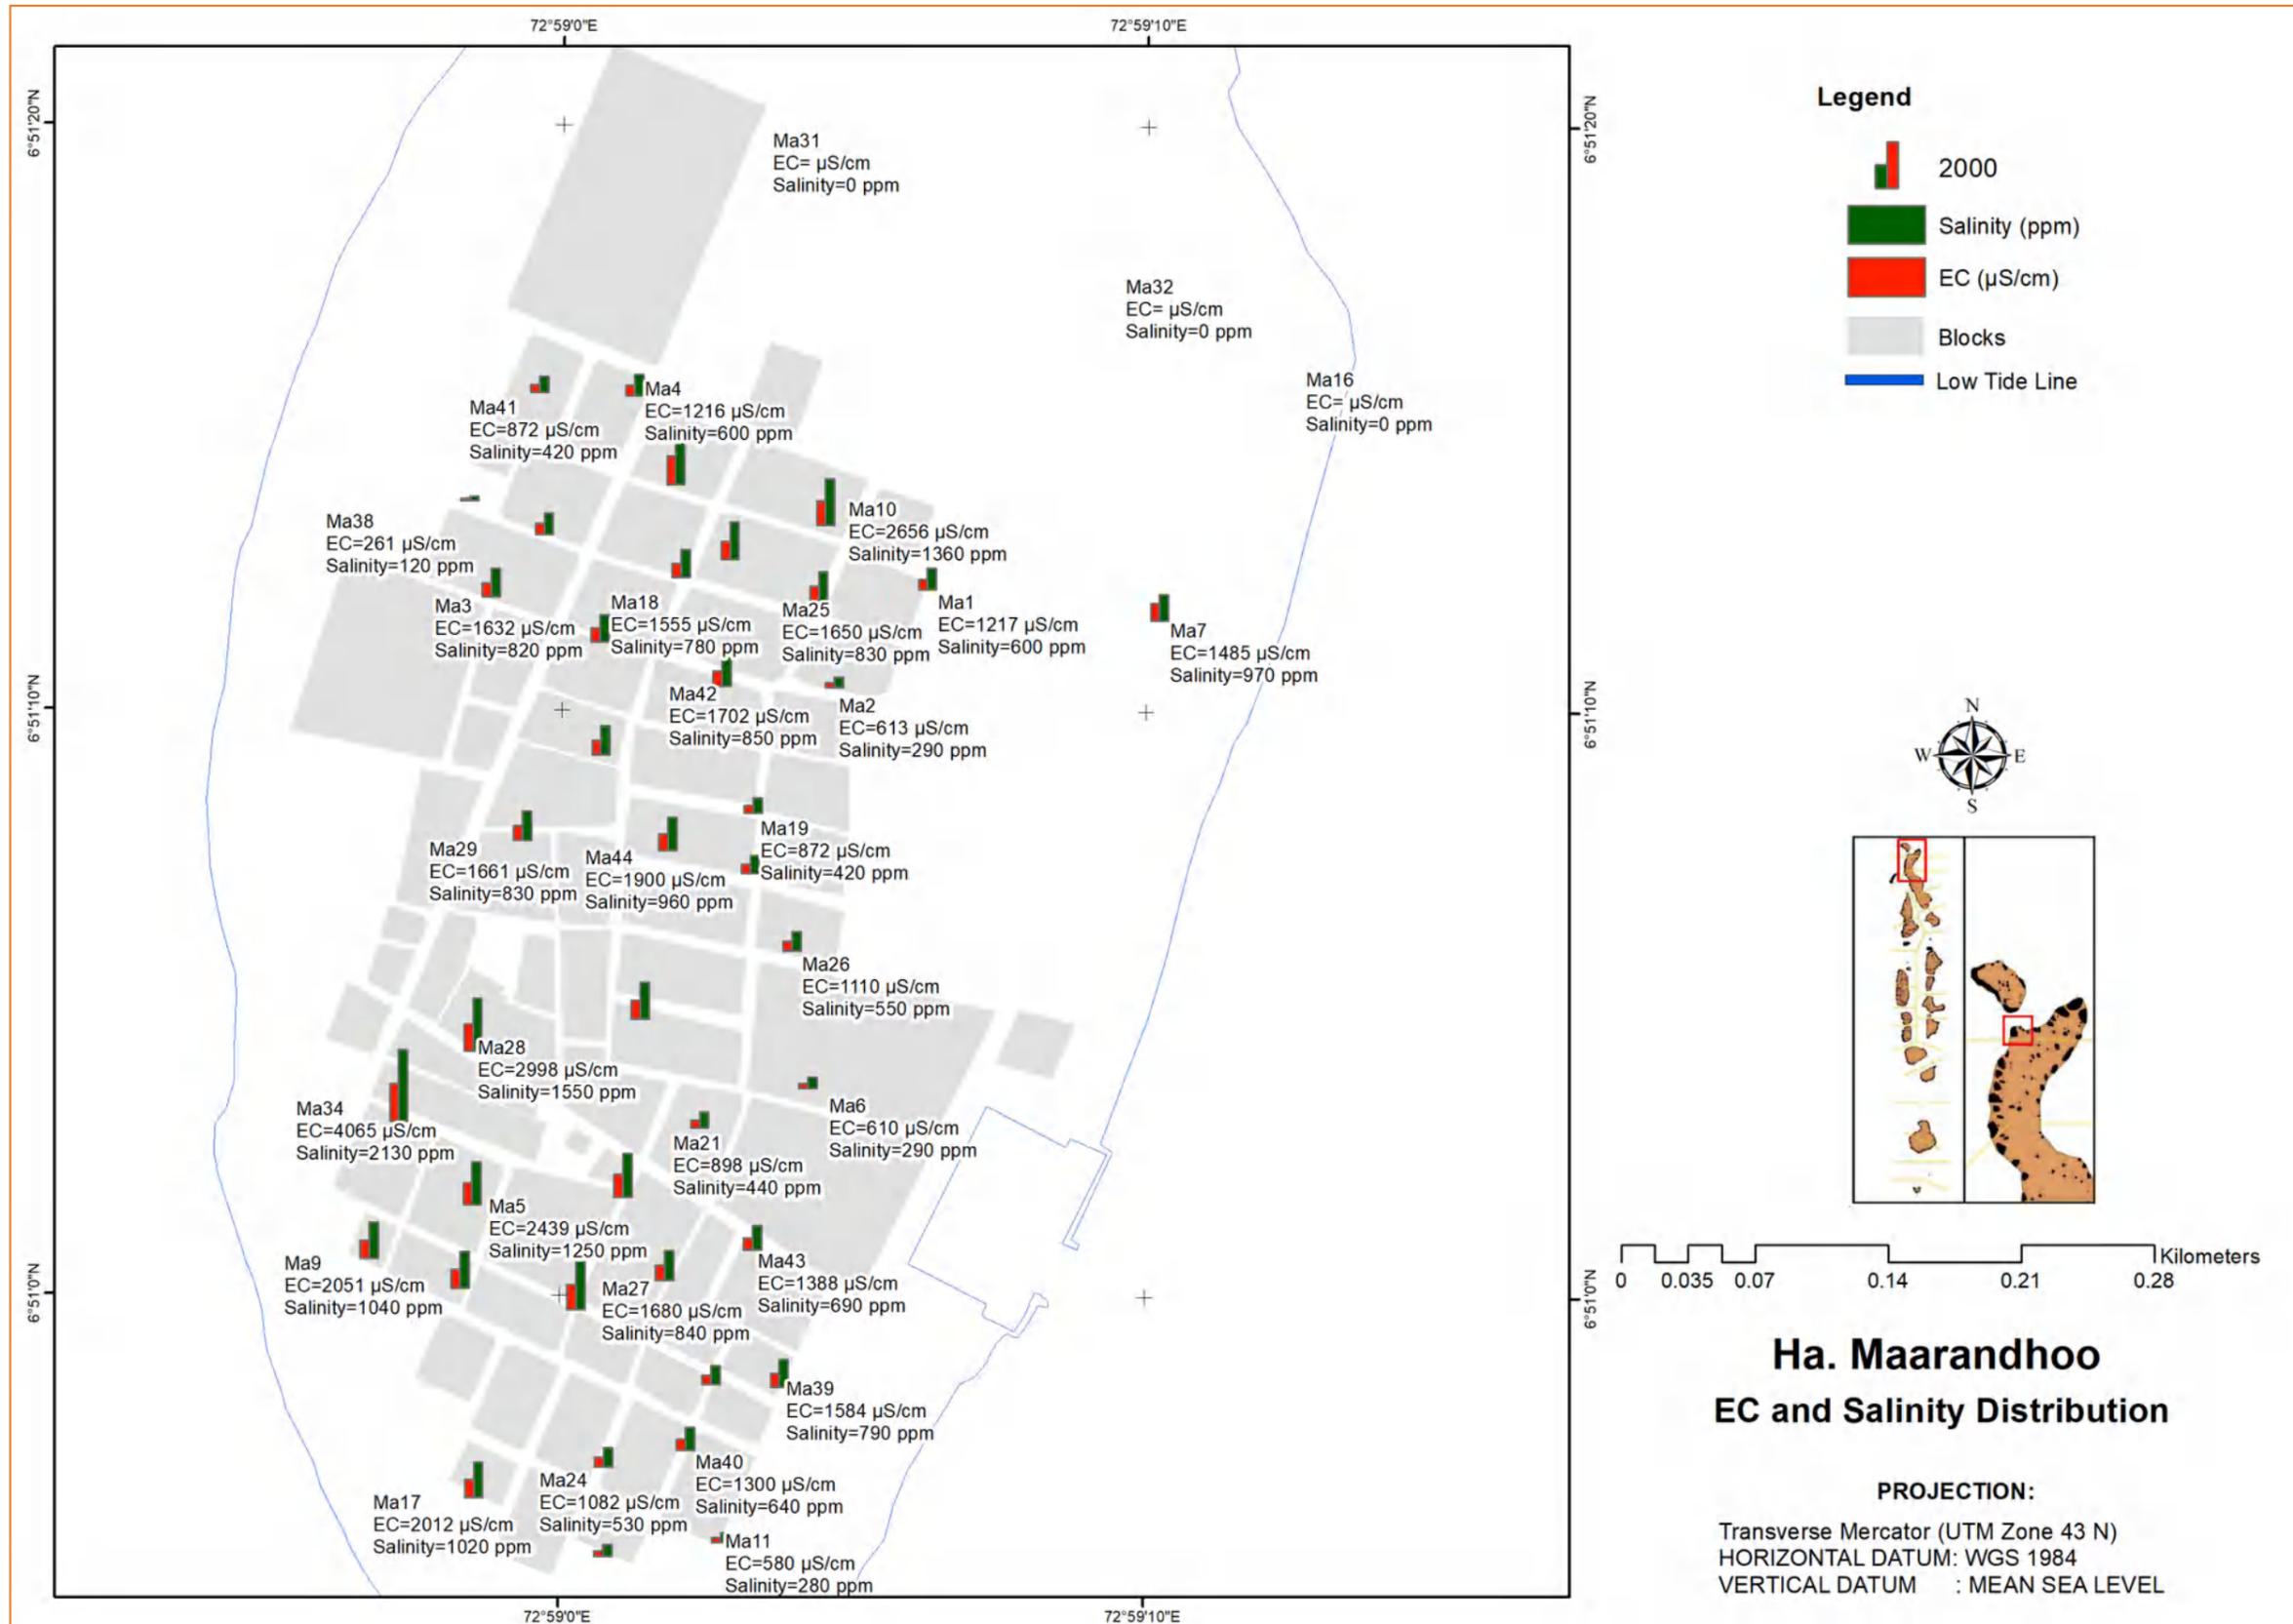
Figure 4-10: EC and Salinity Distribution in Ha. Maarandhoo Island

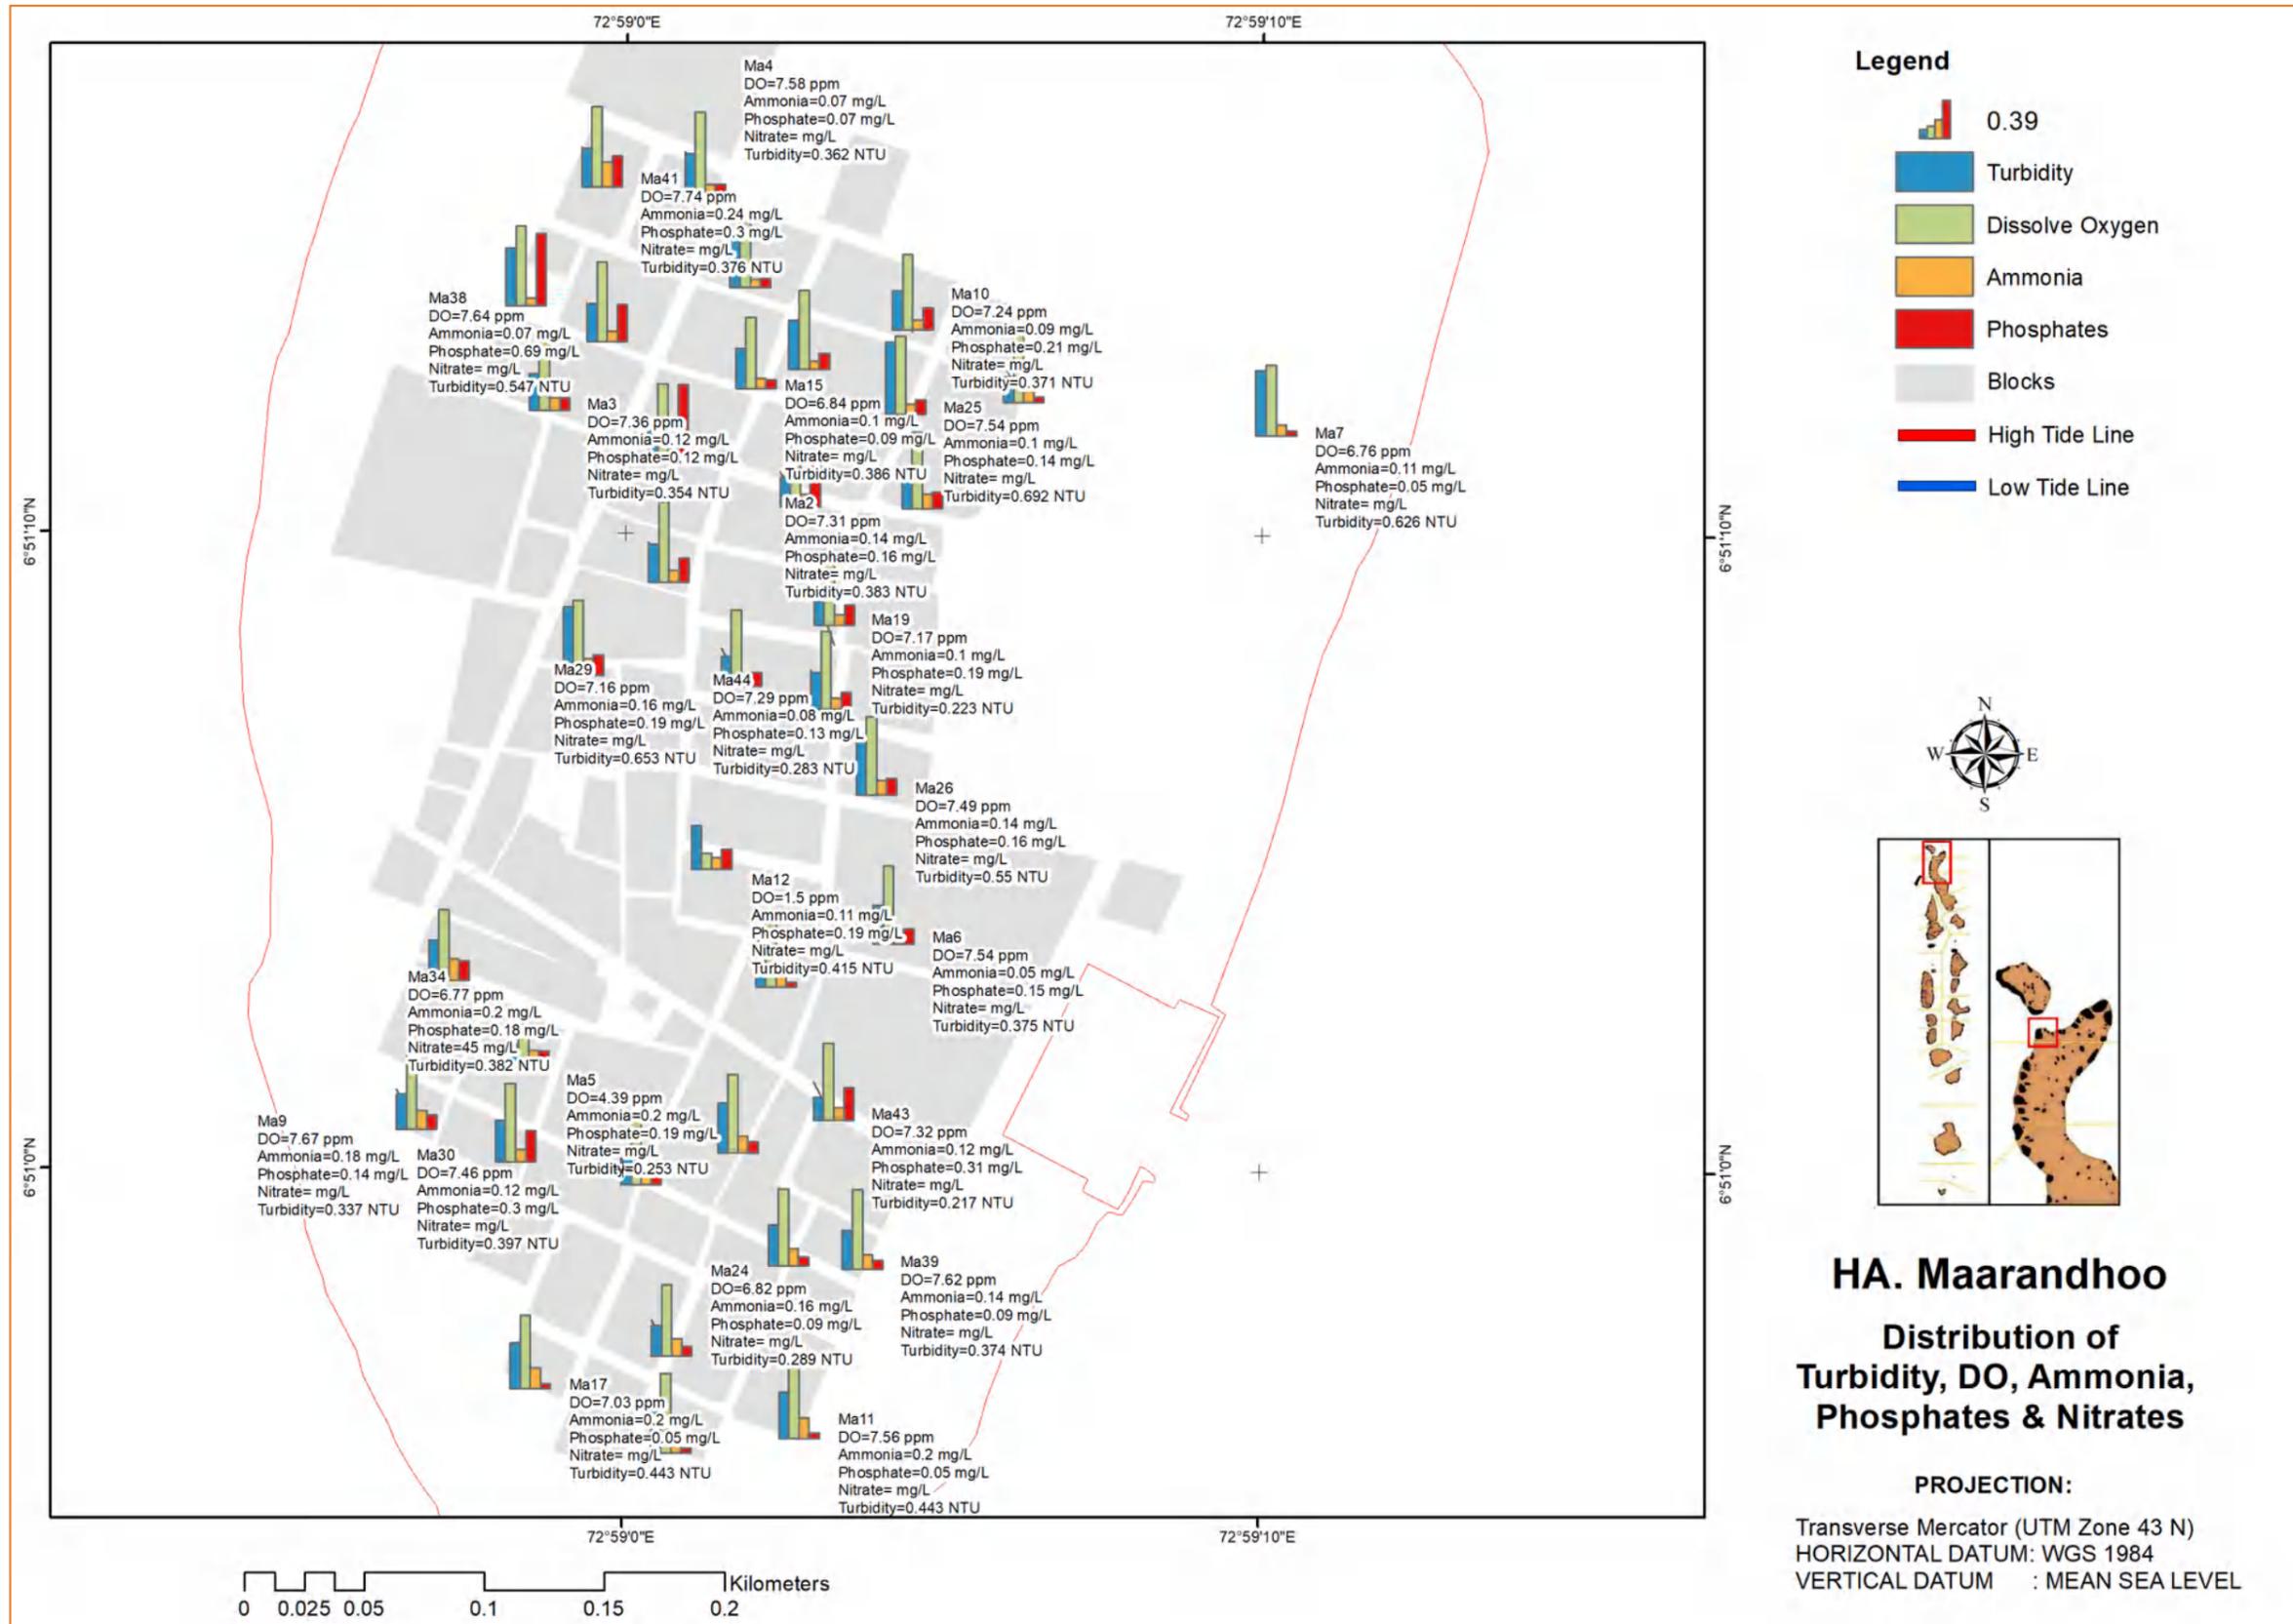
Figure 4-12: Distribution of Turbidity, DO, Ammonia, Phosphates and Nitrates in Ha. Maarandhoo Island

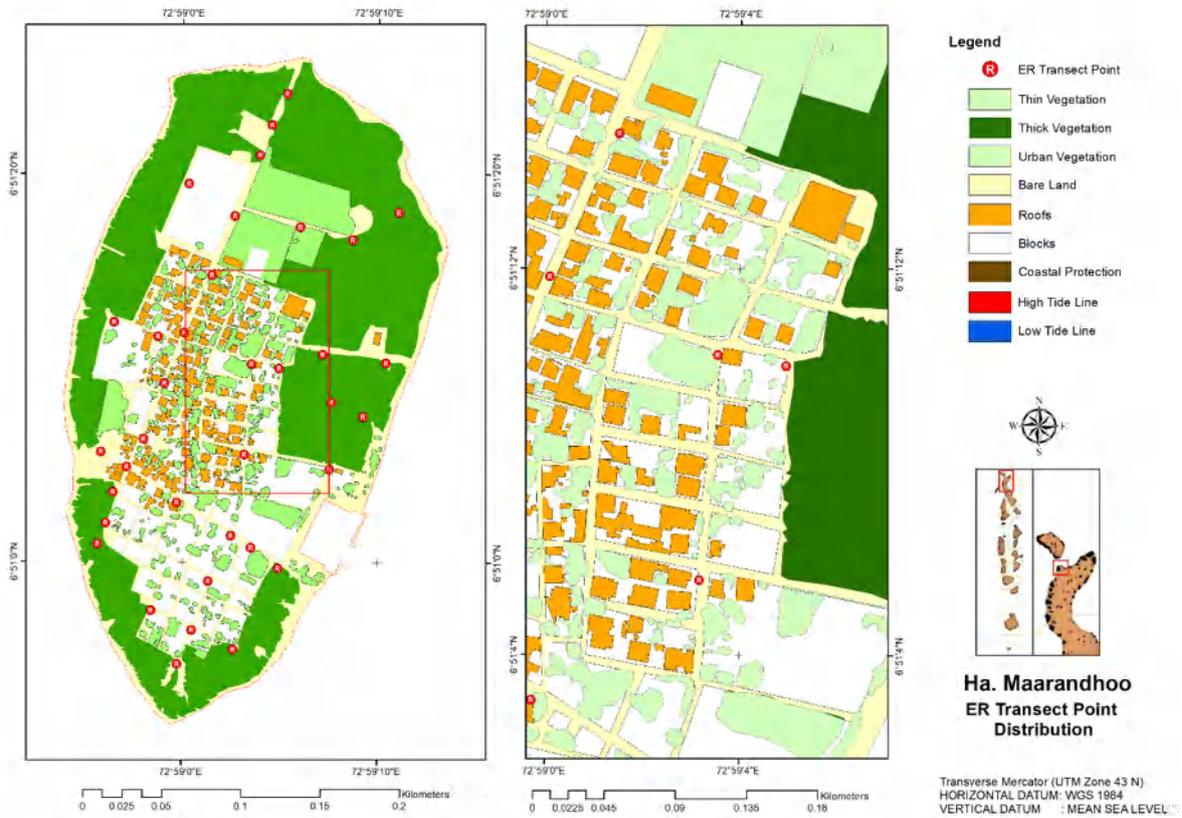
Figure 4-16: Location of ER points in Maarandhoo Island

The Electrical Resistivity (ER) tests were carried out in the locations as outlined in Figure 4-16 below. The ER survey included test points along 8 transects selected representatively based on reconnaissance surveys to adequately characterise different land uses and island cross-sections. The main transects were aligned along existing roads to maintain consistency and uniformity.

Based on the Electrical Resistivity (ER) surveys, the depth to groundwater level and the freshwater-saline water interface were determined for a set of transverse transects as shown in Figure 4-16. Plots in Figure 4-2 show the main two cross-sections of island. The dotted lines in the plots indicate a simple interpolation of levels to mean sea level in the island boundaries.

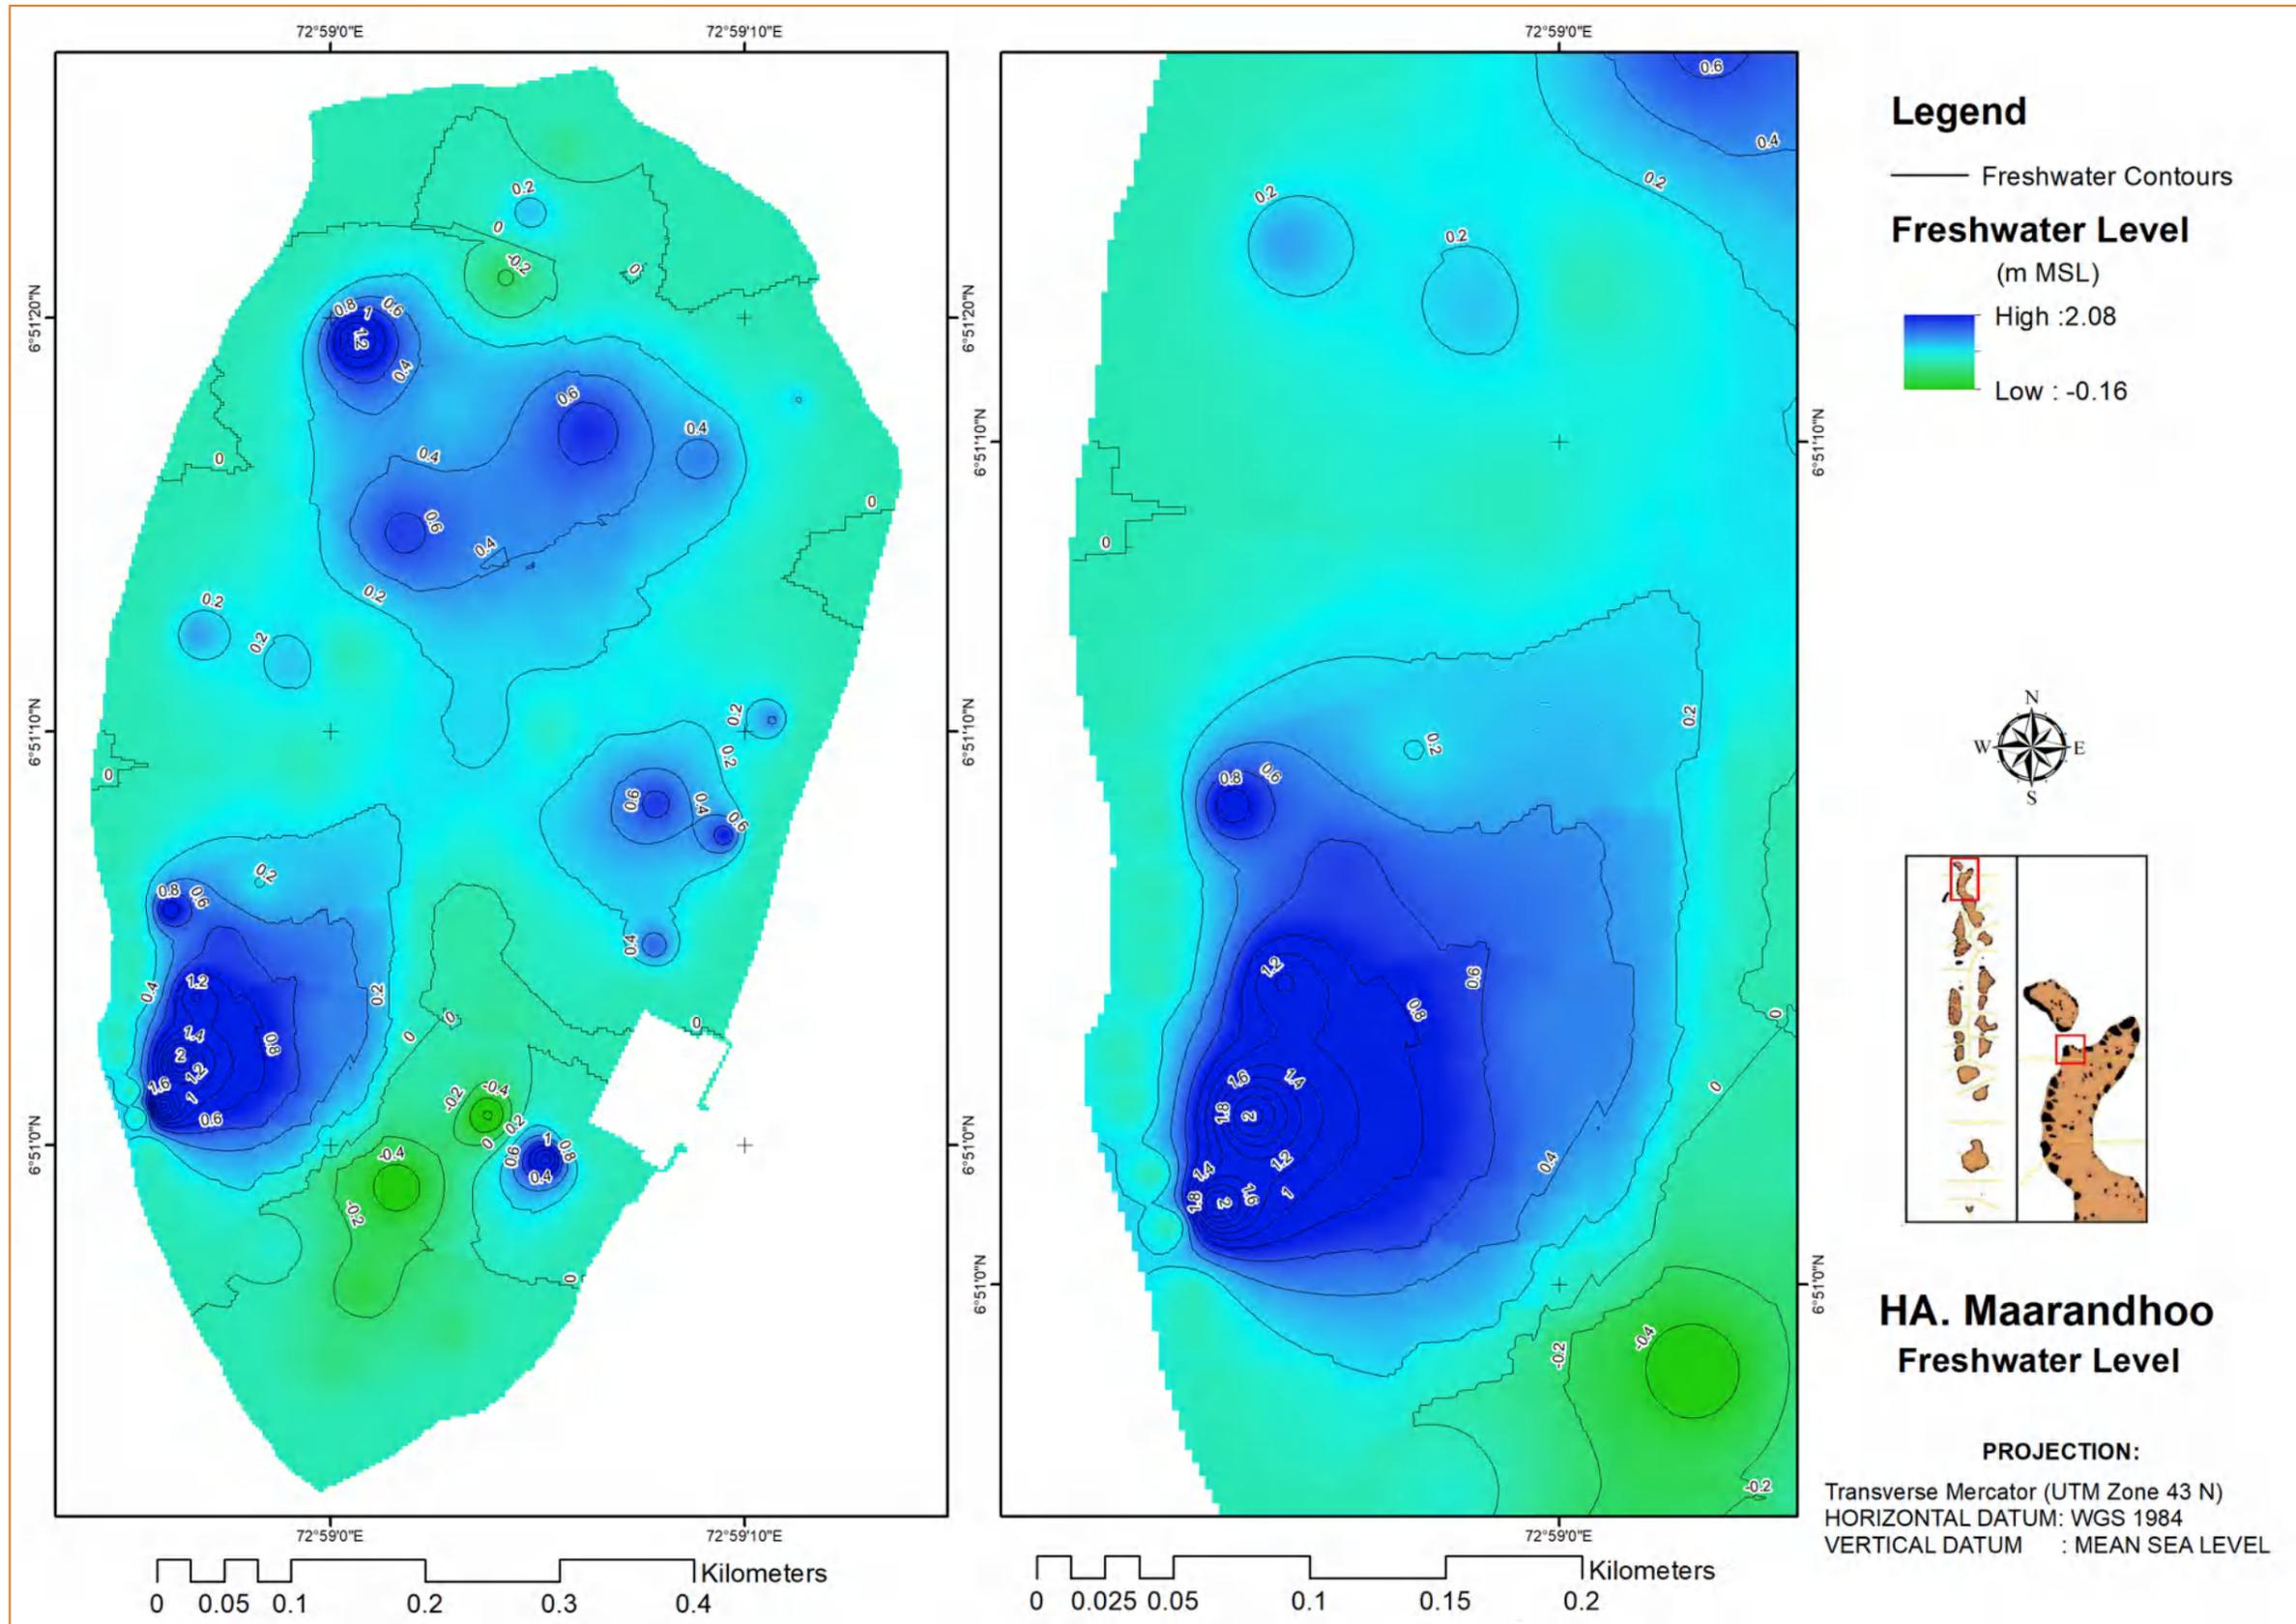
Figure 4-18: Freshwater Level in Maarandhoo Island

The 2-D freshwater lens distribution density maps produced with GIS software for visualization of the spatial and volume extents are also presented below in Figure 4-18 to Figure 4-20.
