Assessing Groundwater Resources and Design of Aquifer
Recharge Systems in Selected 17 Islands of Maldives - L1

BASELINE ASSESSMENT REPORT

Ha Filladhoo, Ha Maarandhoo, Ha Muraidhoo
Ha Uligan, and Ha Molhadhoo

Assignment: Assessing Groundwater Resources and Design of Aquifer Recharge Systems in Selected 17 Islands of Maldives (Lot 1)

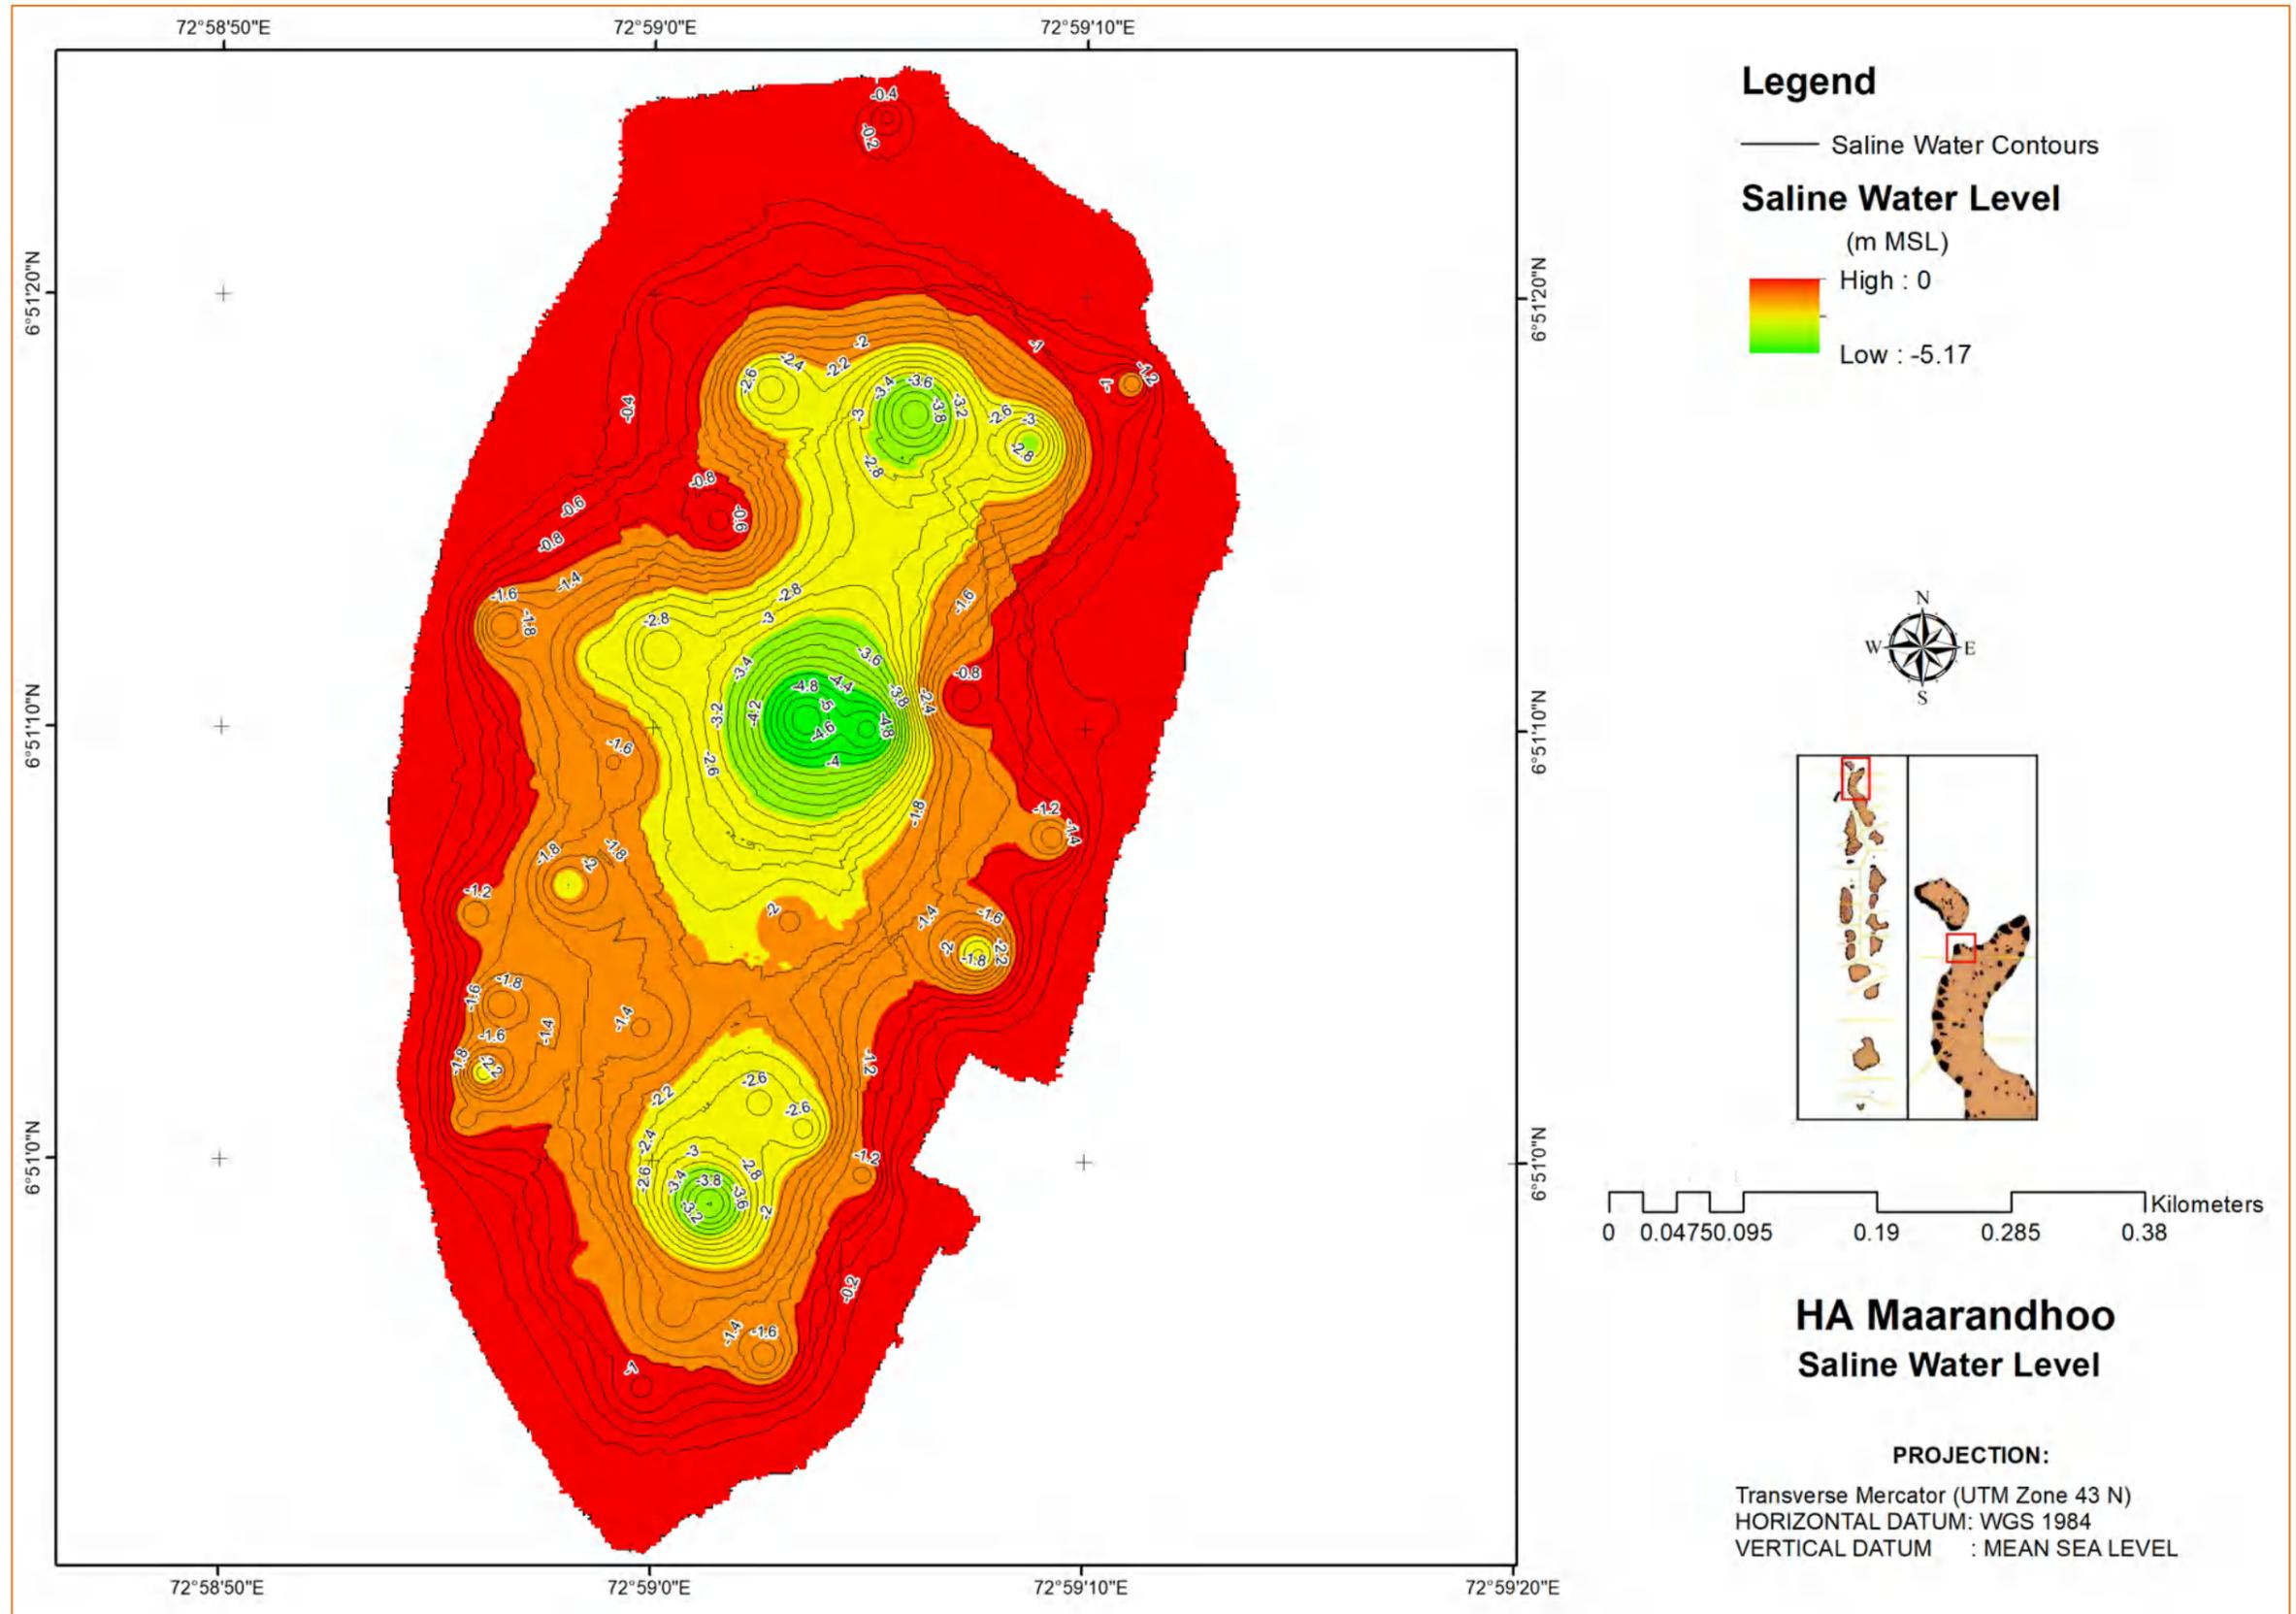
Figure 4-19: Saline water Level in Maarandhoo Island

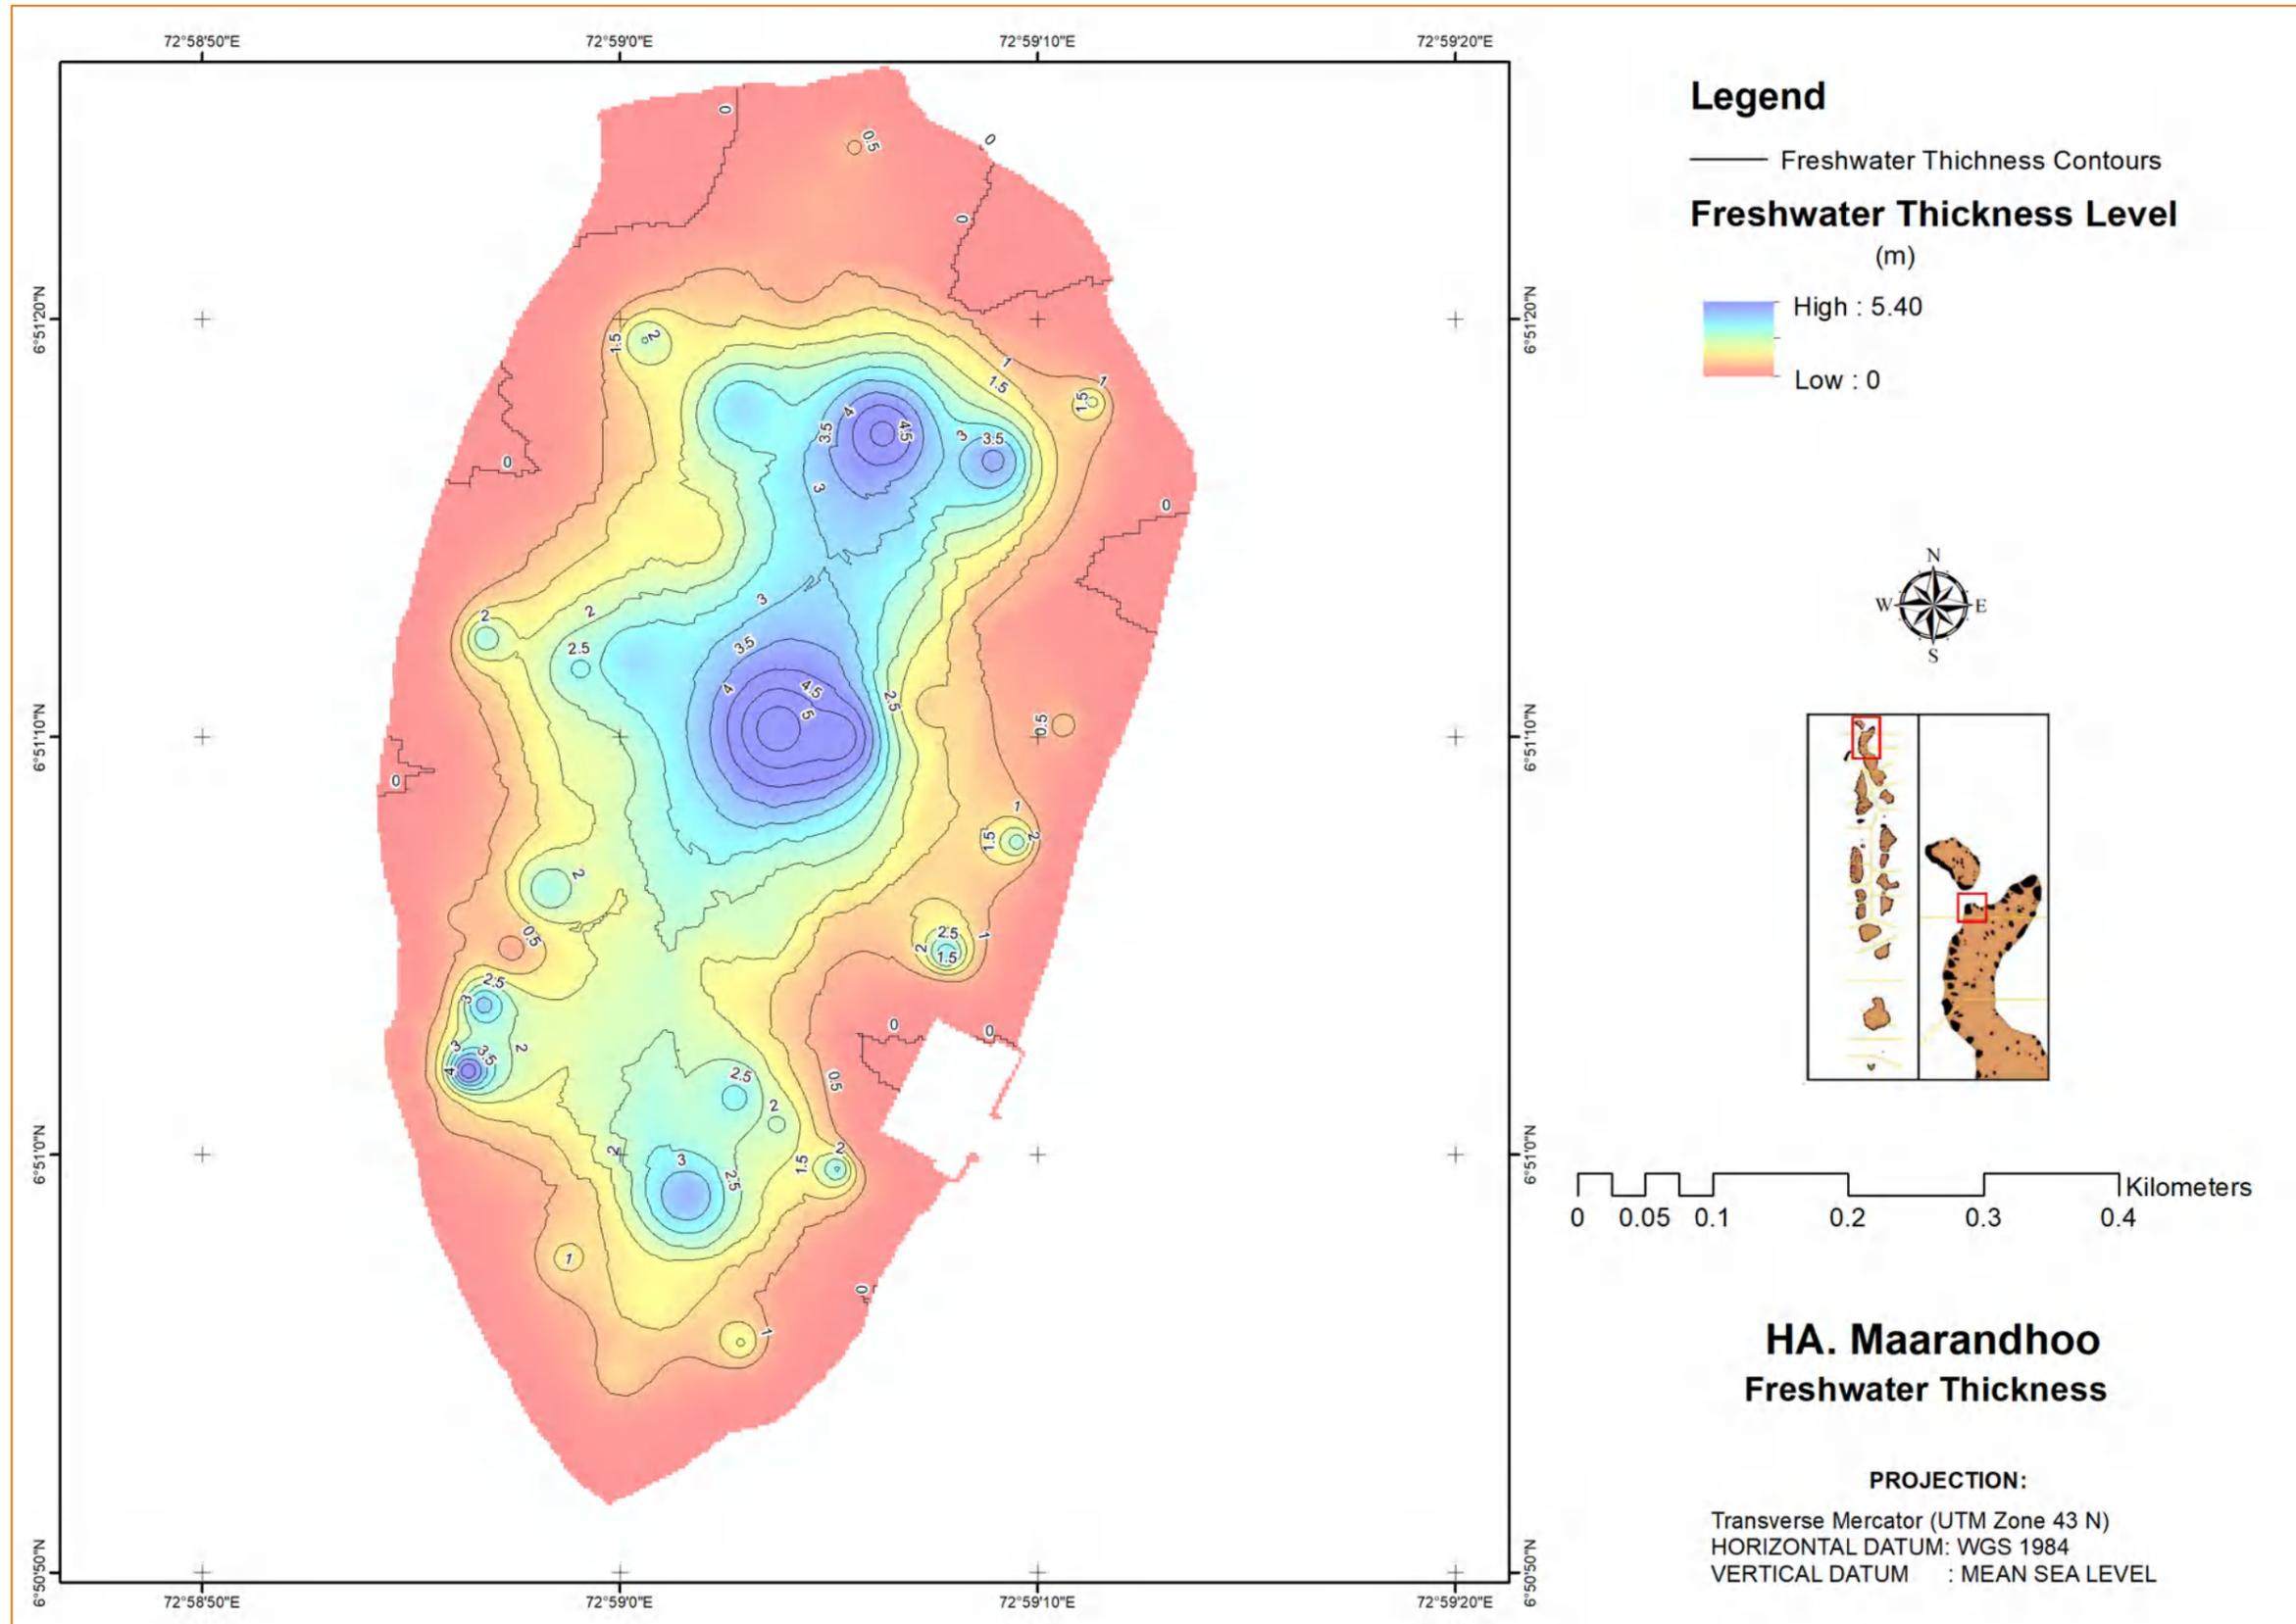
Figure 4-20: Freshwater thickness in Maarandhoo Island

The maximum freshwater thickness of the island is 3.39 m (It is noted here that these readings were taken in October, which is the wet season and the with a reasonably higher number of wet days per month of the year).

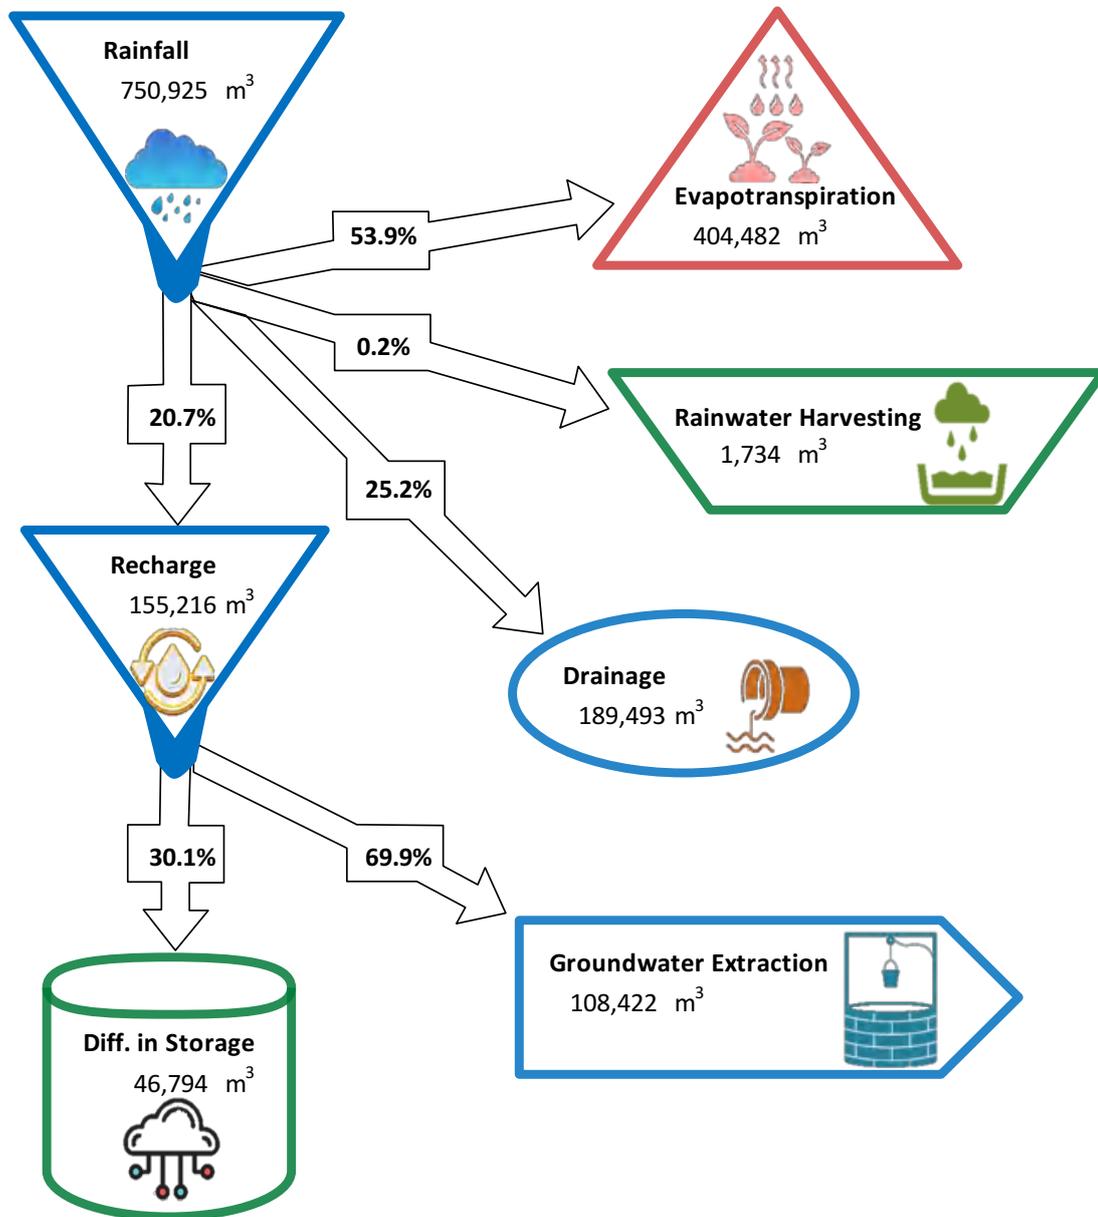
Figure 4-21: Schematic of water balance in Maarandhoo Island

An annual estimation is carried out based on the water balance method (Falkland, 2000). Rainwater harvesting is calculated using the number of rainwater harvesting units on the island. According to the spatial mean annual rainfall of the Maldives, the annual average rainfall of Maarandhoo Island is reported as 1,750 mm/year. Evapotranspiration was estimated using crop water requirements for different land use. Then, the rainfall was subtracted from rainwater harvesting, evapotranspiration, drainage to get the recharge volume. Drainage or the surface runoff was calculated by considering an aggregate runoff coefficient for the island based on the land usage (roof cover, bare land, farmland, roads, playgrounds, wetlands). The groundwater extractions were estimated from the amount of water usage in different sectors (residential, resorts, restaurants, agriculture and farming). The difference between recharge and groundwater extraction is taken to estimate the difference in storage.

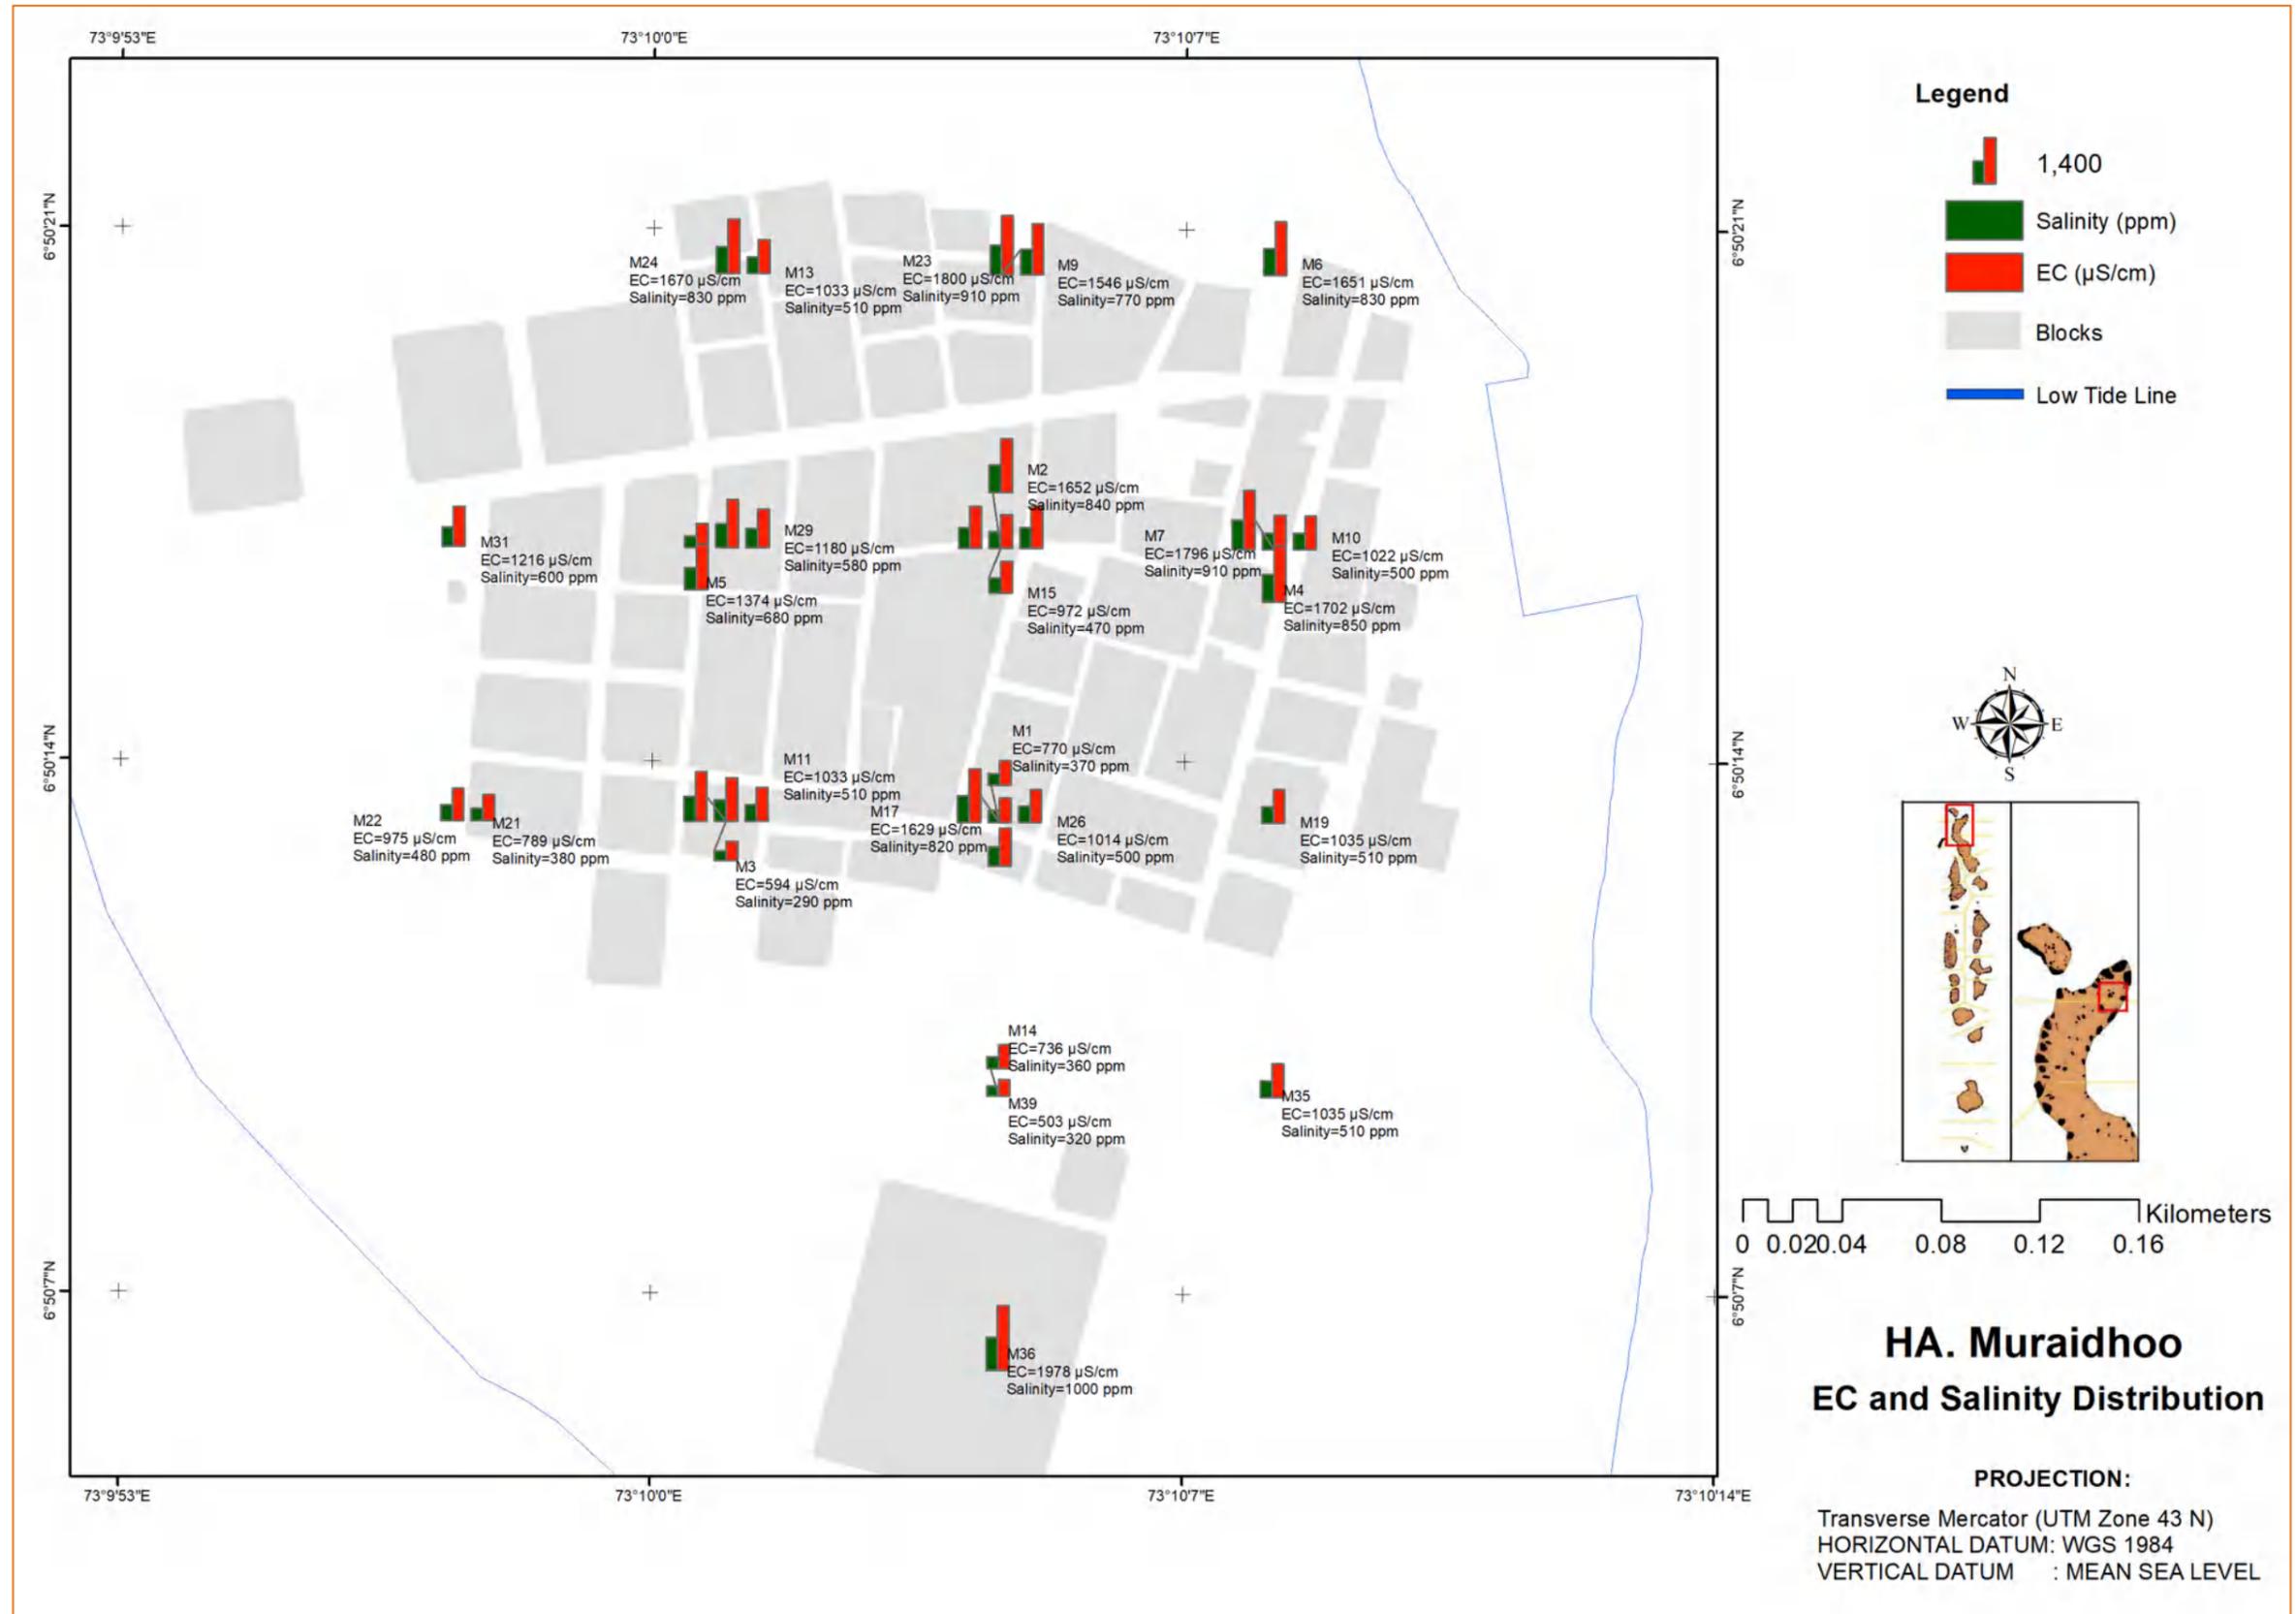
Figure 5-9: EC and Salinity Distribution in Ha. Muraidhoo Island

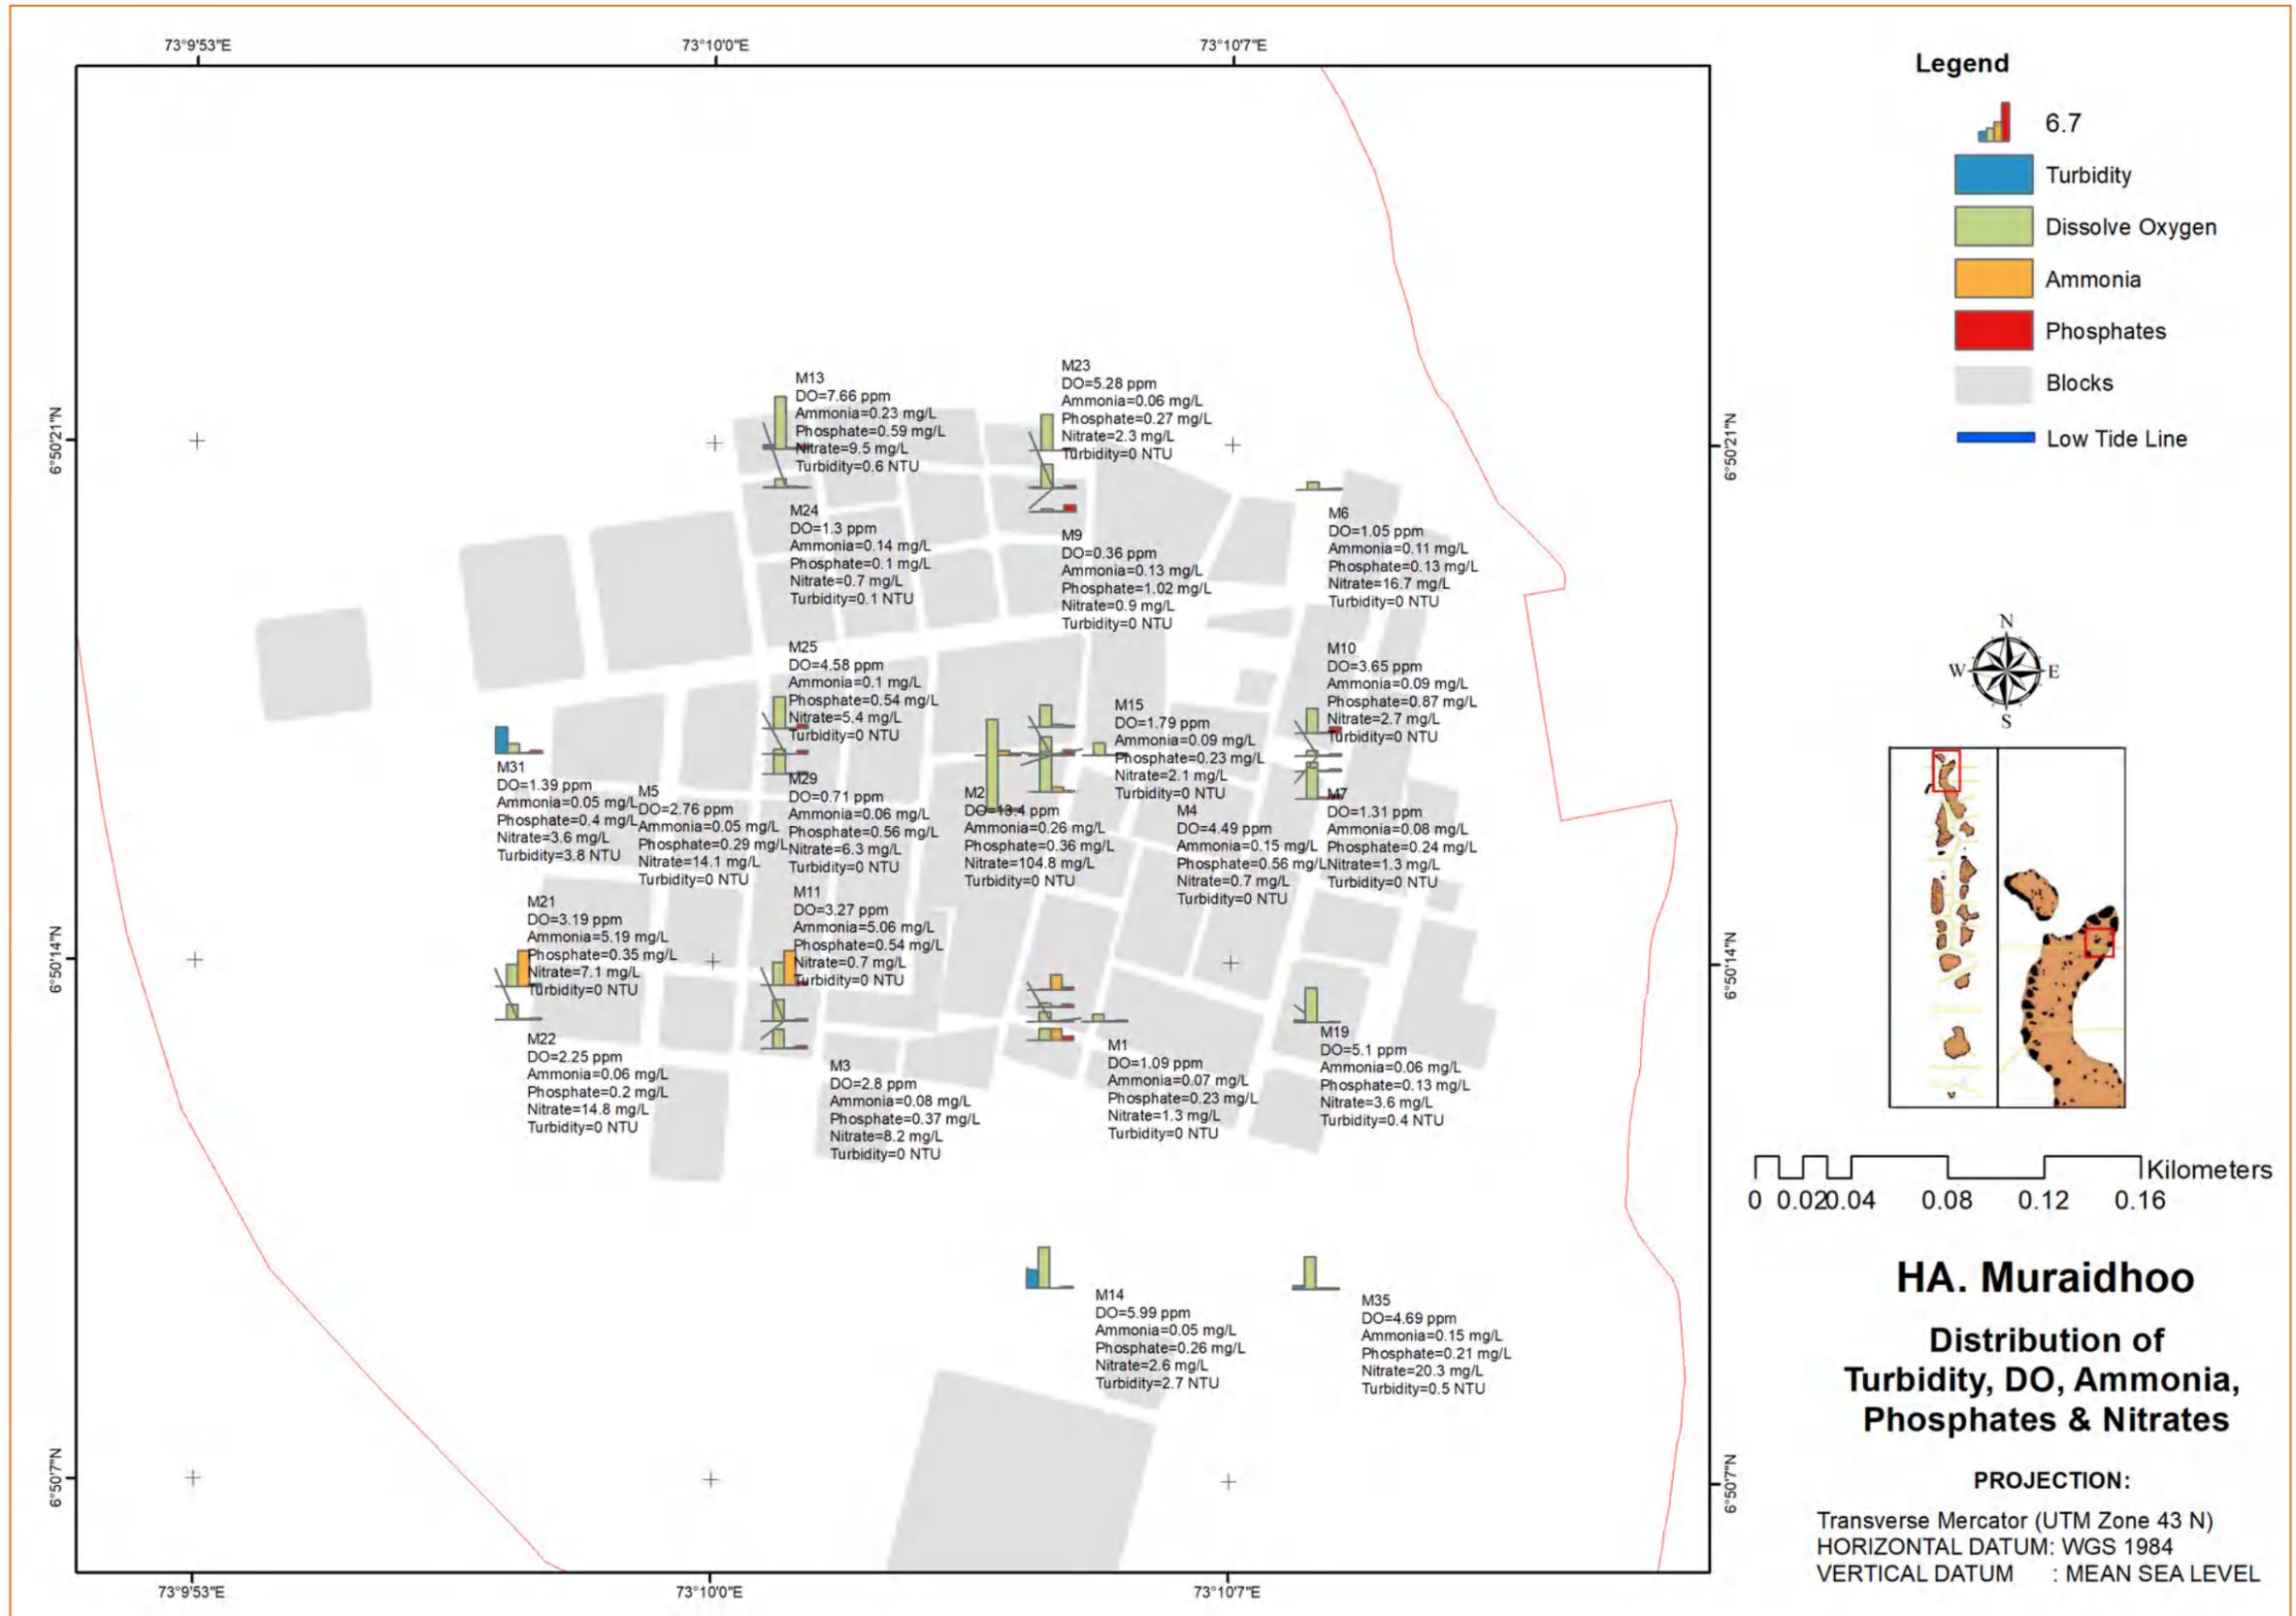
Figure 5-11: Distribution of Turbidity, DO, Ammonia, Phosphates and Nitrates in Ha. Muraidhoo Island

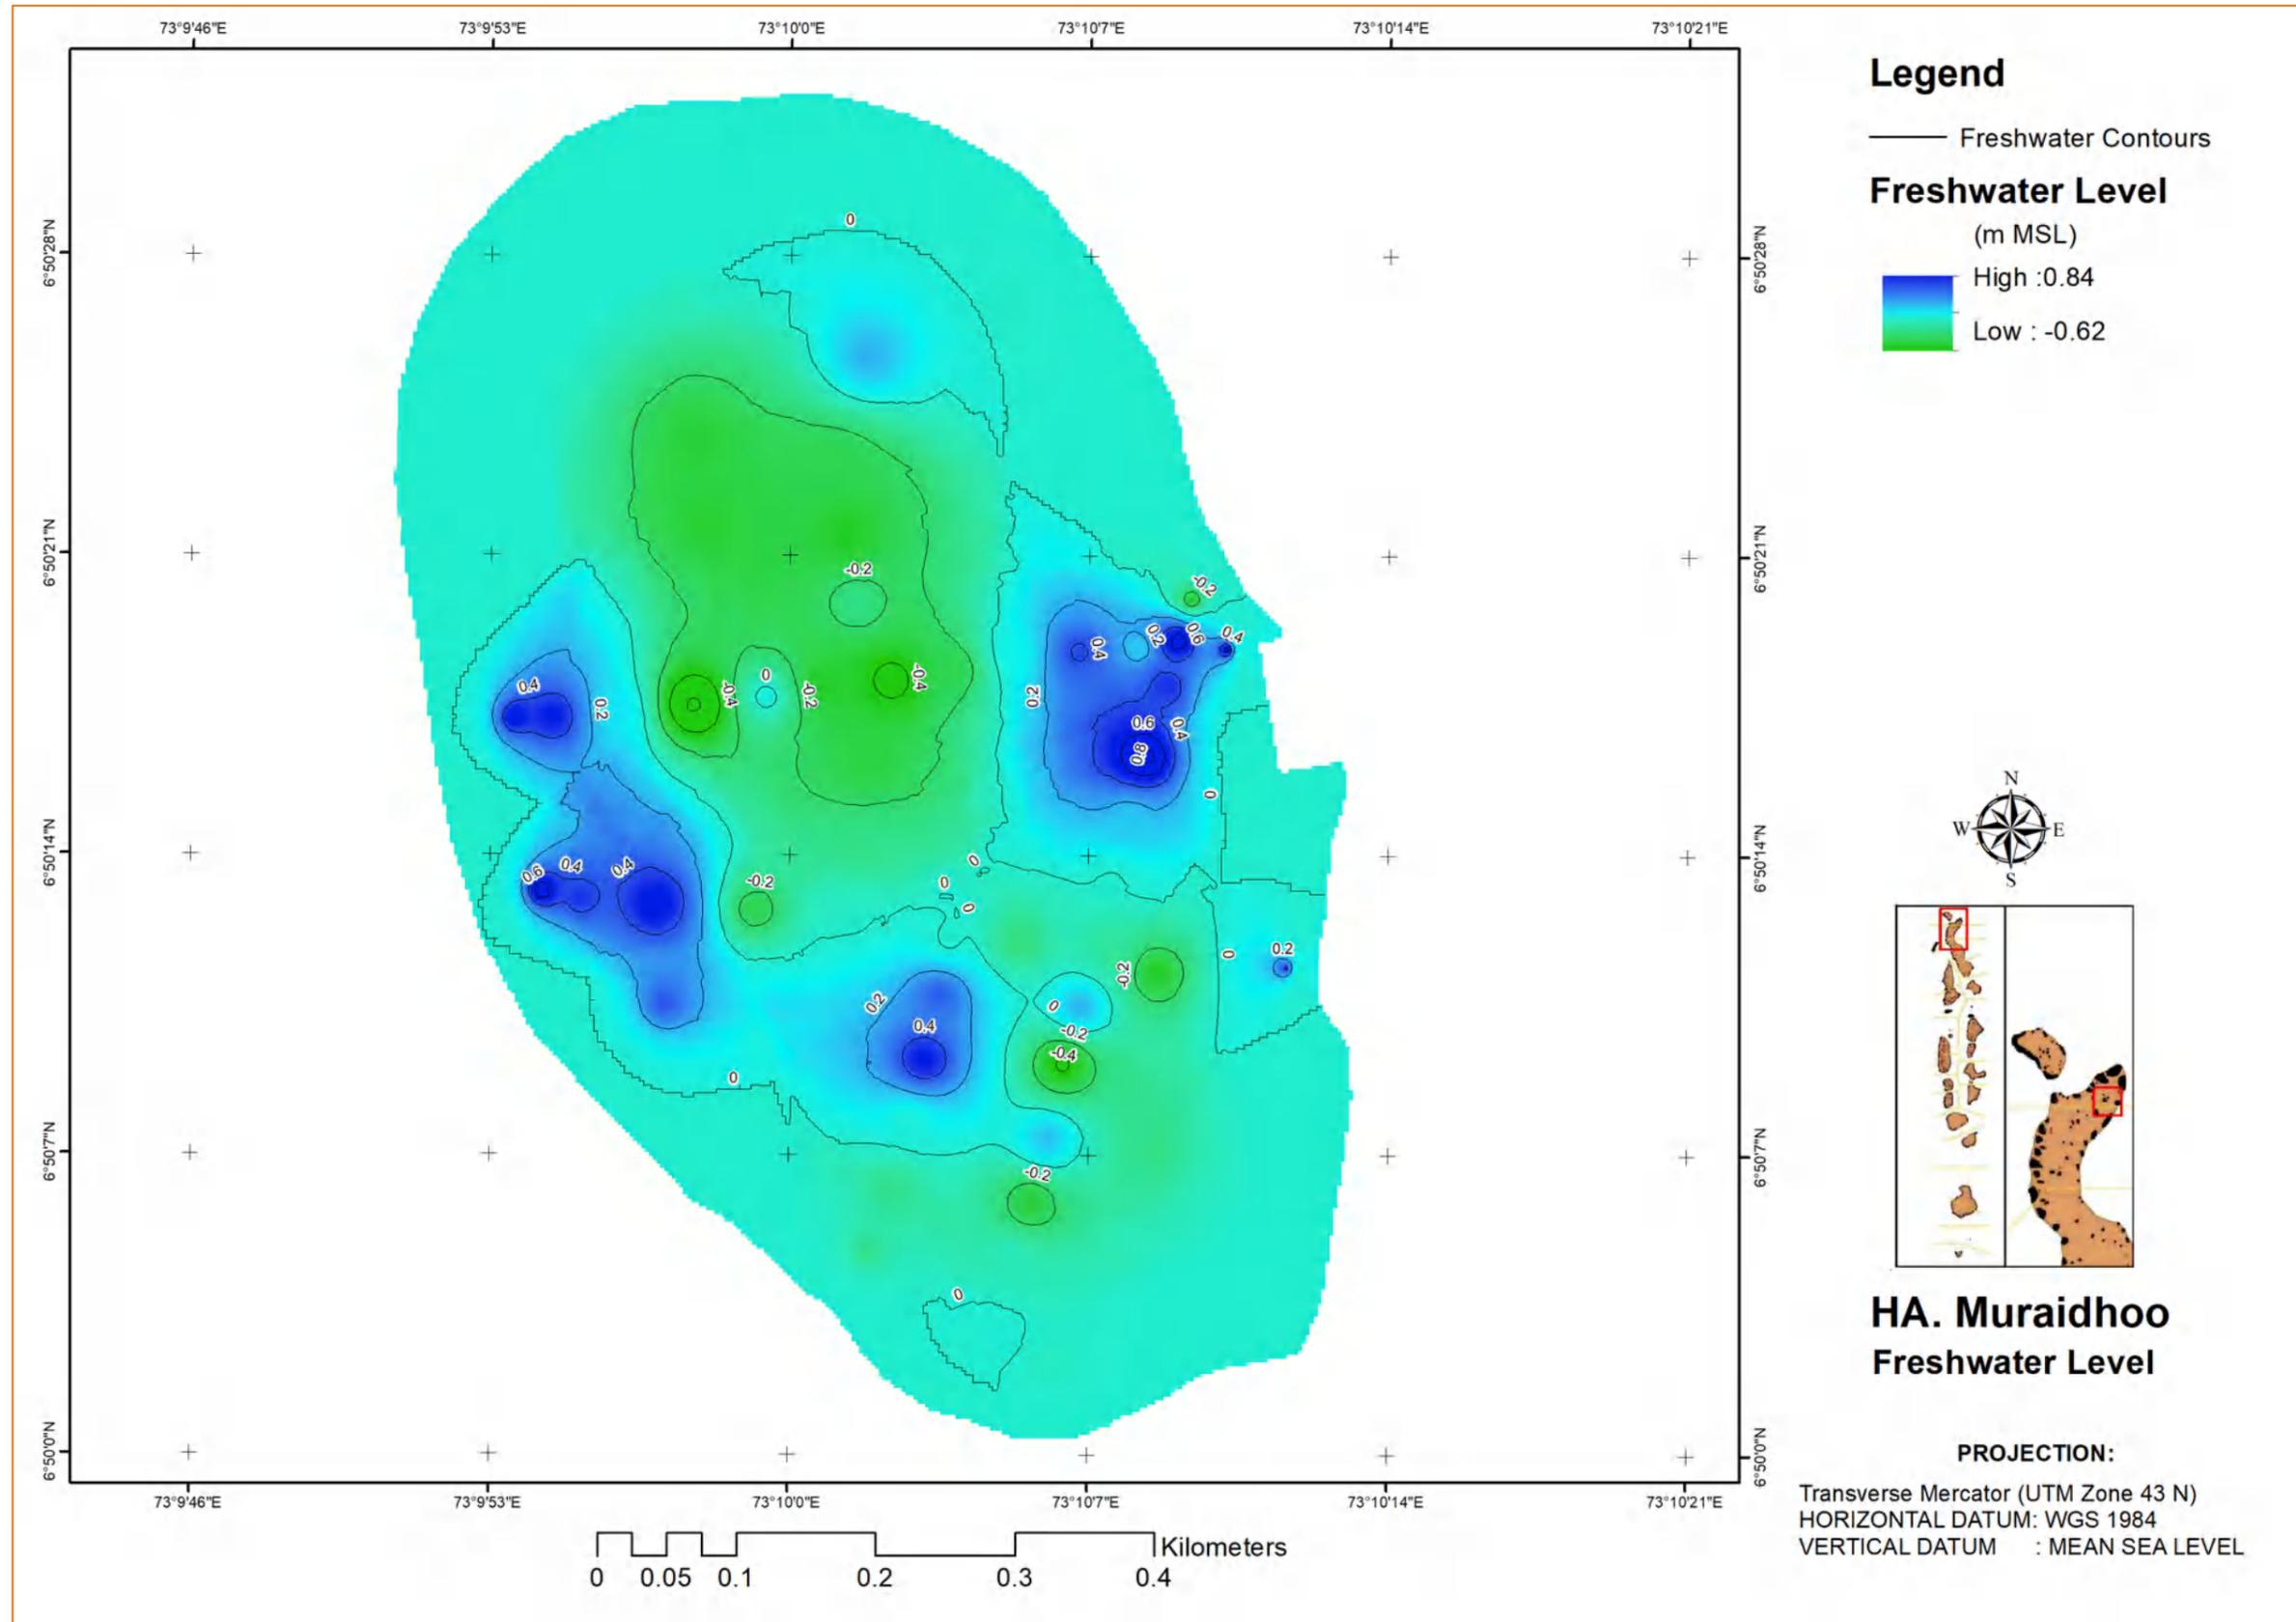
Figure 5-17: Freshwater Level in Muraidhoo Island

The 2-D freshwater lens distribution density maps produced with GIS software for visualization of the spatial and volume extents are also presented below in Figure 5-17 to Figure 5-19.
