Assessing Groundwater Resources and Design of Aquifer
Recharge Systems in Selected 17 Islands of Maldives - L1

BASELINE ASSESSMENT REPORT

Ha Filladhoo, Ha Maarandhoo, Ha Muraidhoo
Ha Uligan, and Ha Molhadhoo

Assignment: Assessing Groundwater Resources and Design of Aquifer Recharge Systems in Selected 17 Islands of Maldives (Lot 1)

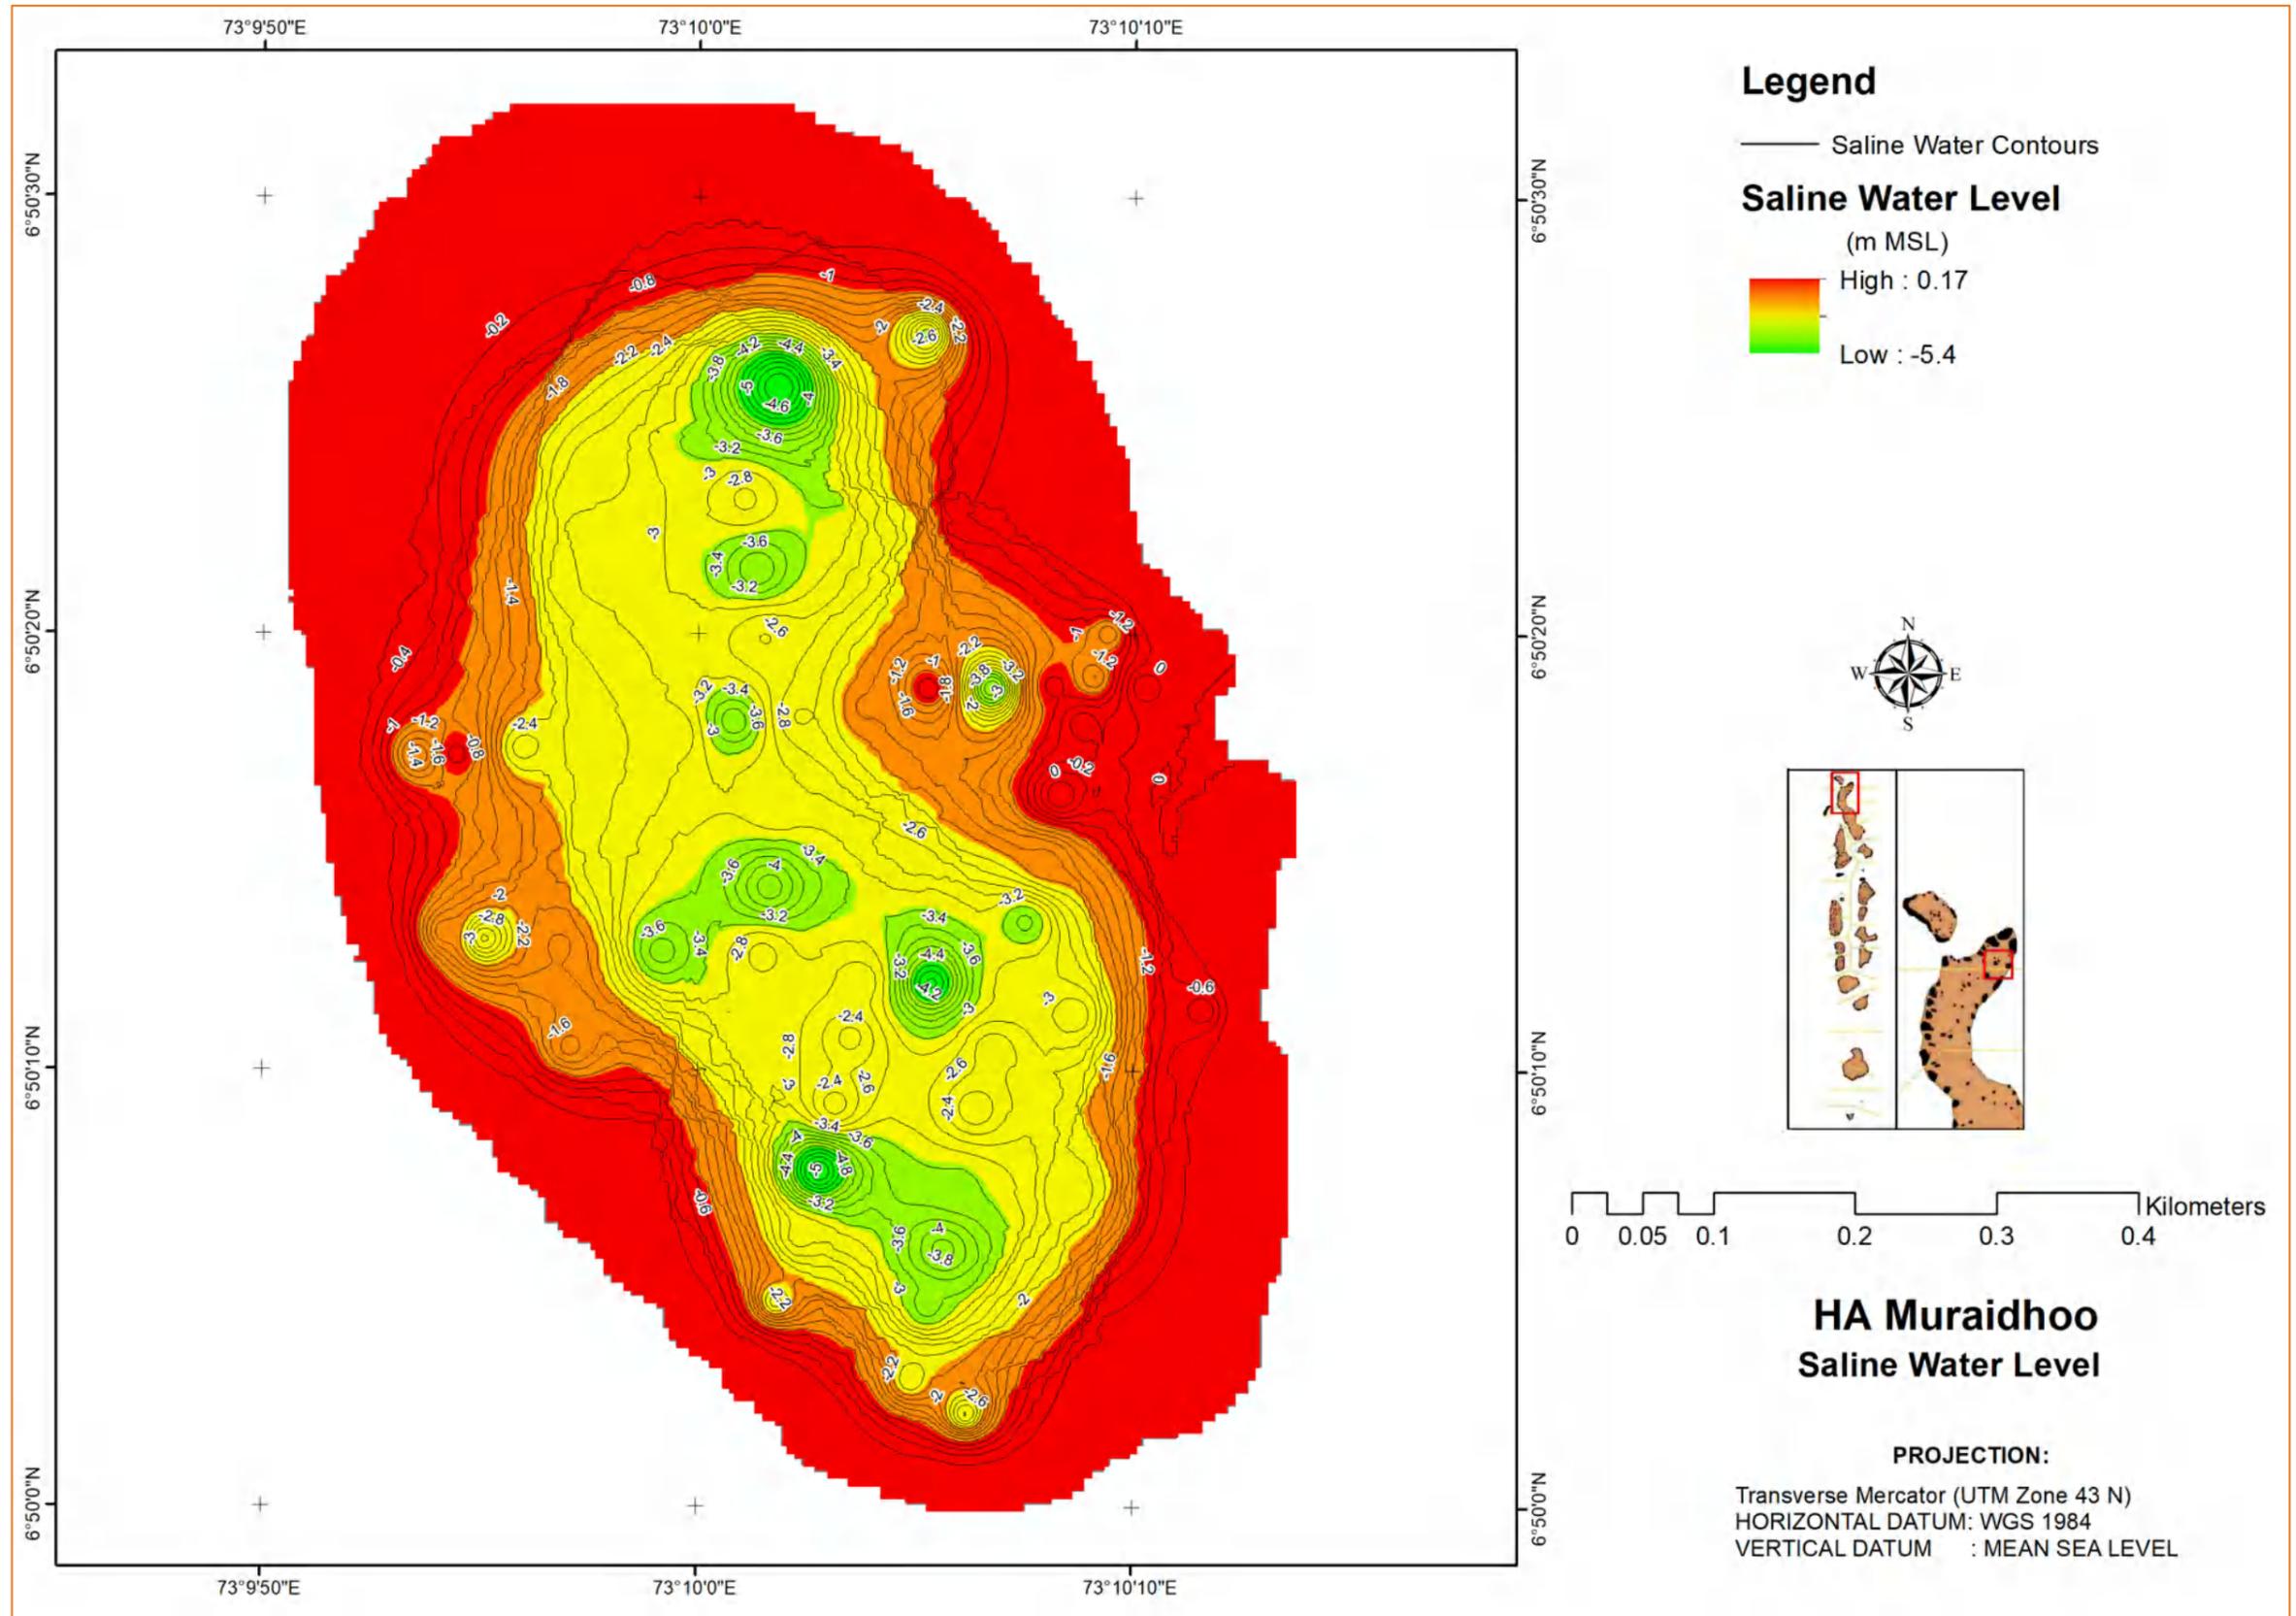
Figure 5-18: Saline water Level in Muraidhoo Island

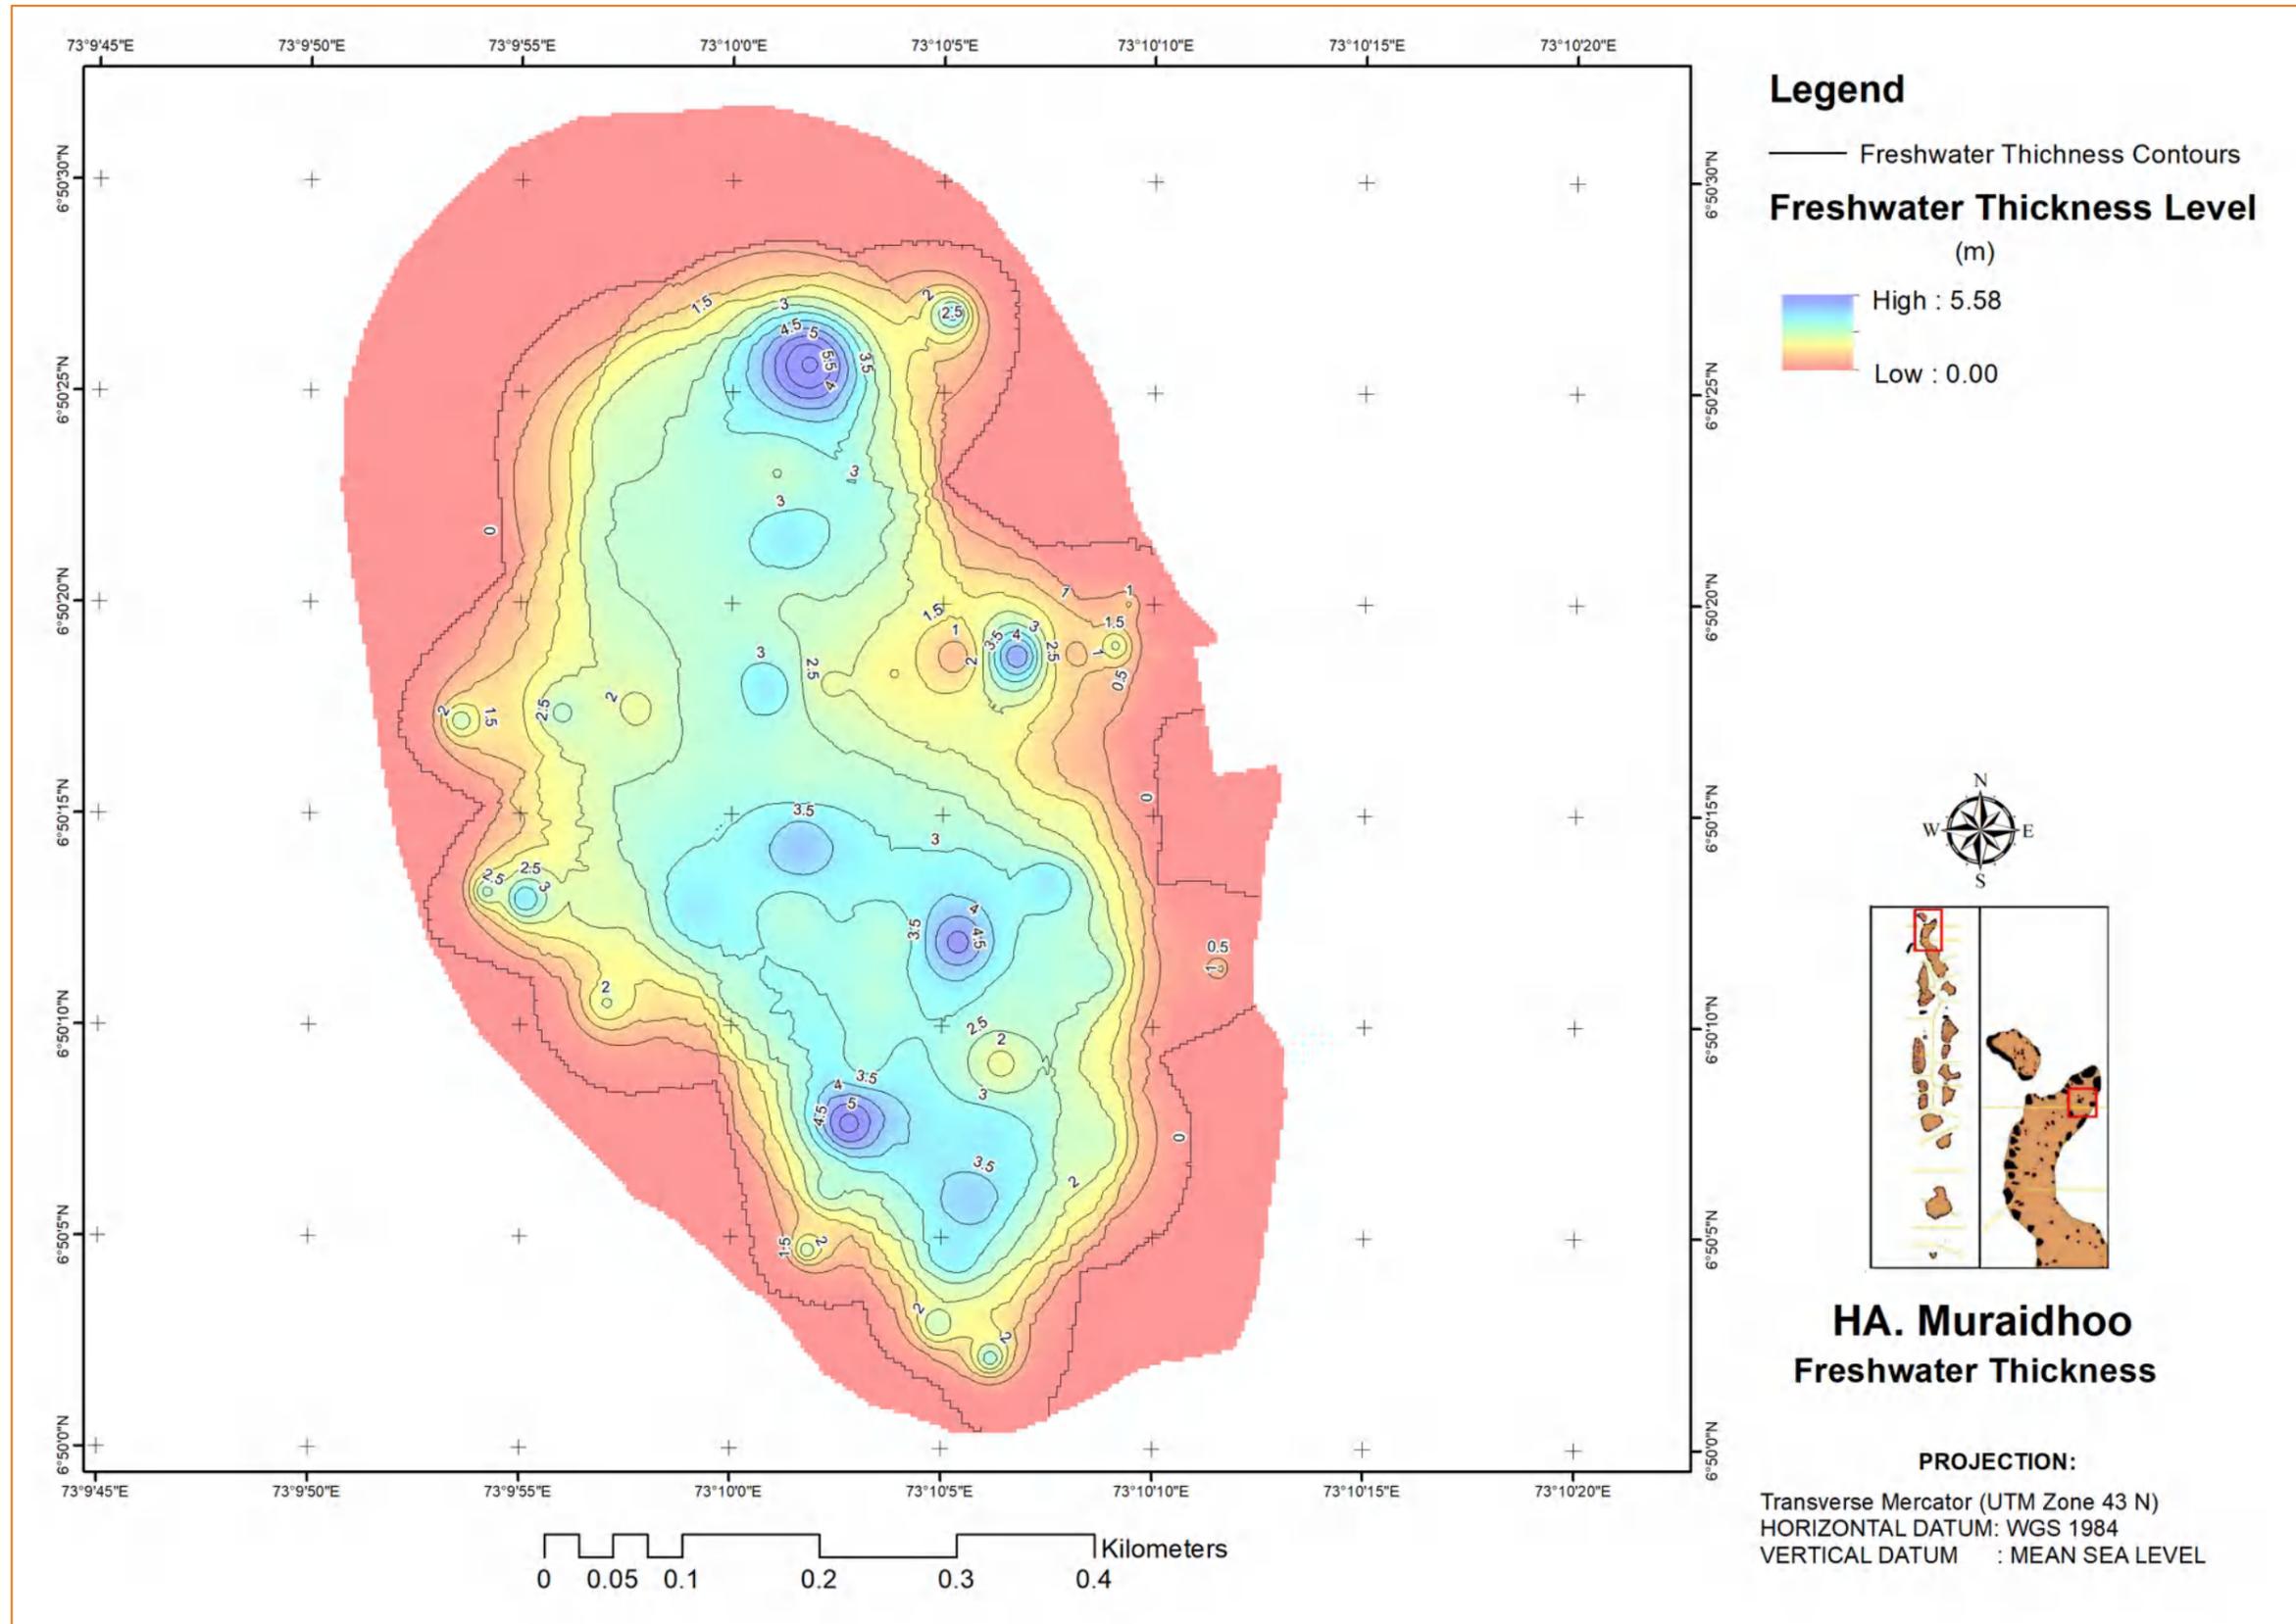
Figure 5-19: Freshwater thickness in Muraidhoo Island

The maximum freshwater thickness of the island is 3.19 m (It is noted here that these readings were taken in October, which is the wet season and the with a reasonably higher number of wet days per month of the year).

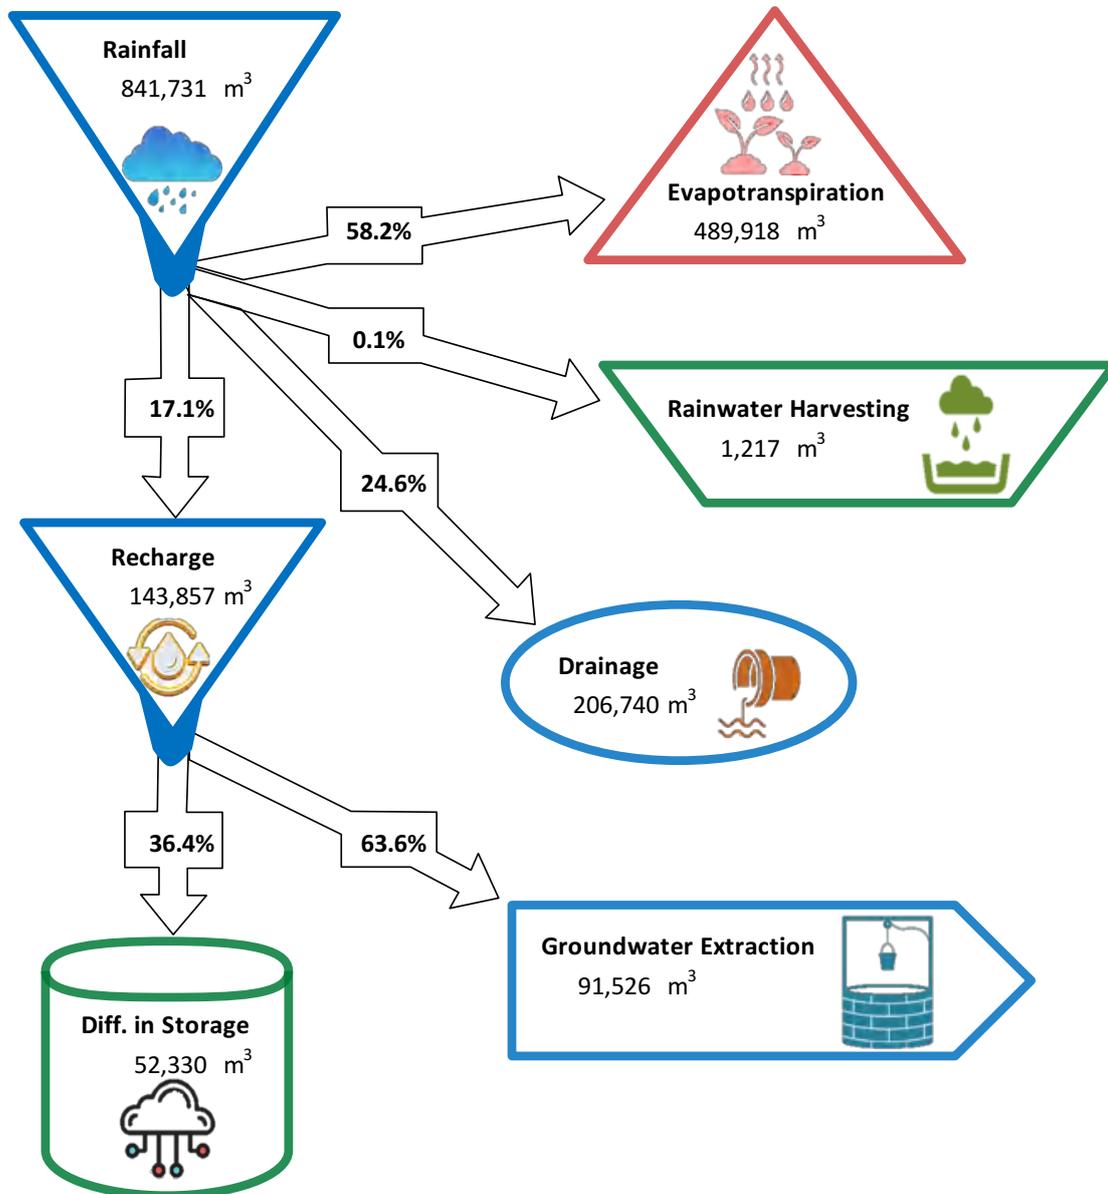
Figure 5-20: Schematic of water balance in Muraidhoo Island

An annual estimation is carried out based on the water balance method (Falkland, 2000). Rainwater harvesting is calculated using the number of rainwater harvesting units on the island. According to the spatial mean annual rainfall of the Maldives, the annual average rainfall of Muraidhoo Island is reported as 1,750 mm/year. Evapotranspiration was estimated using crop water requirements for different land use. Then, the rainfall was subtracted from rainwater harvesting, evapotranspiration, drainage to get the recharge volume. Drainage or the surface runoff was calculated by considering an aggregate runoff coefficient for the island based on the land usage (roof cover, bare land, farmland, roads, playgrounds, wetlands). The groundwater extractions were estimated from the amount of water usage in different sectors (residential, resorts, restaurants, agriculture and farming). The difference between recharge and groundwater extraction is taken to estimate the difference in storage.

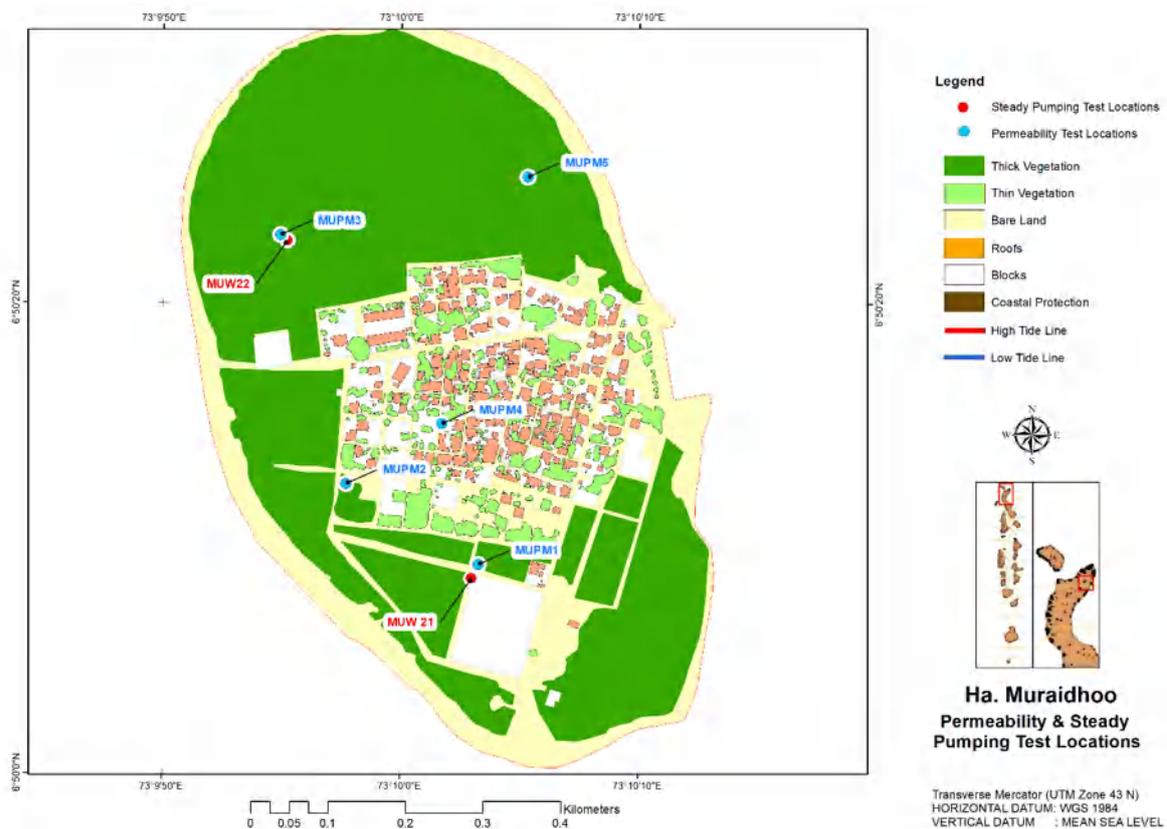
Figure 5-21: Locations of permeability and steady pumping tests in Muraidhoo Island

Permeability tests were carried out in the selected locations as outlined in Figure 5-21.

The estimated permeability values for the above test locations are presented below in Table 5.9. The data will be comparatively verified and interpreted when additional data is acquired and calculations for other islands are completed.

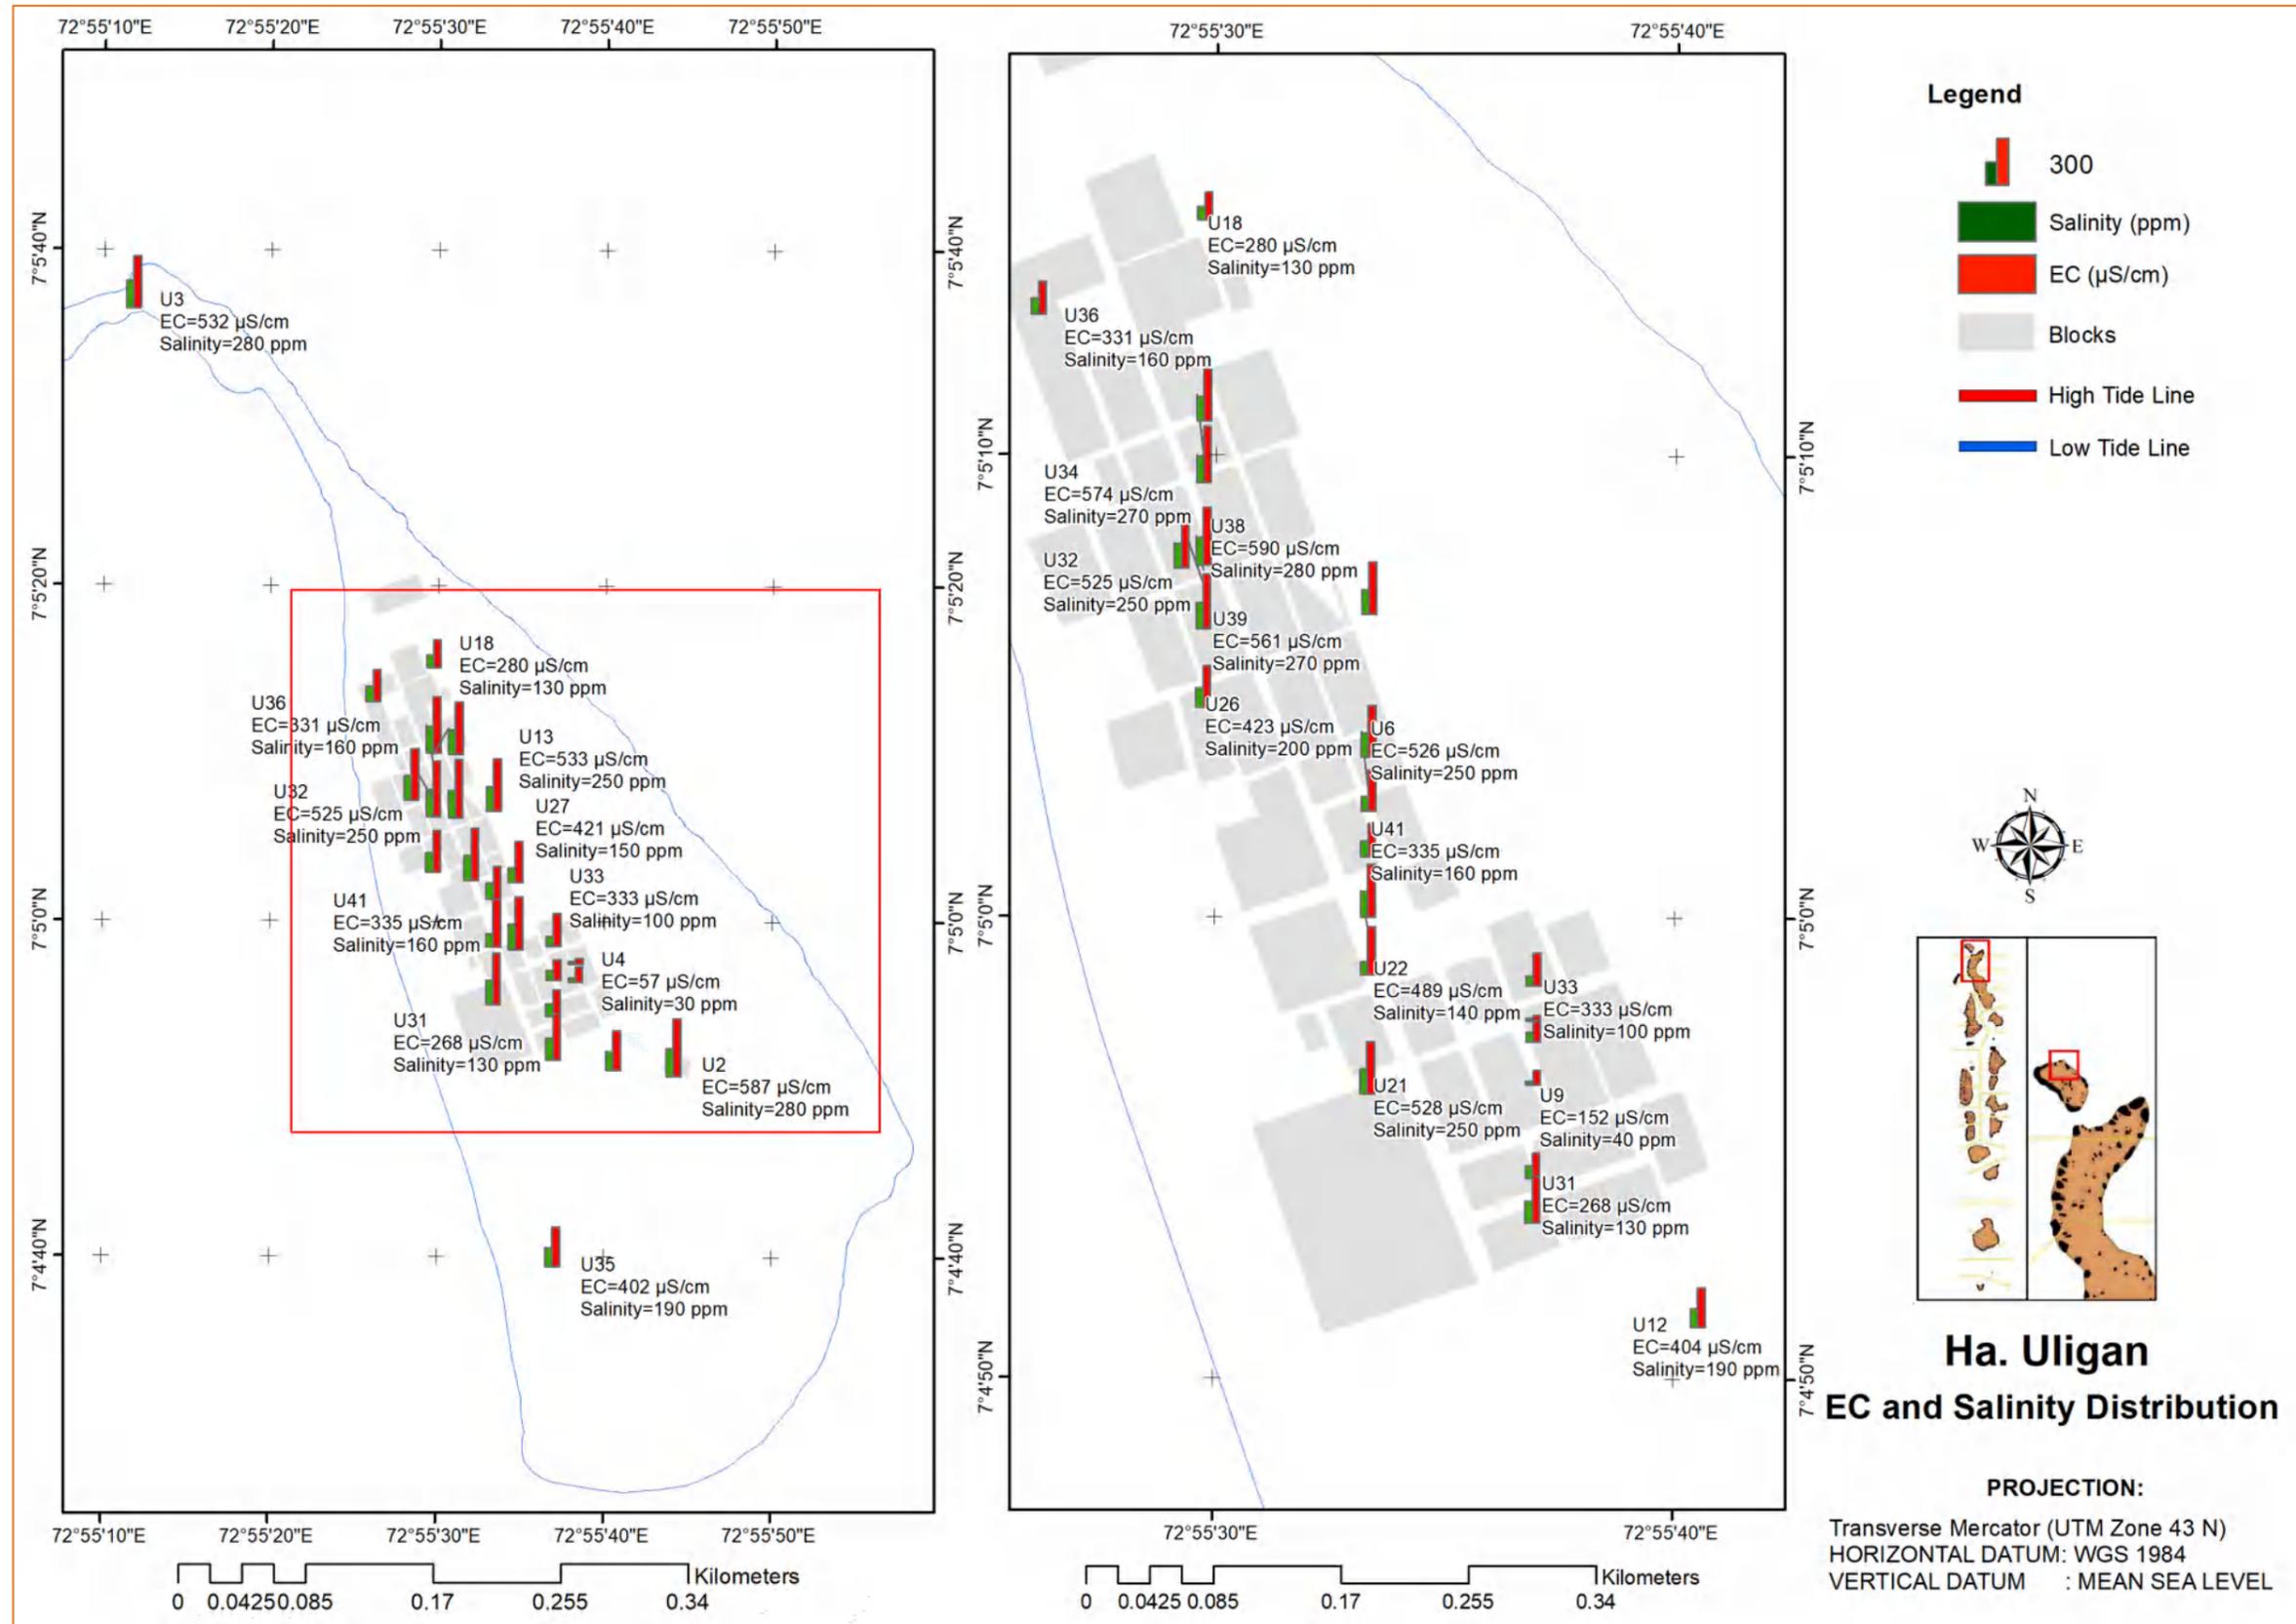
Figure 6-10: EC and Salinity Distribution in Ha. Uligan Island

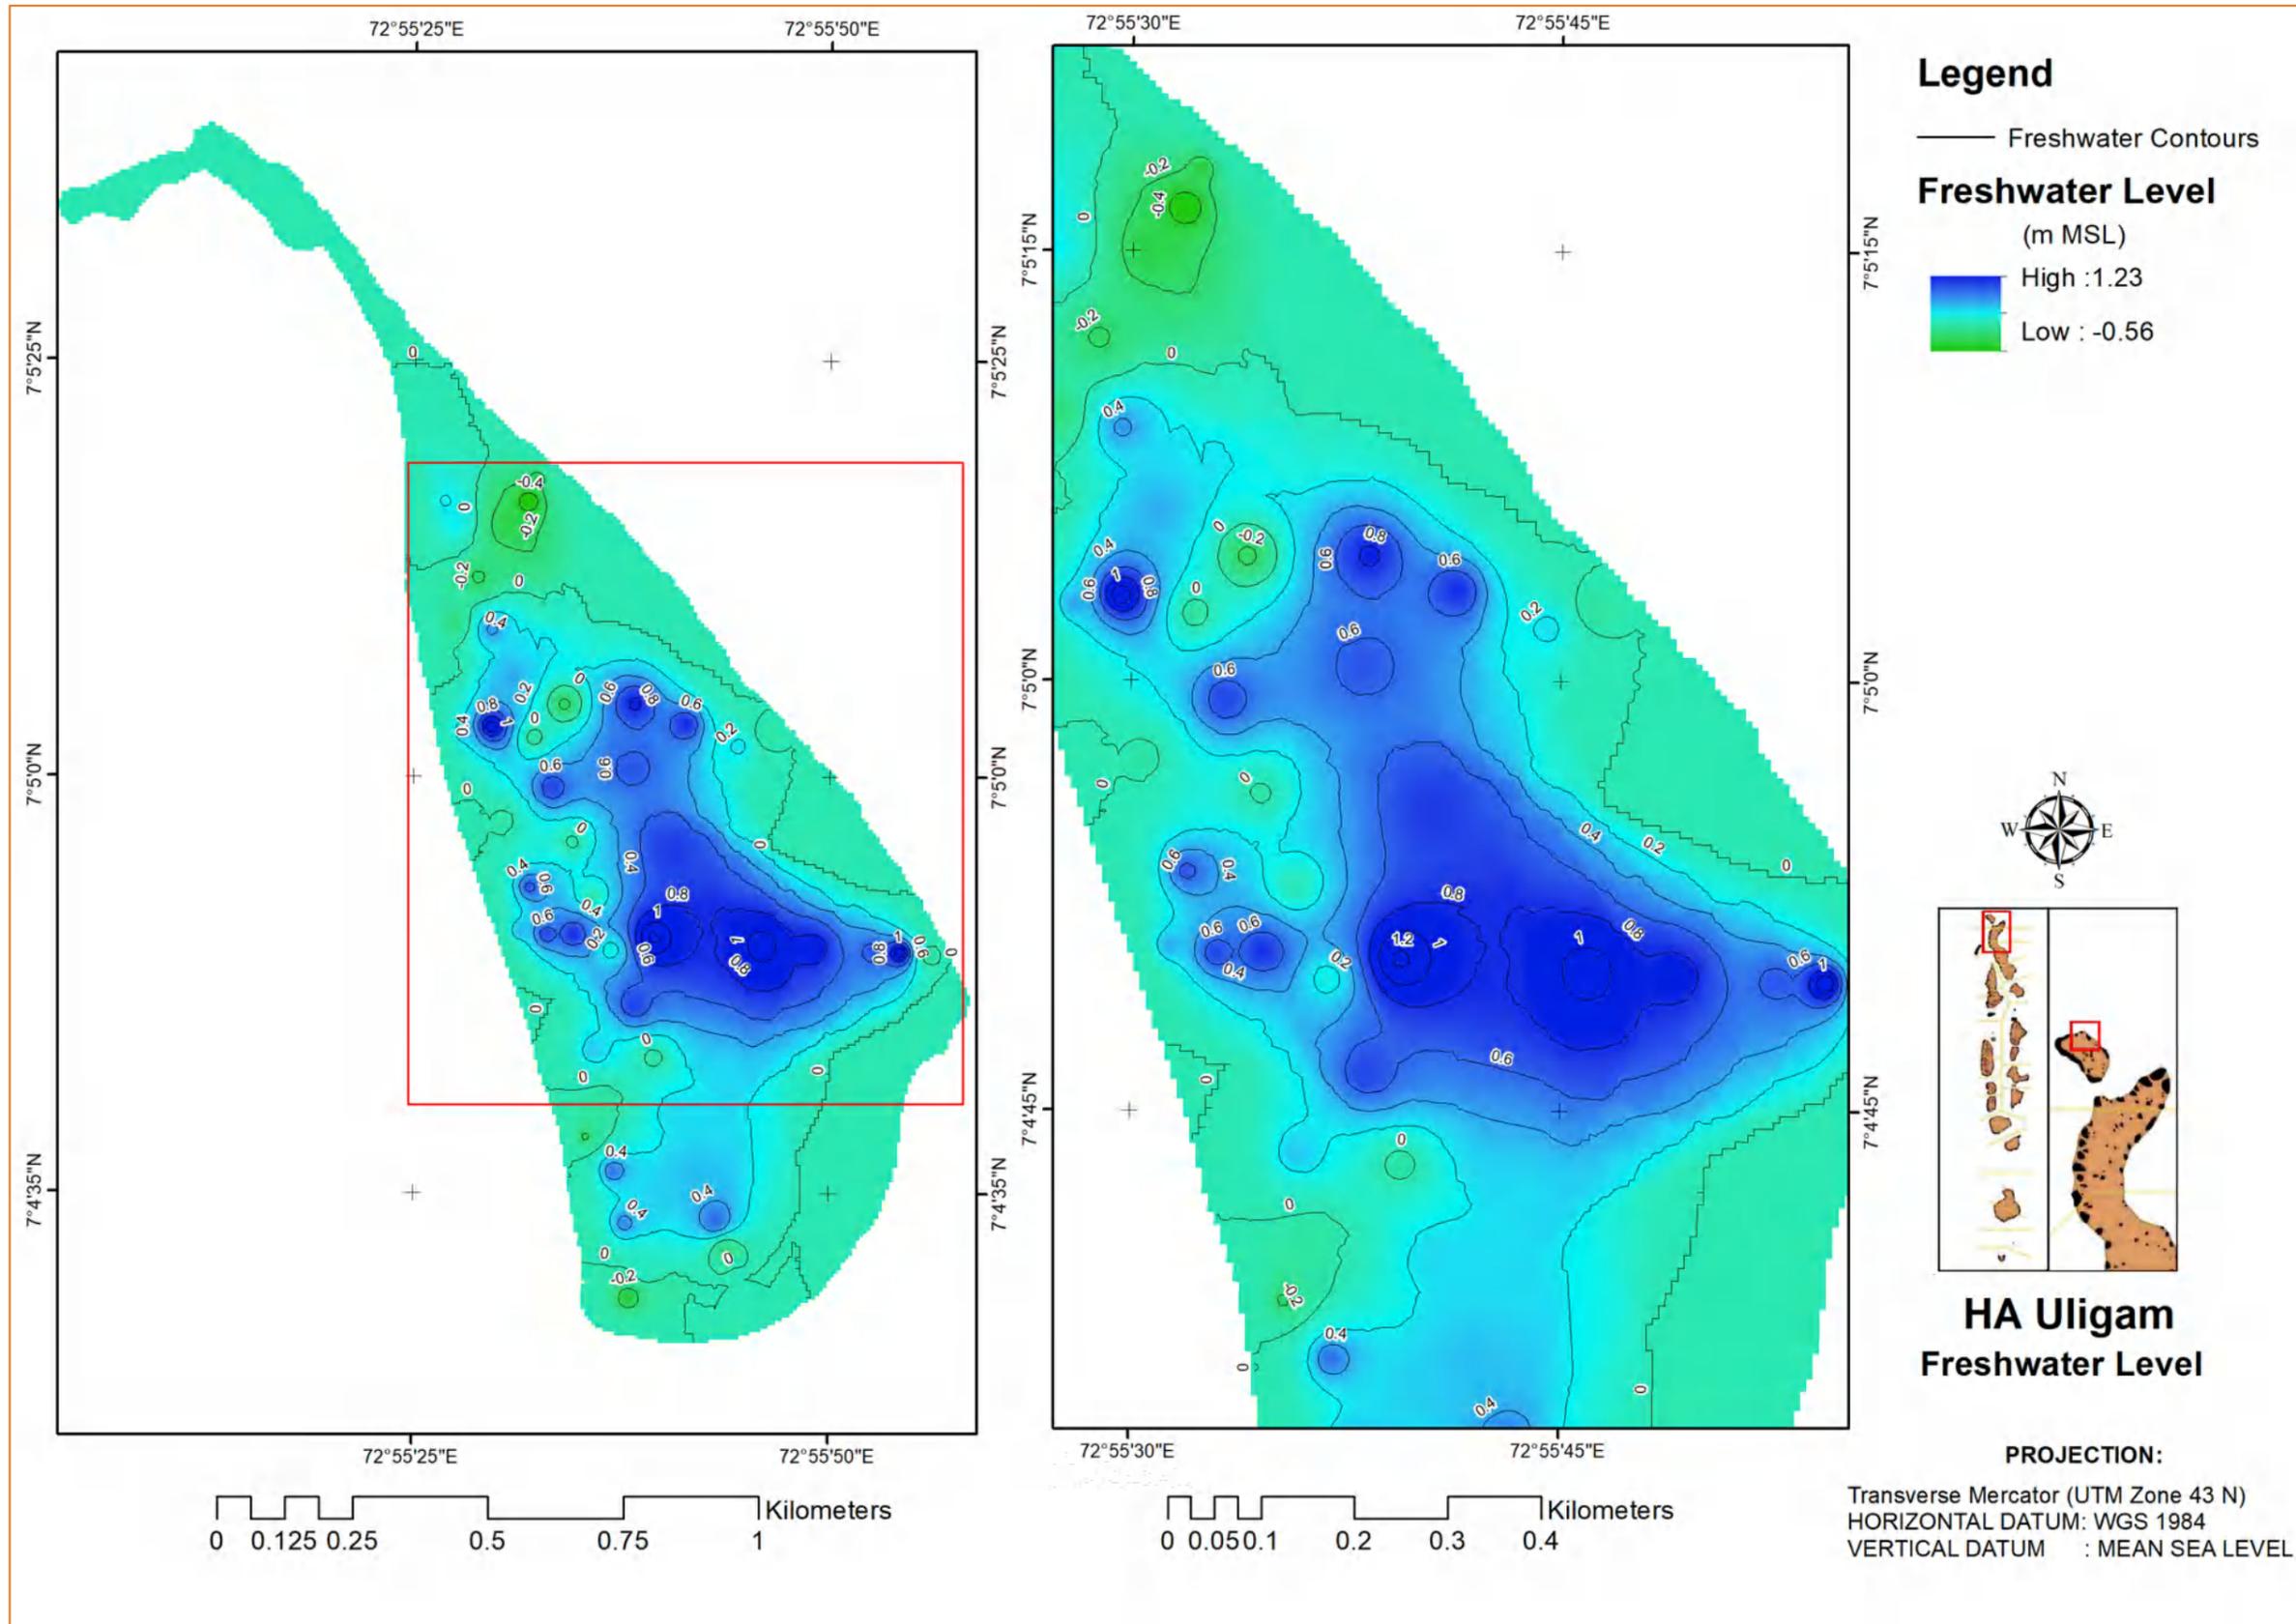
Figure 6-18: Freshwater Level in Uligam Island

The 2-D freshwater lens distribution density maps produced with GIS software for visualization of the spatial and volume extents are also presented below in Figure 6-18 to Figure 6-20.

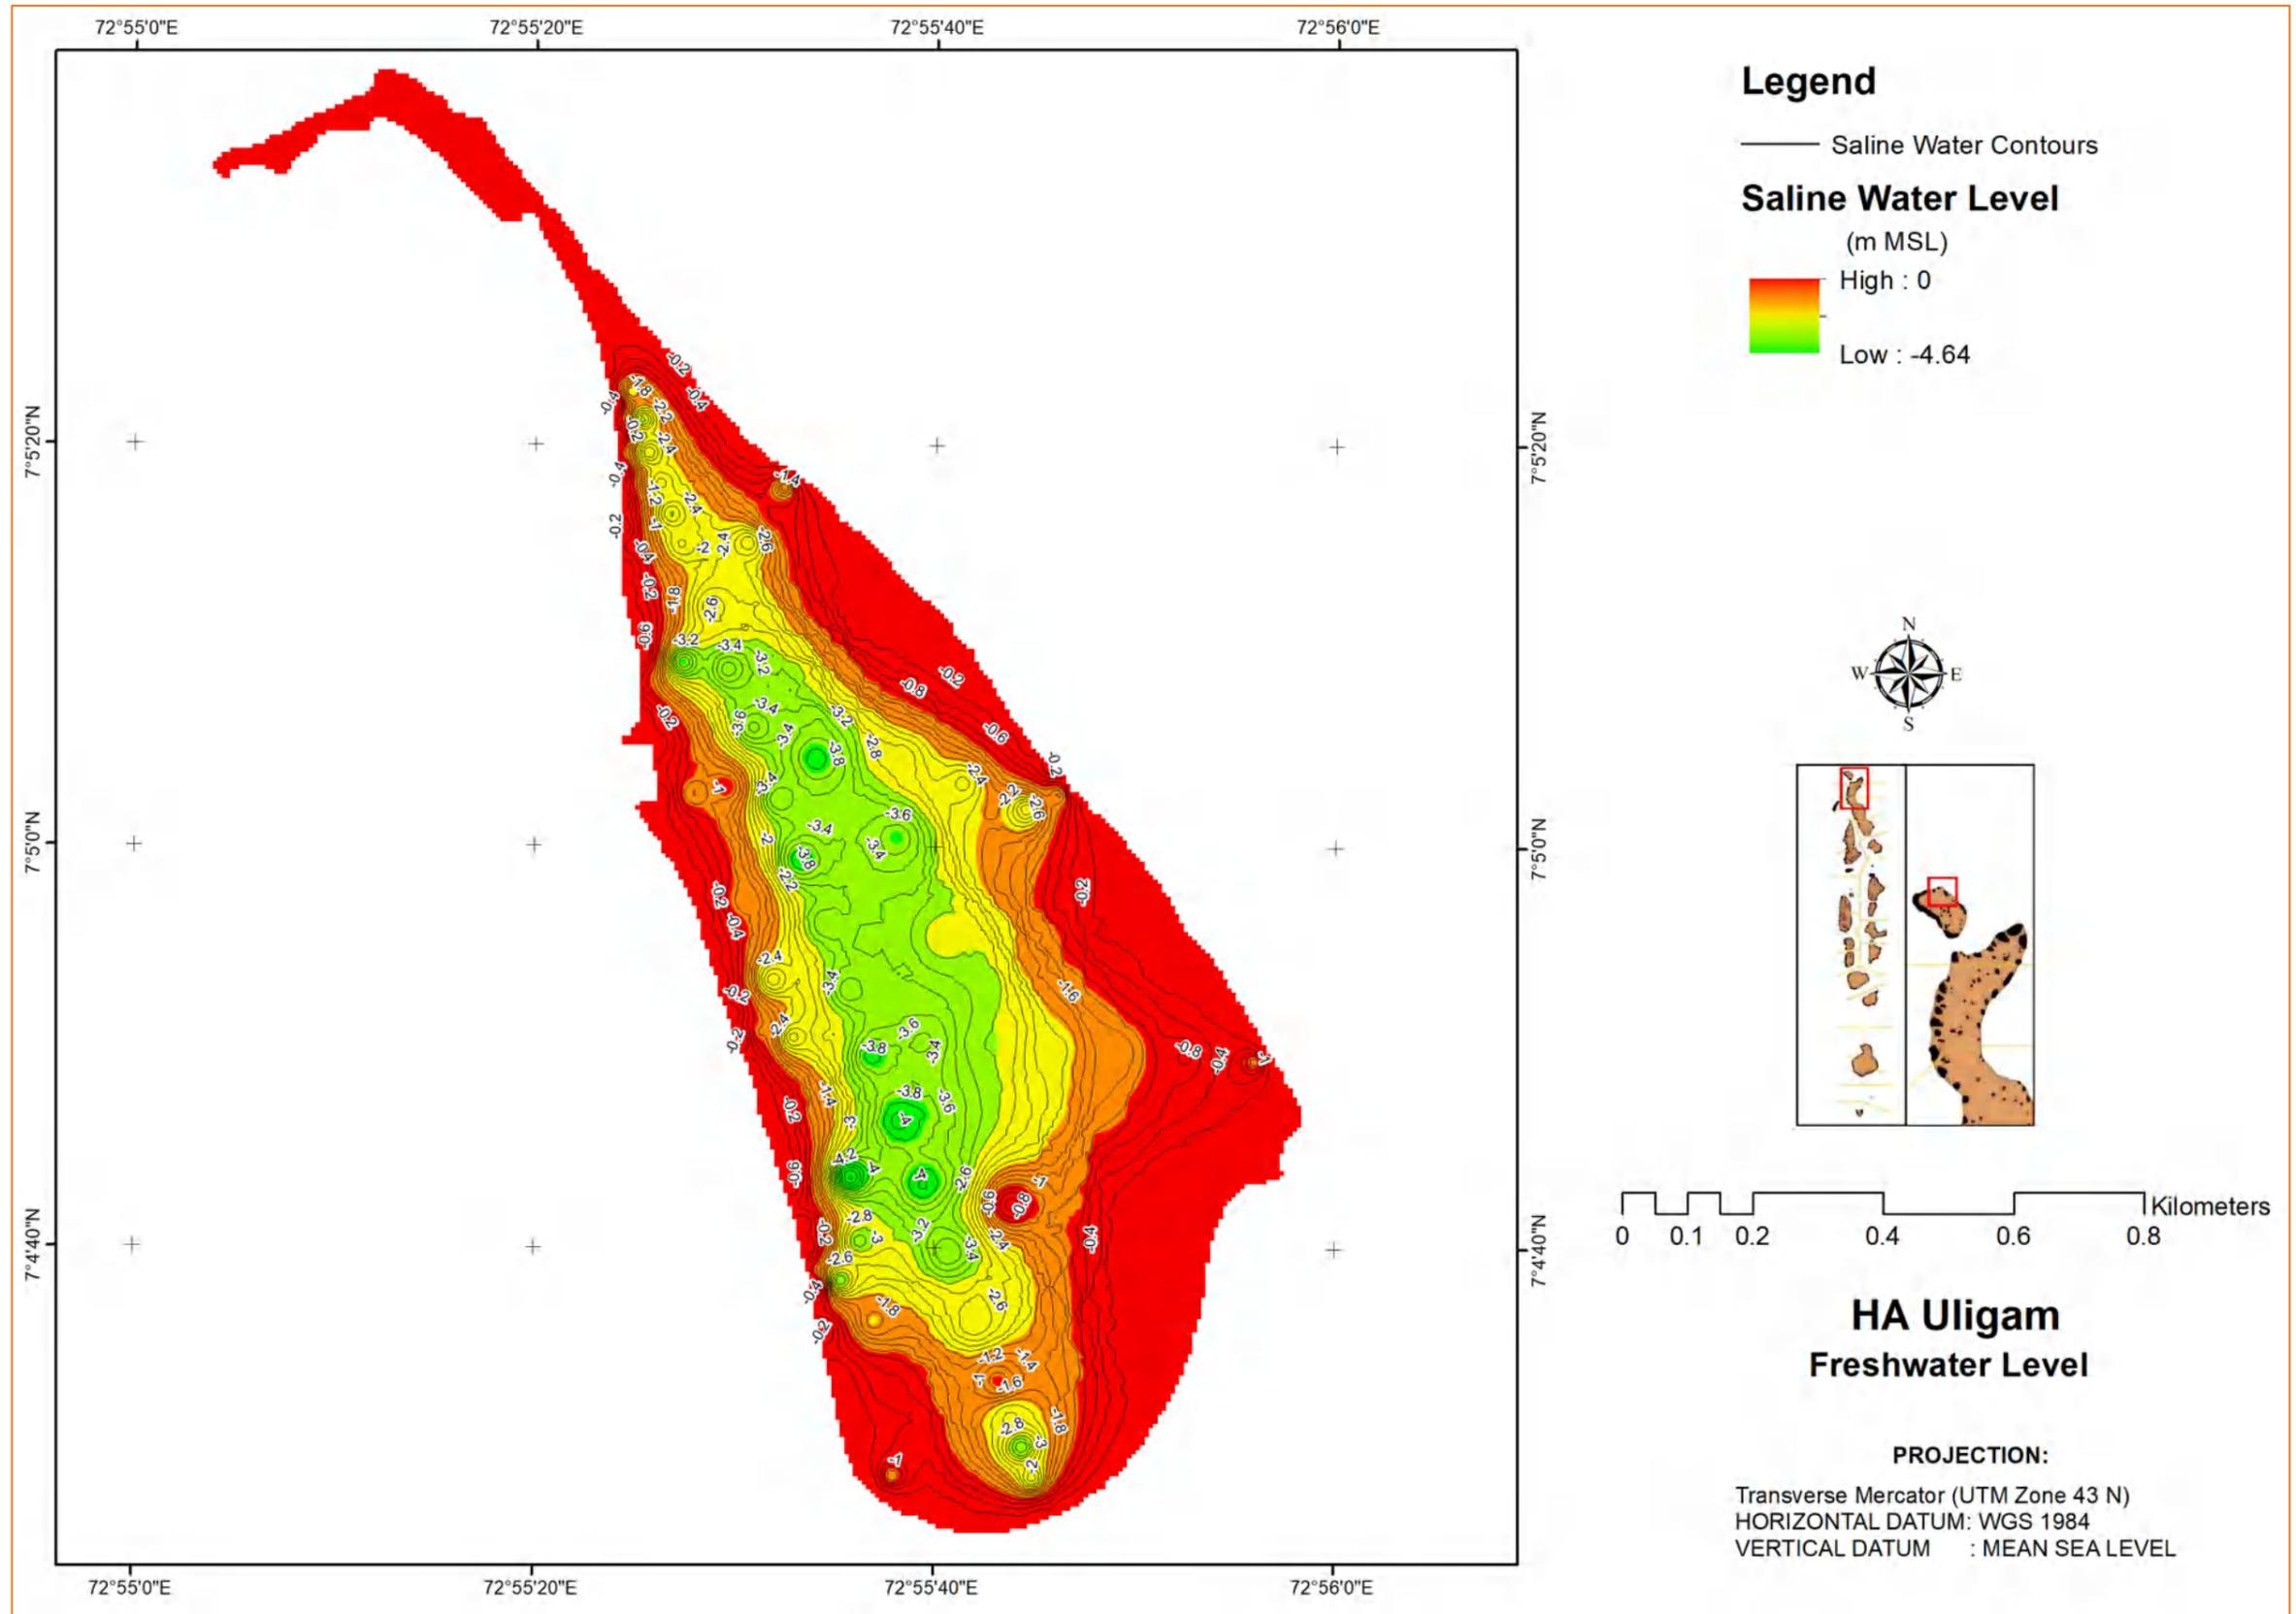
Figure 6-19: Saline water Level in Uligam Island
