Assessing Groundwater Resources and Design of Aquifer
Recharge Systems in Selected 17 Islands of Maldives - L1

BASELINE ASSESSMENT REPORT

Ha Filladhoo, Ha Maarandhoo, Ha Muraidhoo
Ha Uligan, and Ha Molhadhoo

Assignment: Assessing Groundwater Resources and Design of Aquifer Recharge Systems in Selected 17 Islands of Maldives (Lot 1)

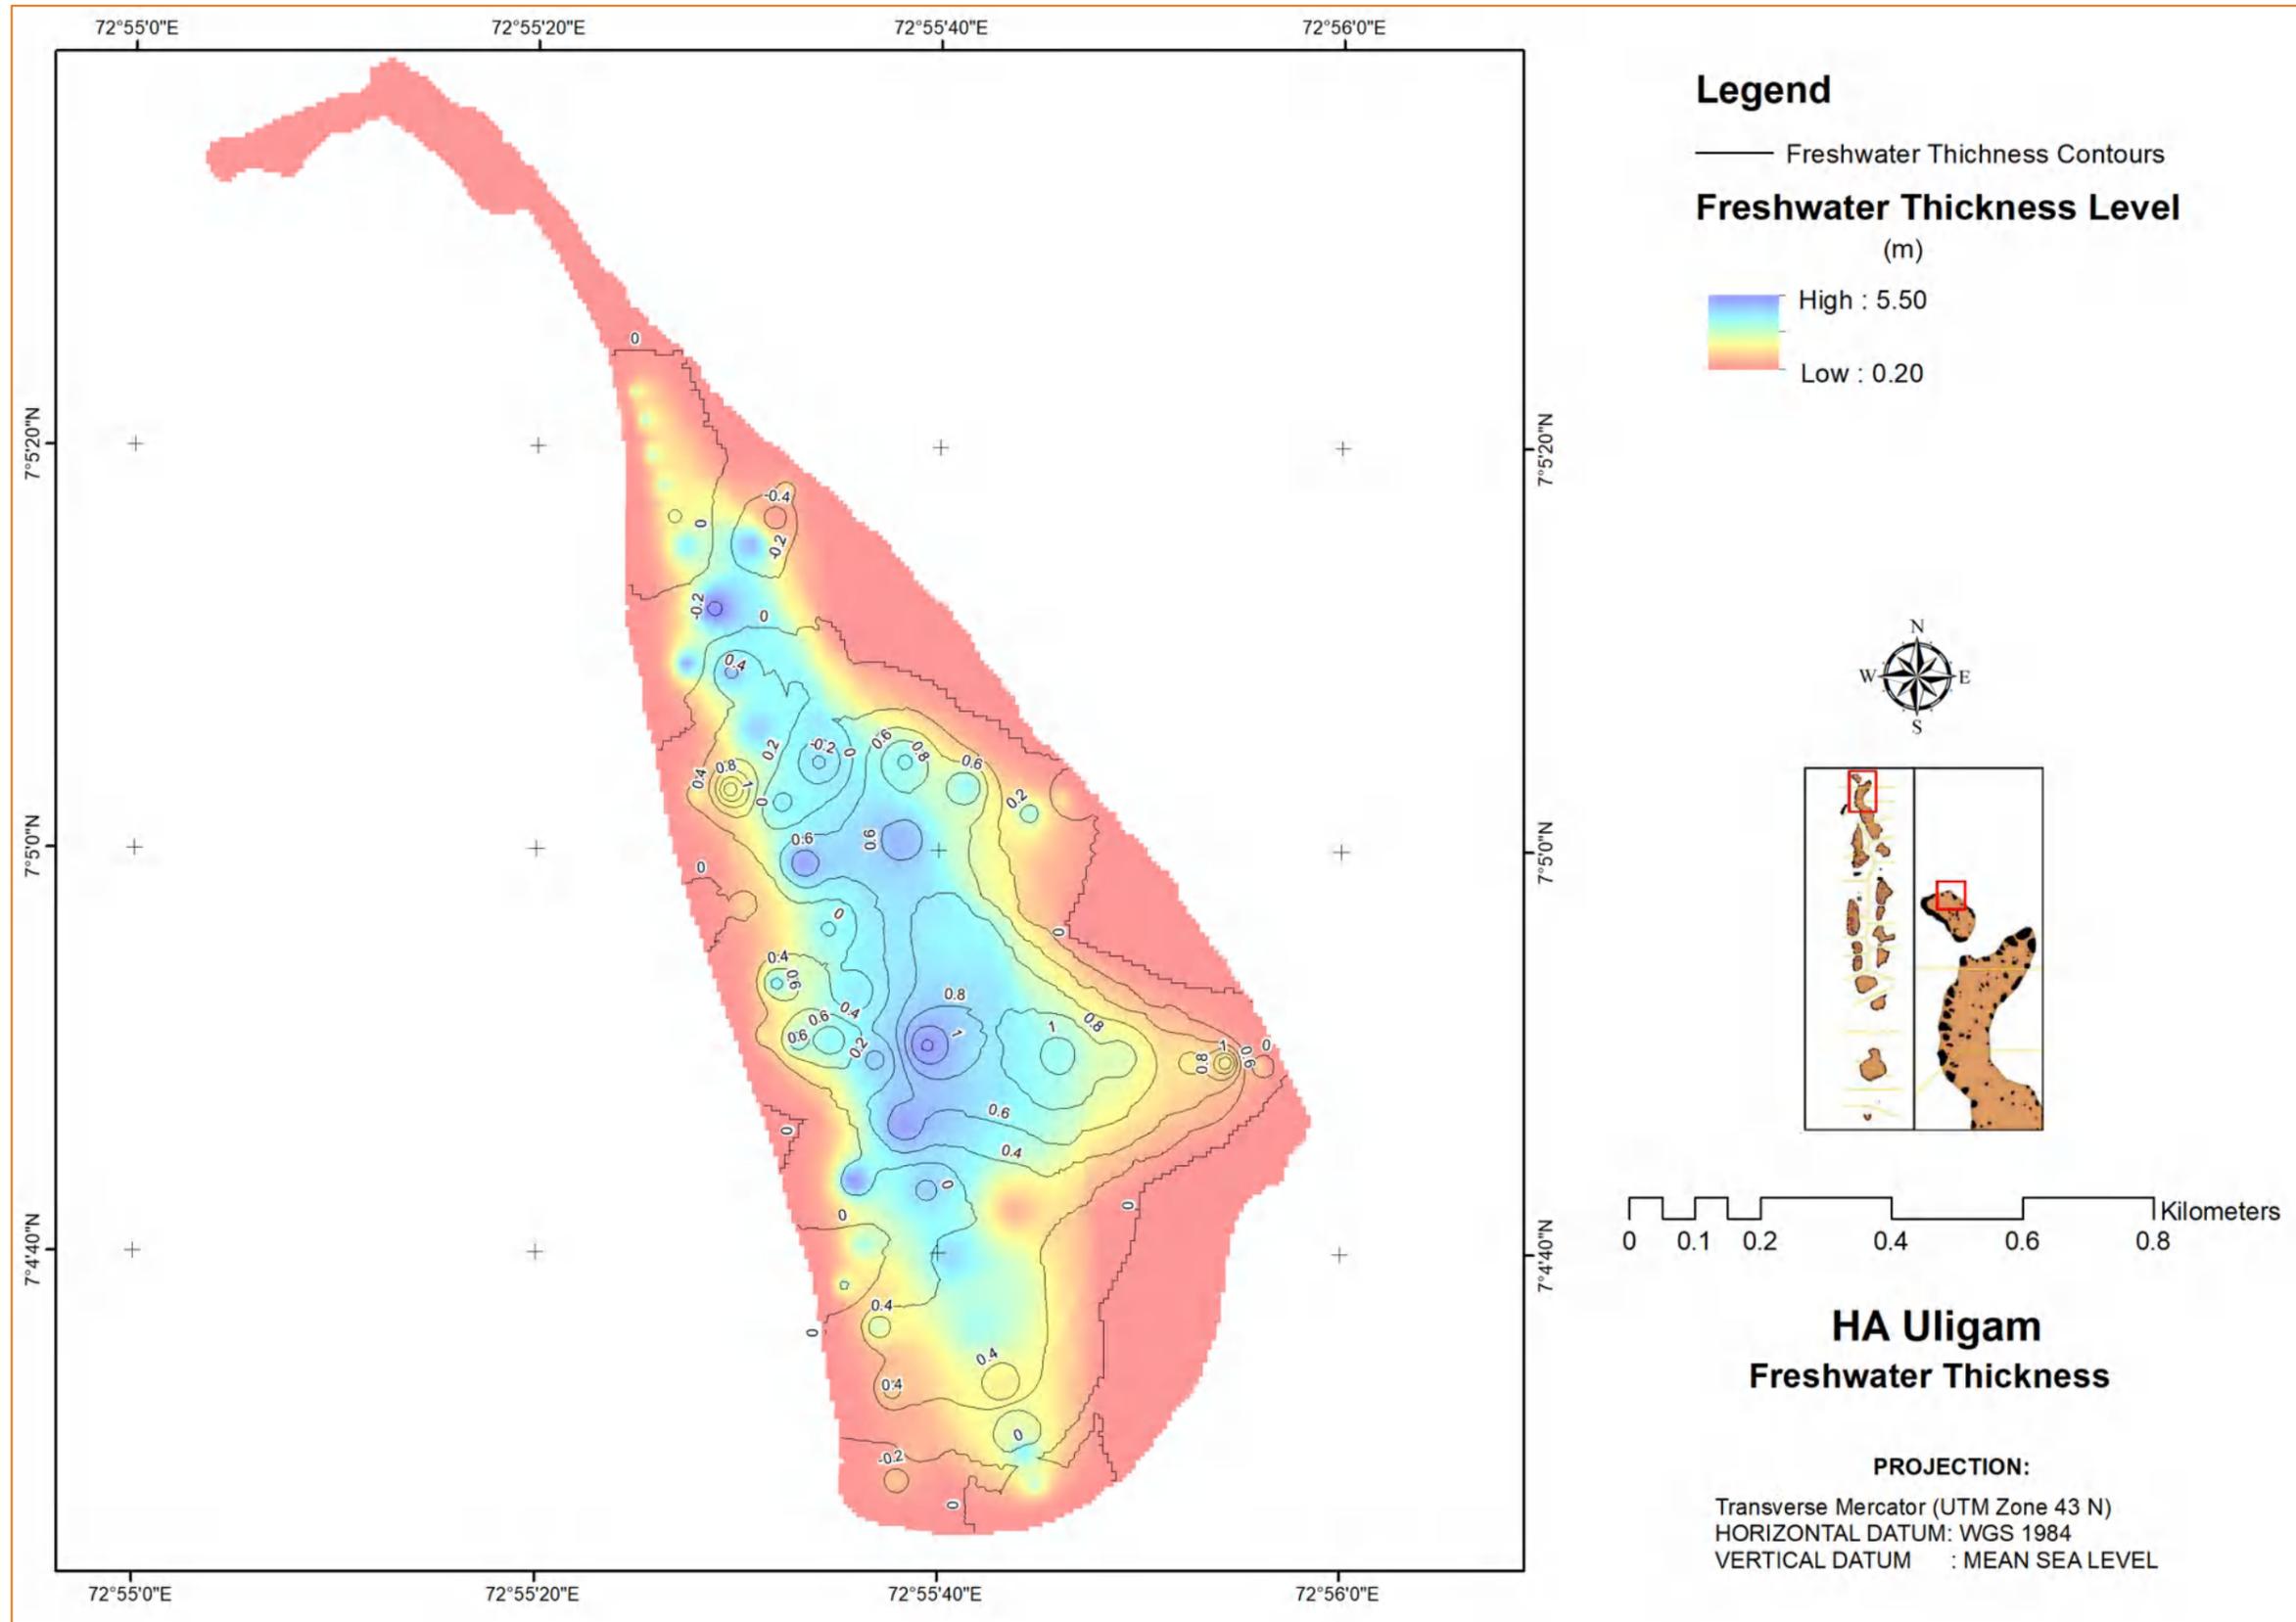
Figure 6-20: Freshwater thickness in Uligam Island

The maximum freshwater thickness of the island is 4.27 m (It is noted here that these readings were taken in October, which is the wet season and the with a reasonably higher number of wet days per month of the year).

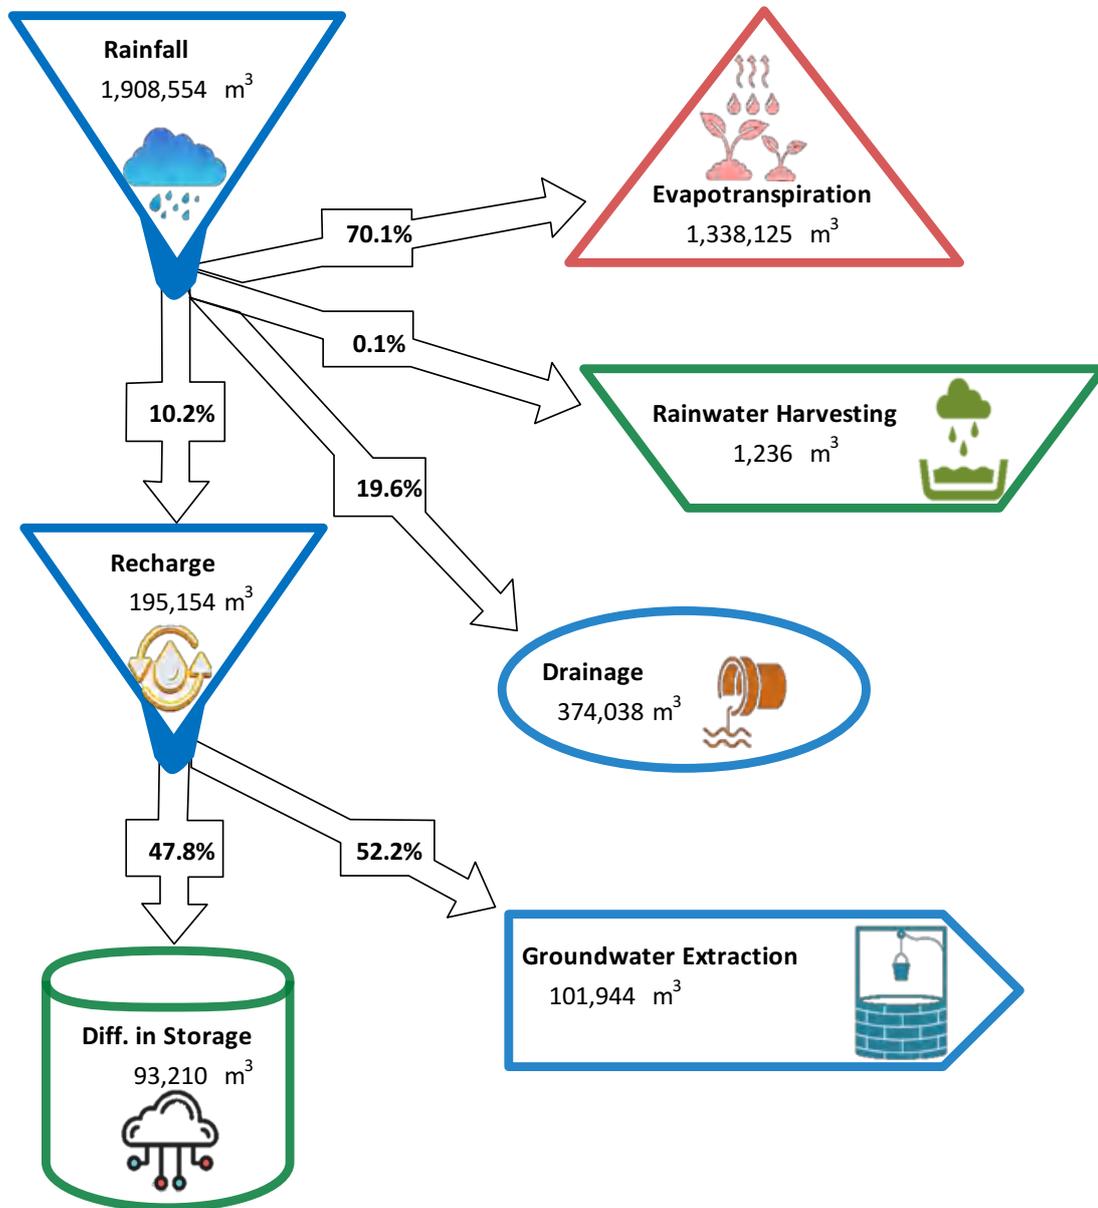
Figure 6-21: Schematic of water balance in Uligan Island

An annual estimation is carried out based on the water balance method (Falkland, 2000). Rainwater harvesting is calculated using the number of rainwater harvesting units on the island. According to the spatial mean annual rainfall of the Maldives, the annual average rainfall of Uligan Island is reported as 1,750 mm/year. Evapotranspiration was estimated using crop water requirements for different land use. Then, the rainfall was subtracted from rainwater harvesting, evapotranspiration, drainage to get the recharge volume. Drainage or the surface runoff was calculated by considering an aggregate runoff coefficient for the island based on the land usage (roof cover, bare land, farmland, roads, playgrounds, wetlands). The groundwater extractions were estimated from the amount of water usage in different sectors (residential, resorts, restaurants, agriculture and farming). The difference between recharge and groundwater extraction is taken to estimate the difference in storage.

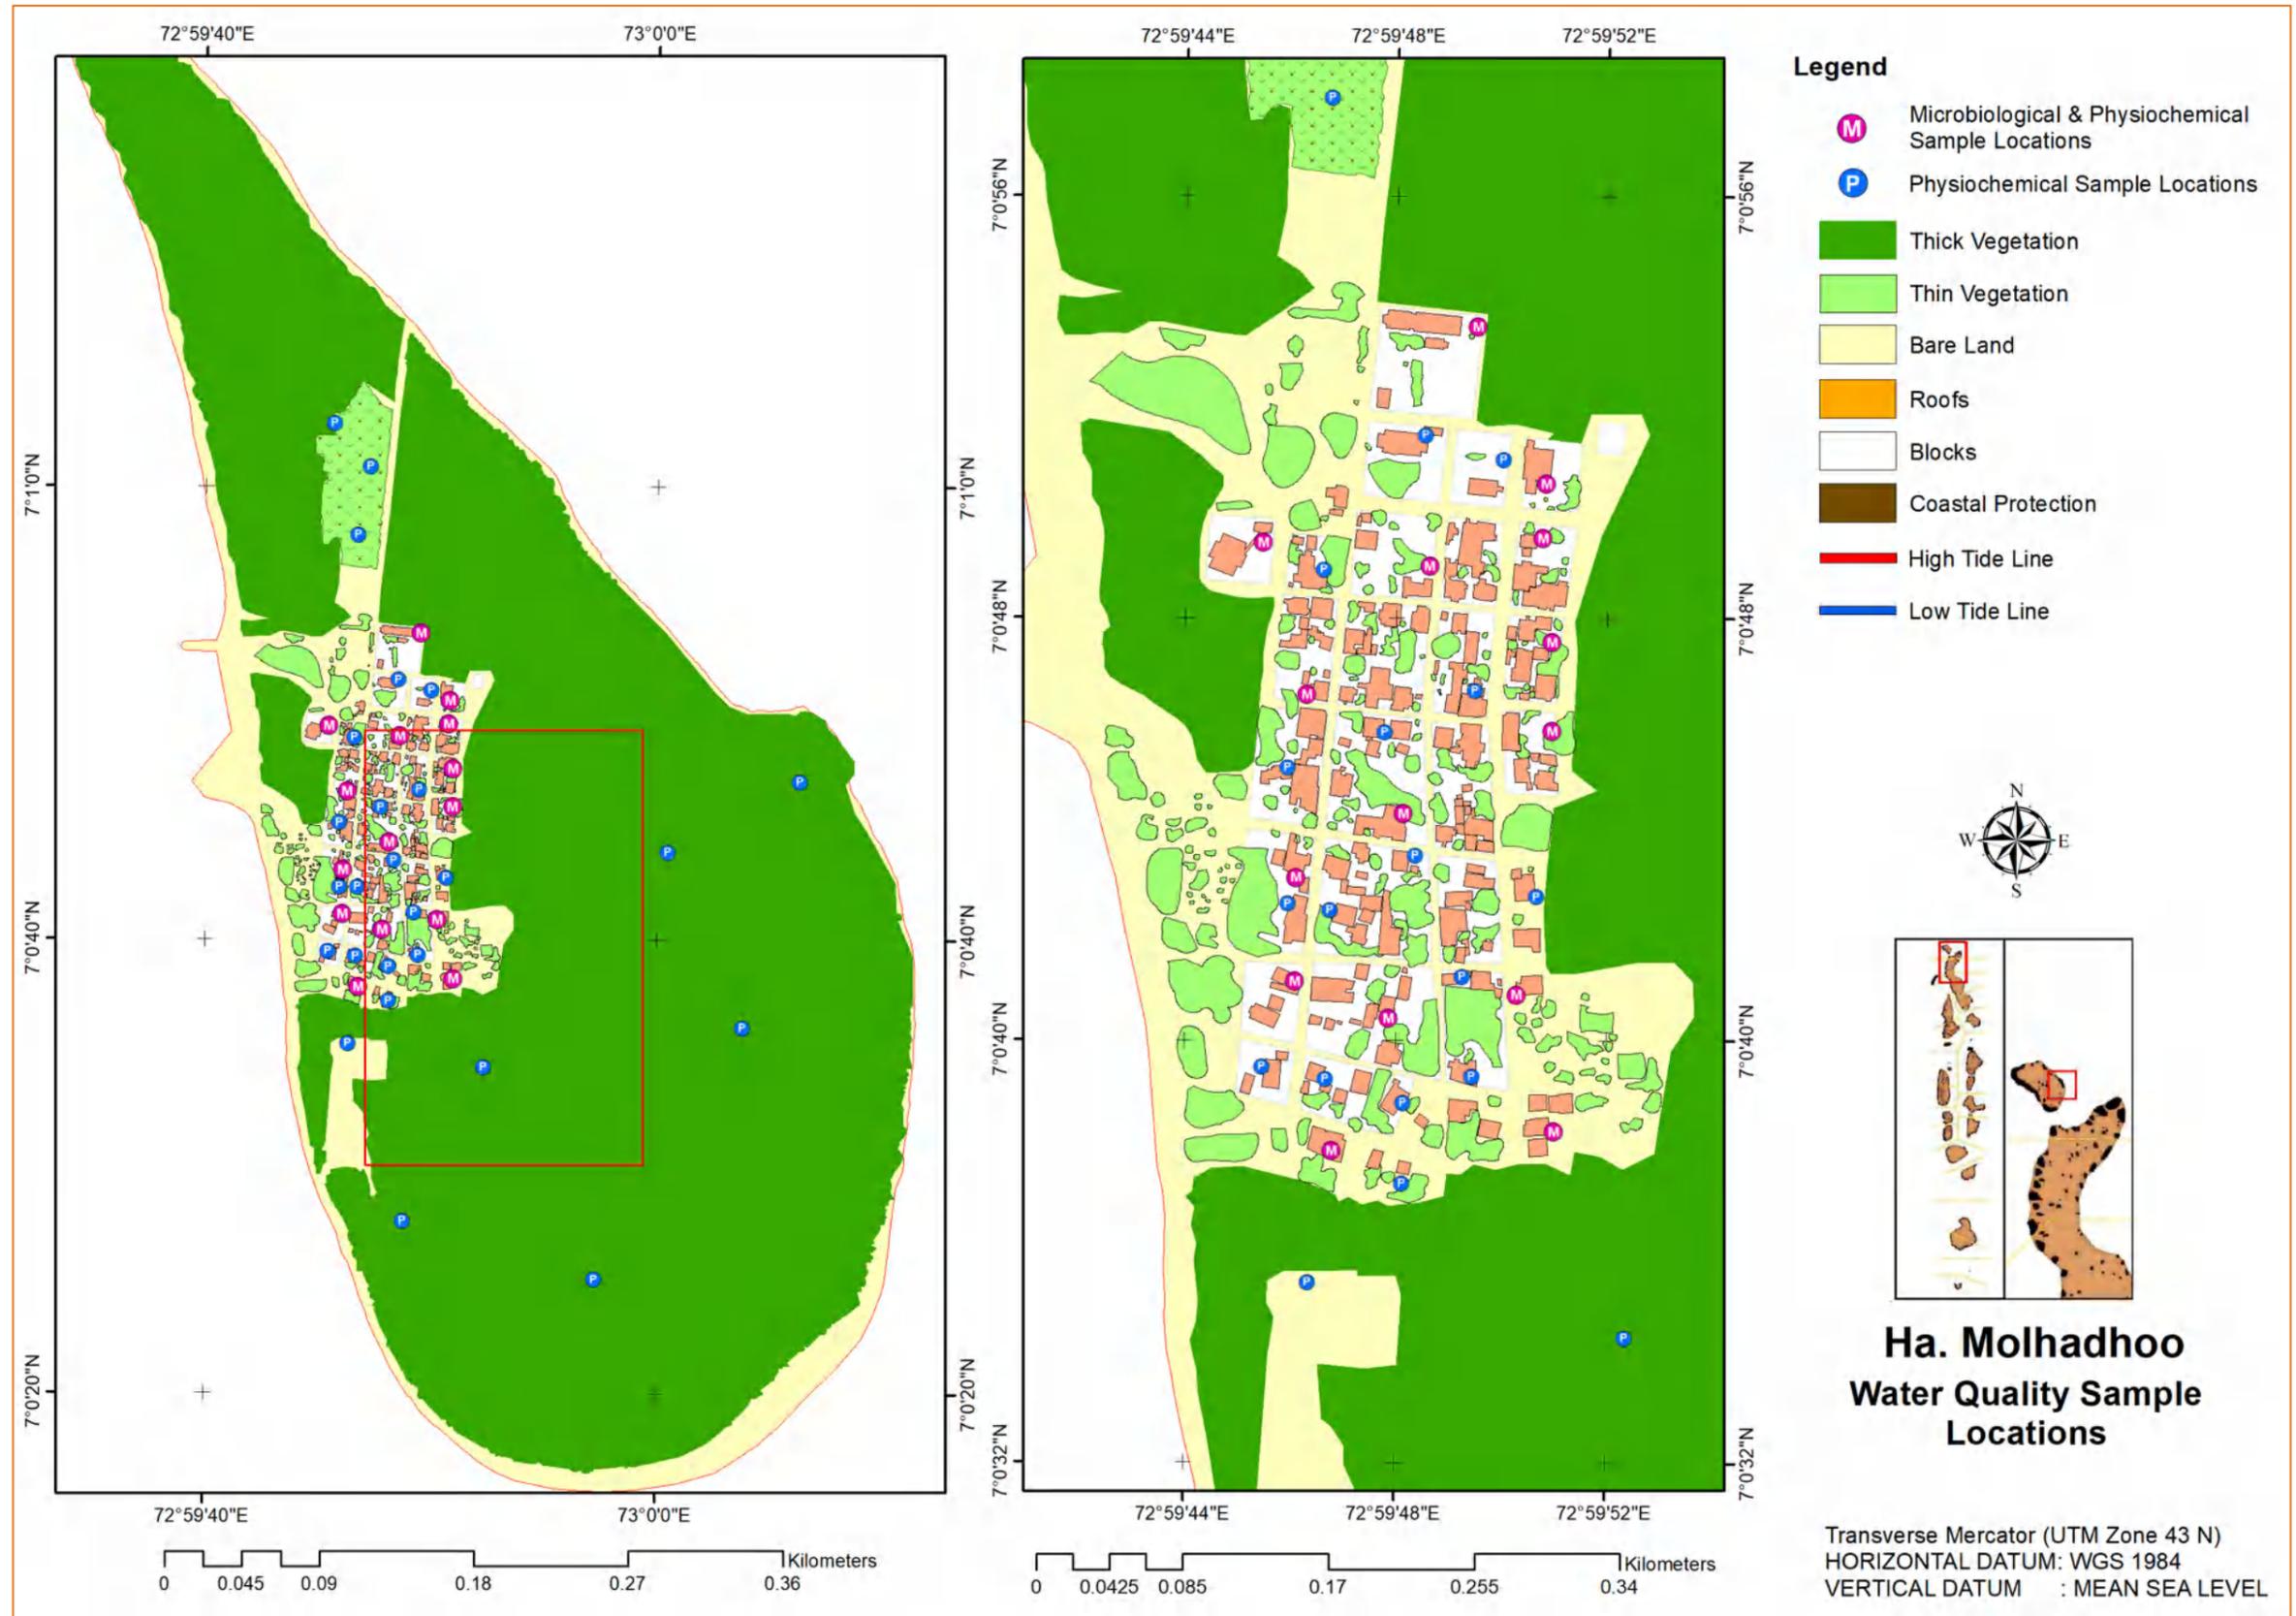
Figure 7-8: Location of groundwater sampling points in Molhadhoo Island

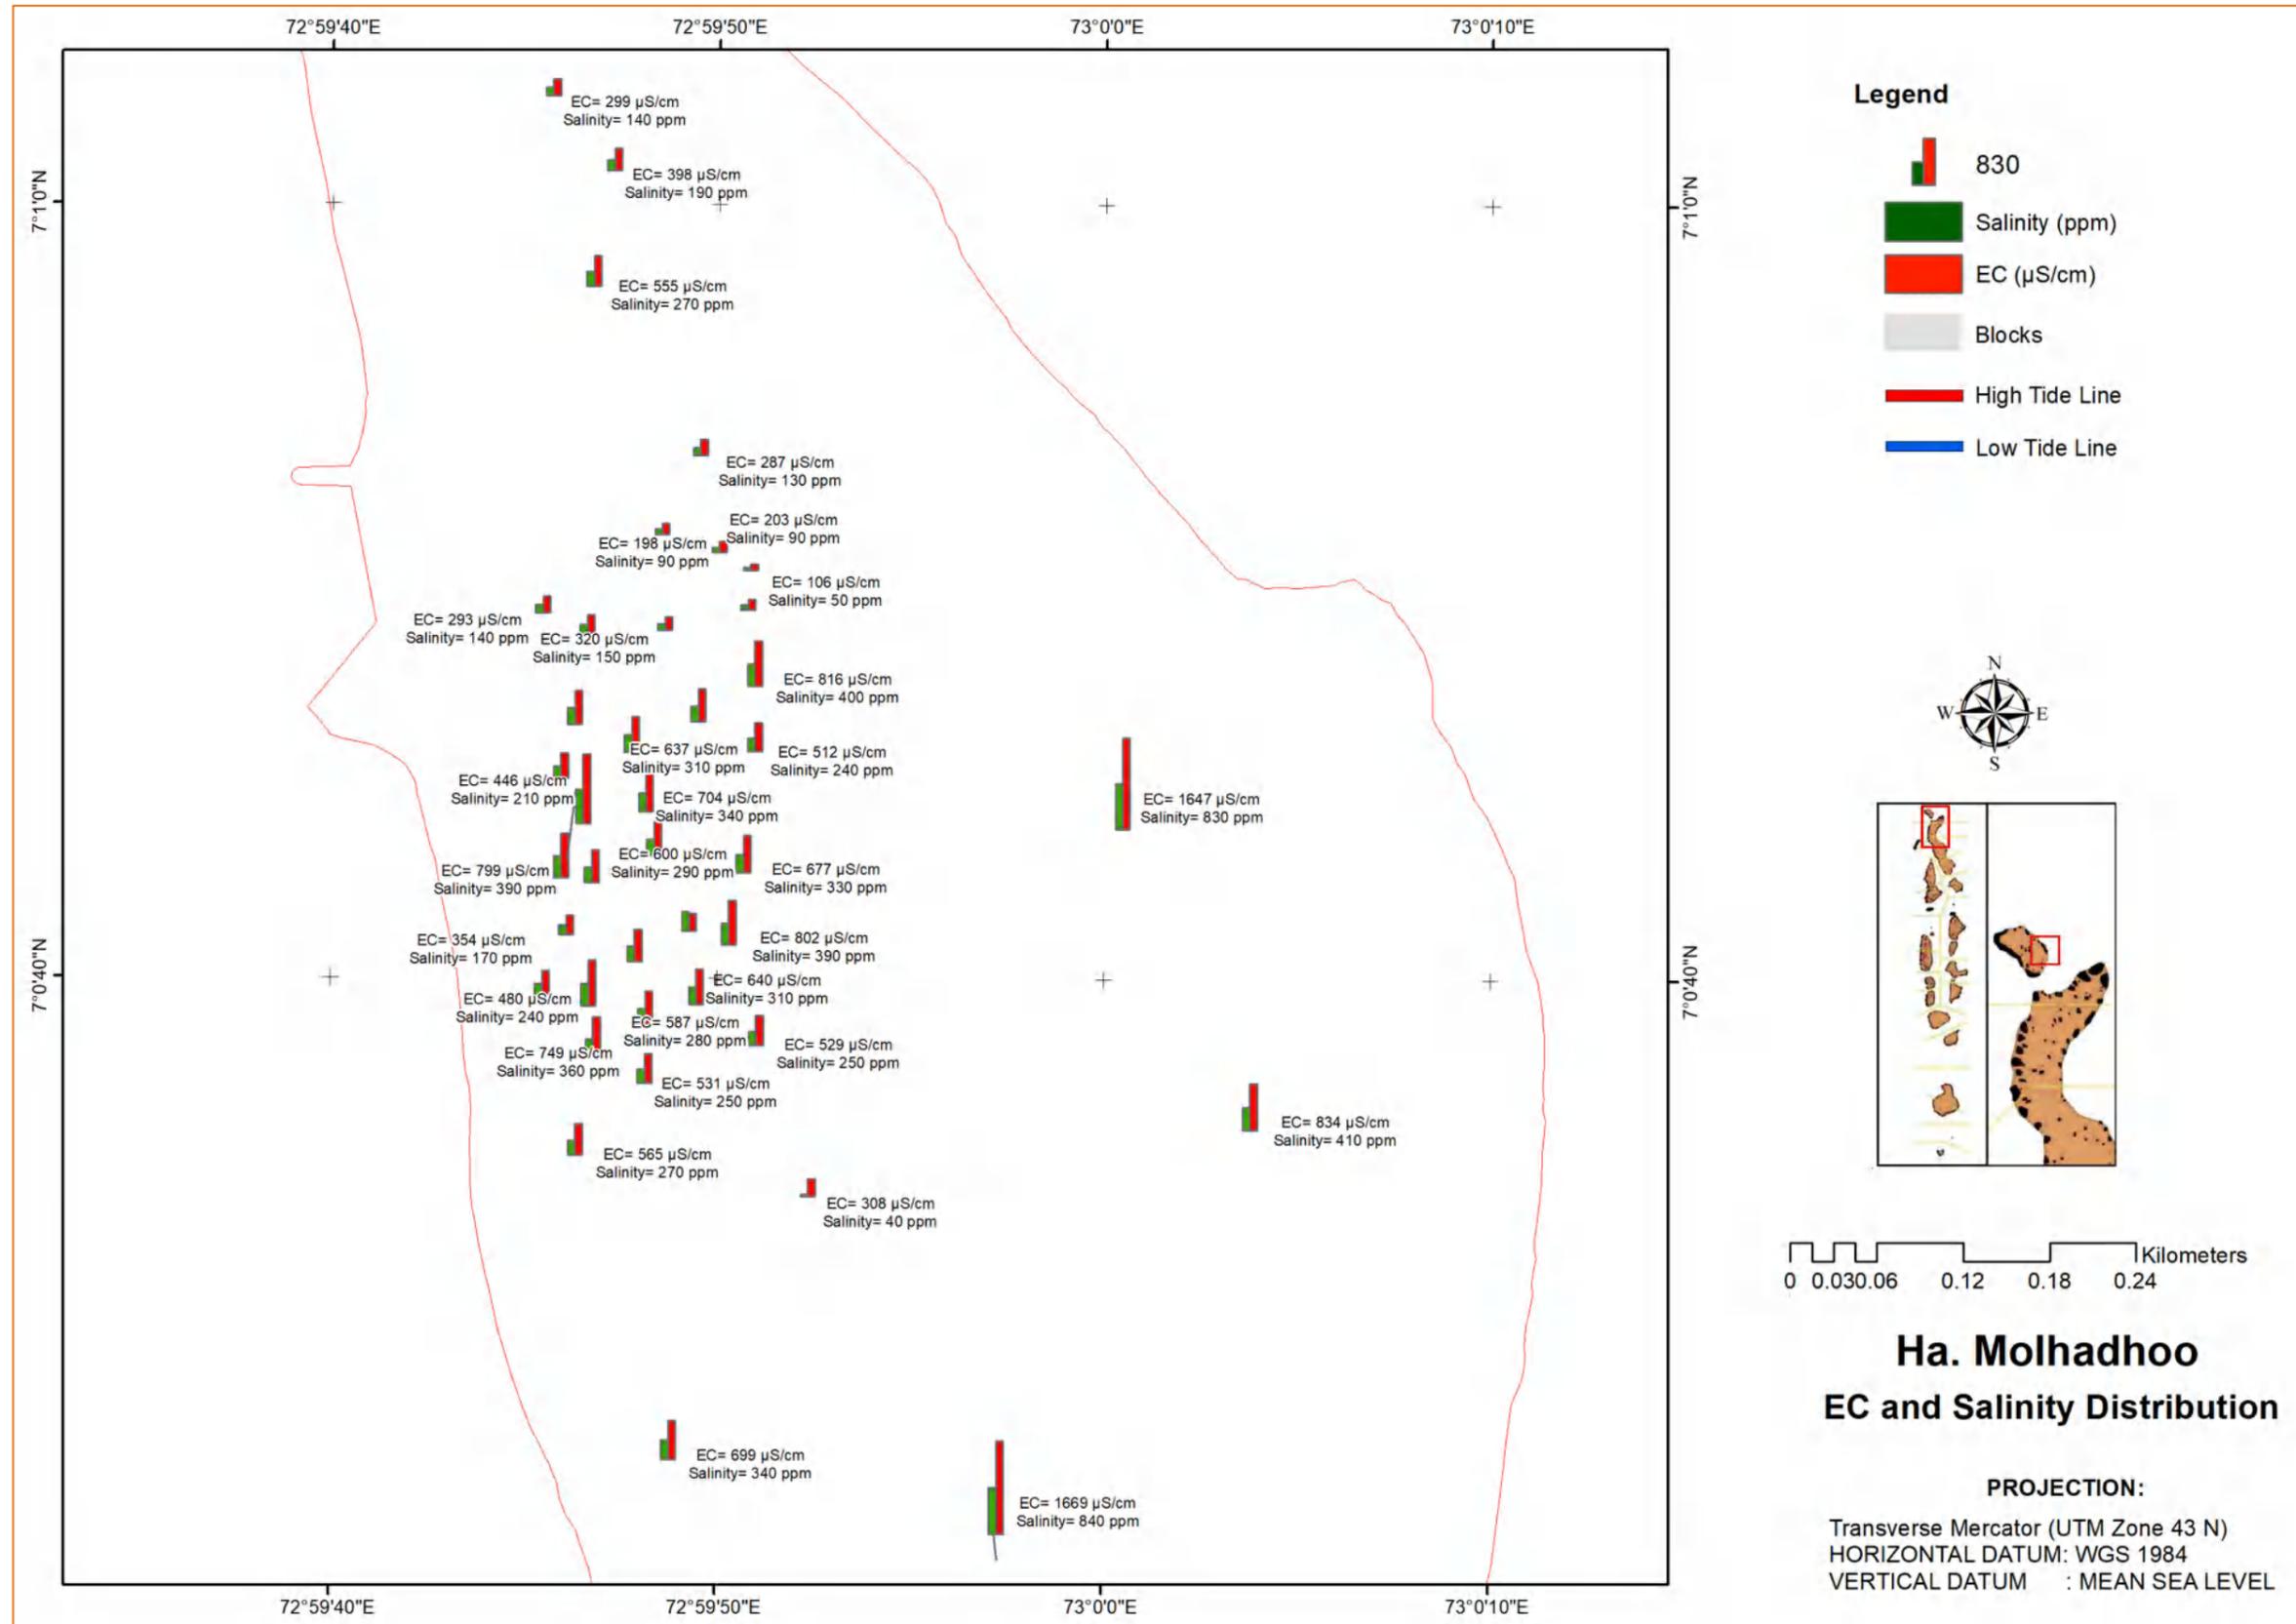
Figure 7-10: EC and Salinity Distribution in Ha. Molhadhoo Island

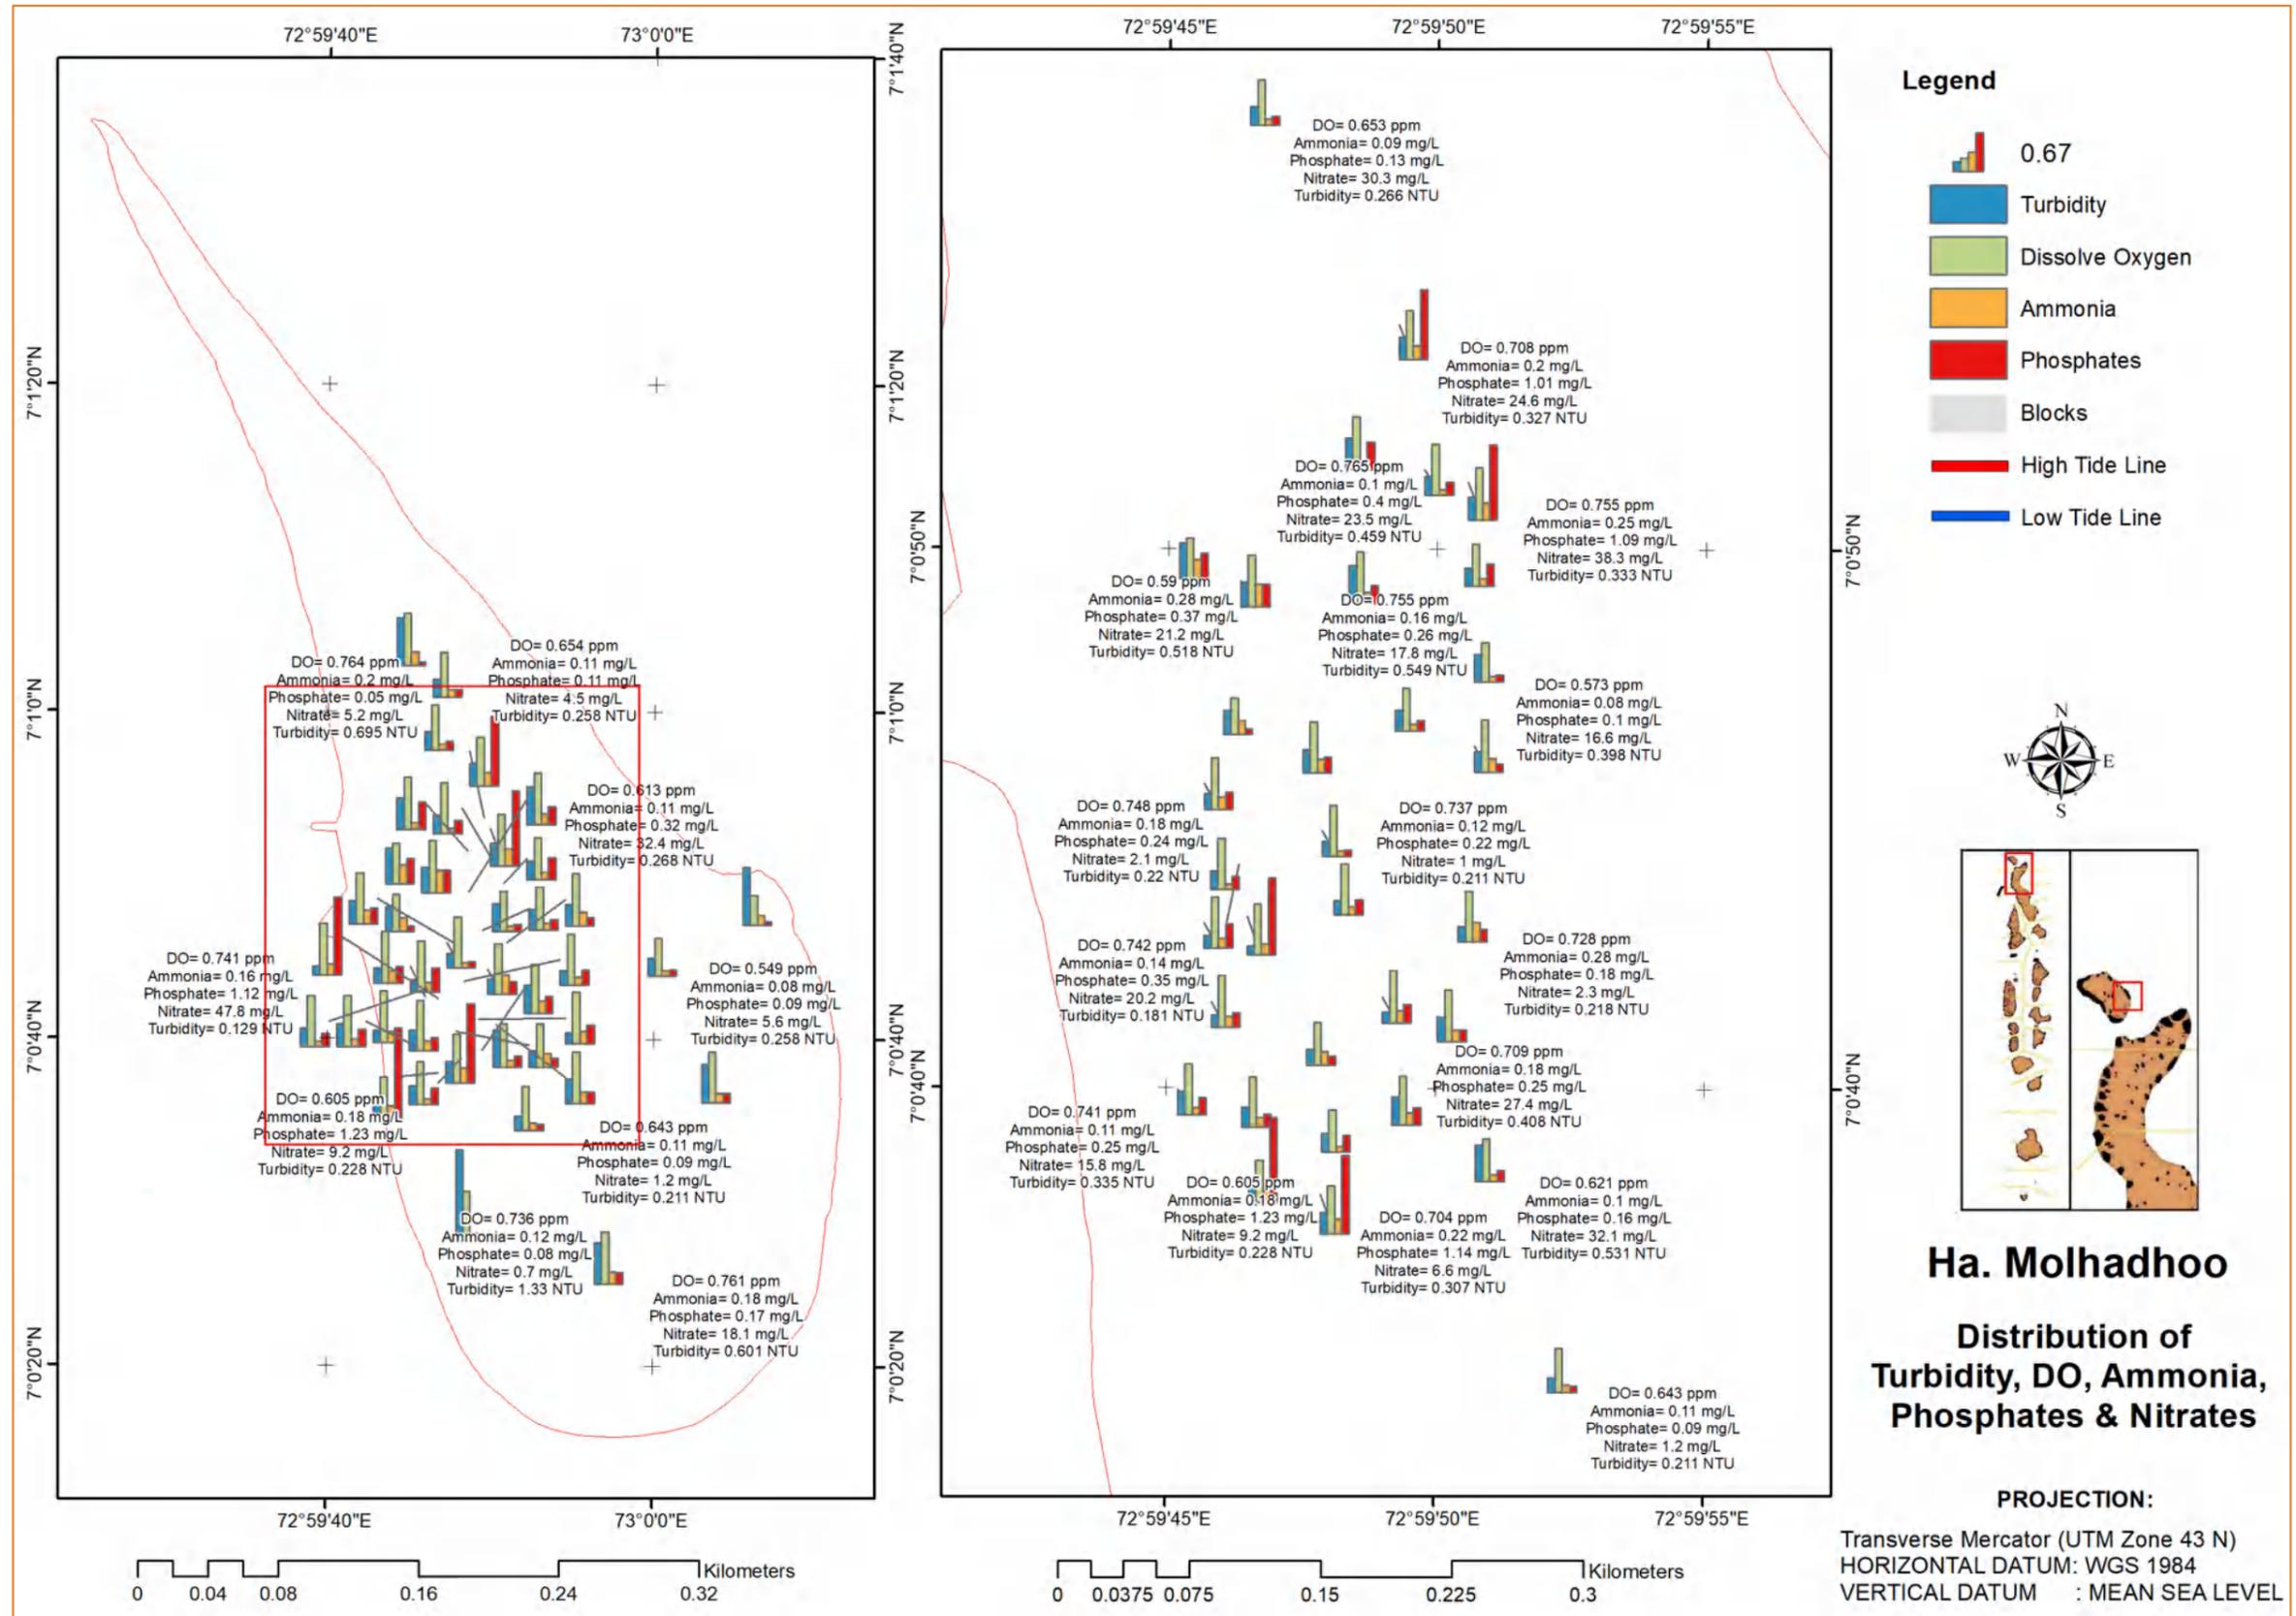
Figure 7-12: Distribution of Turbidity, DO, Ammonia, Phosphates and Nitrates in Ha. Molhadhoo Island

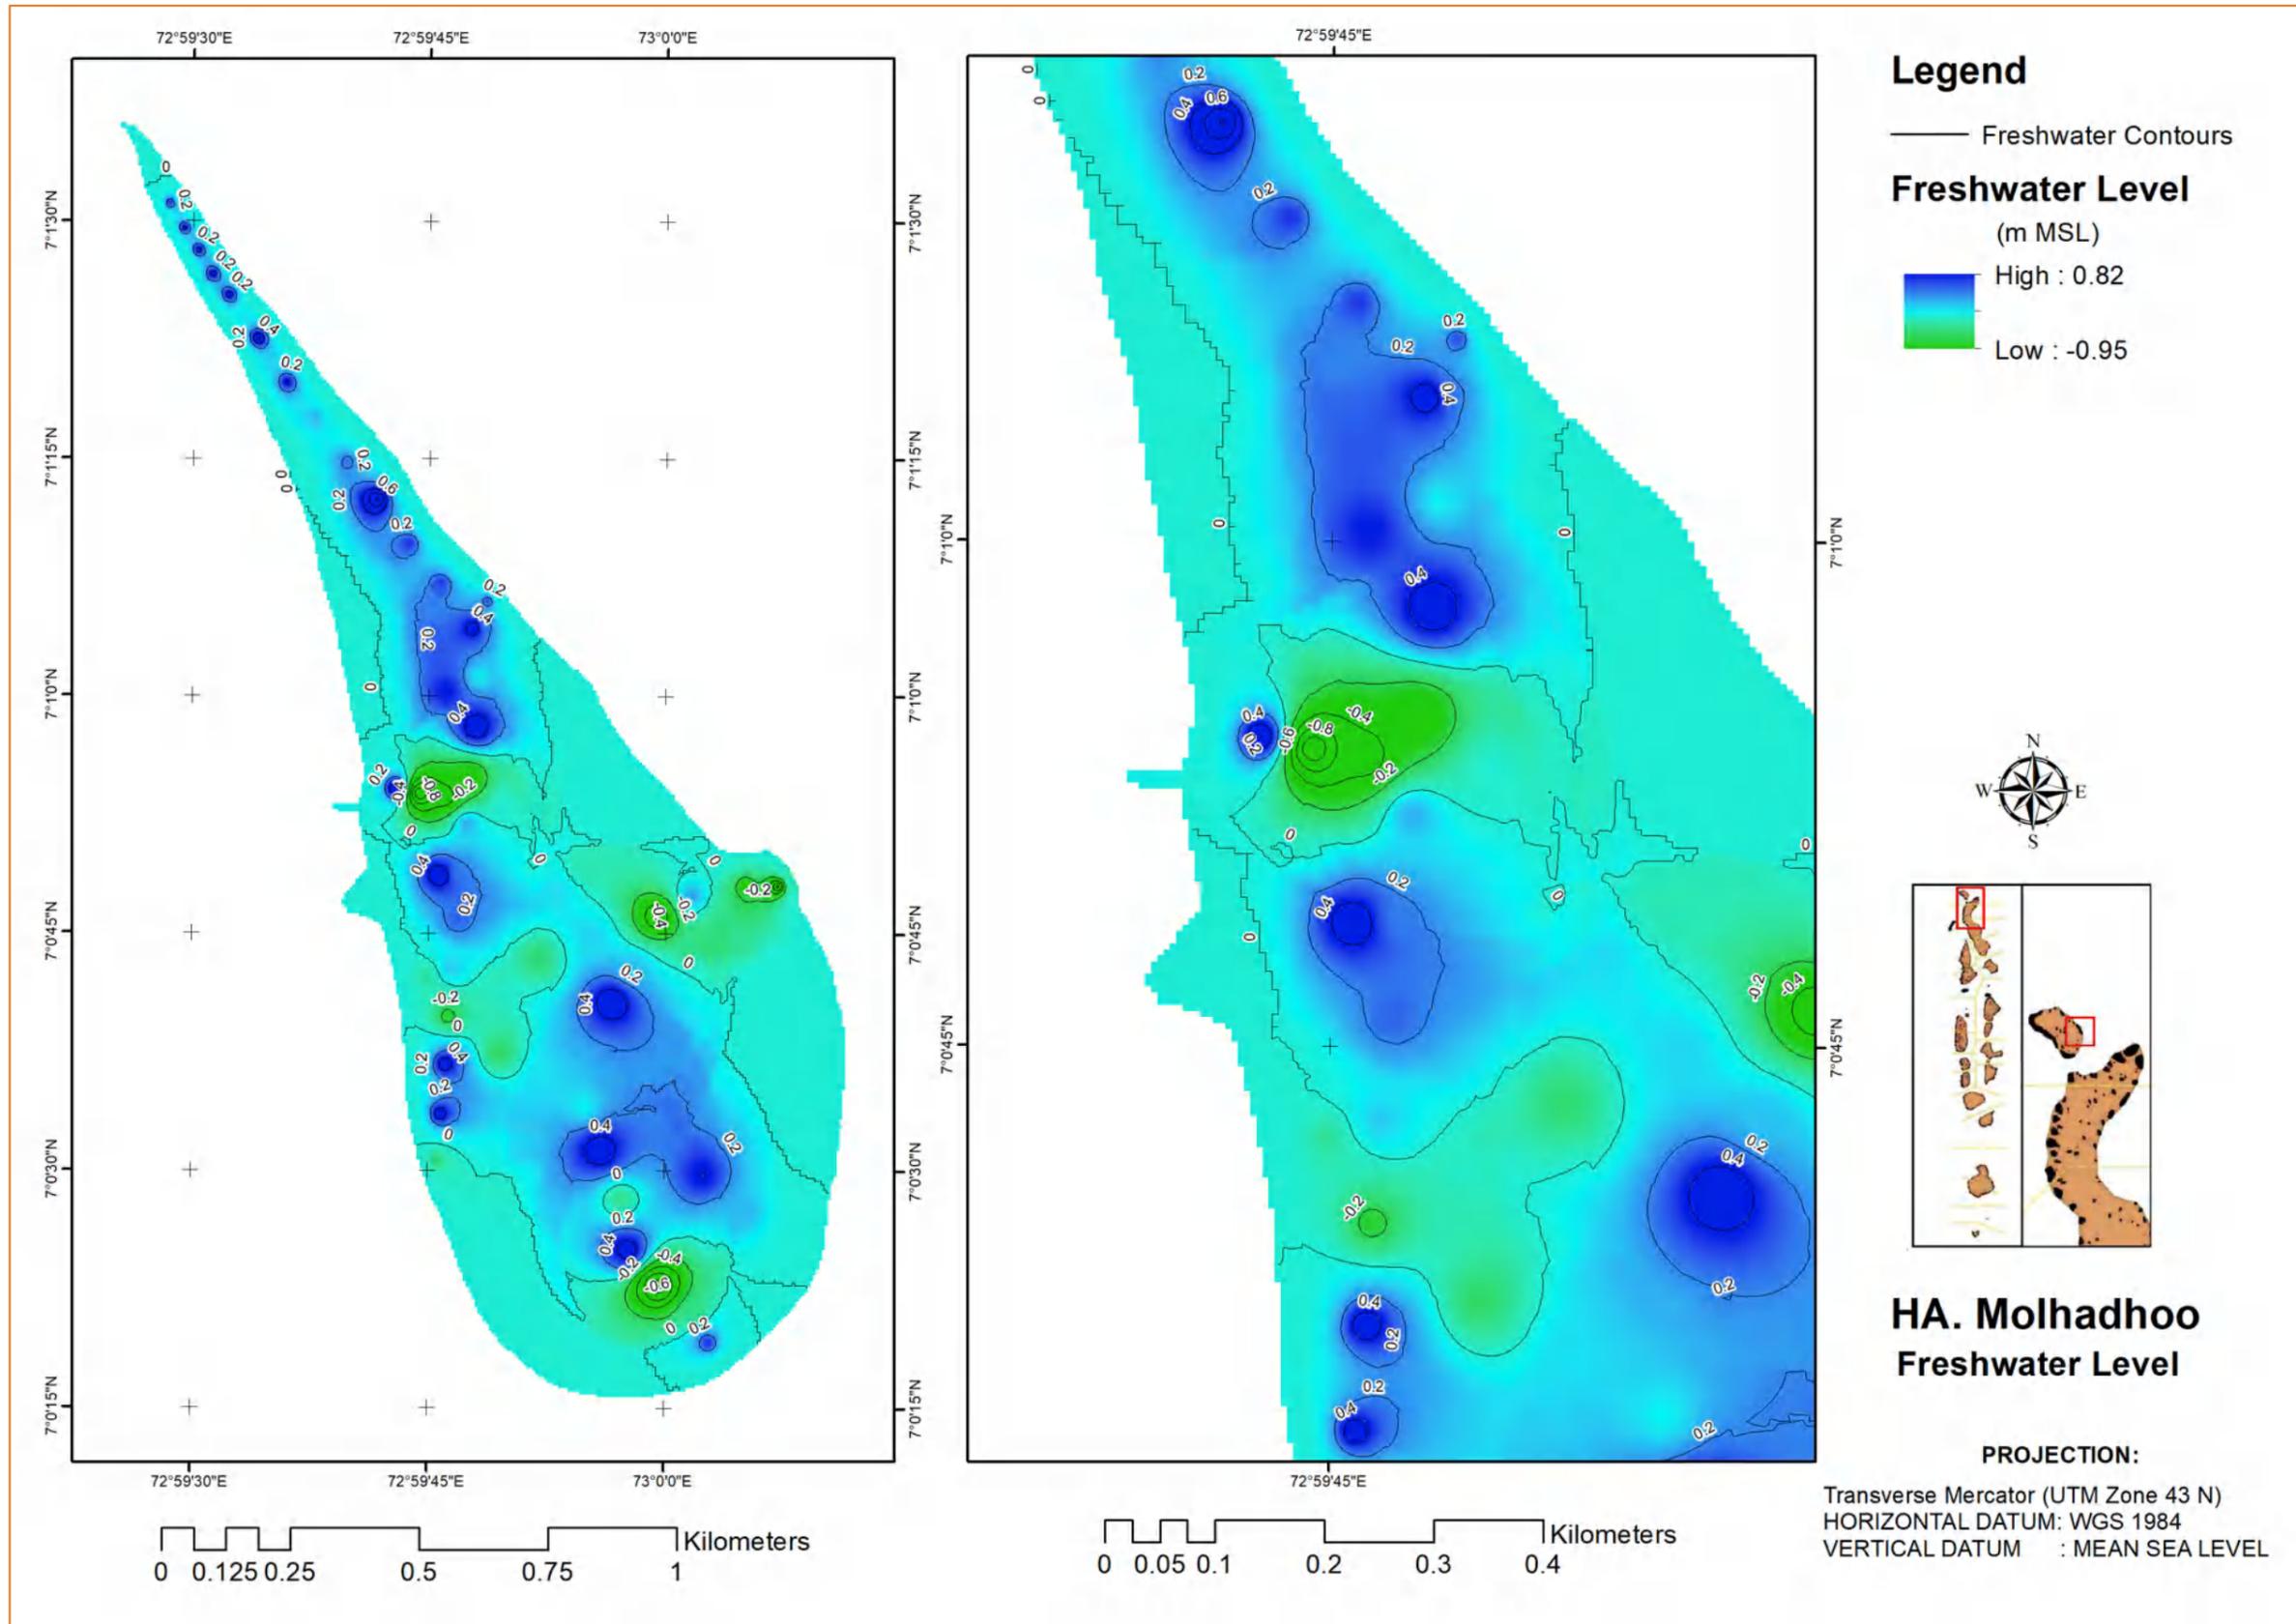
Figure 7-18: Freshwater Level in Molhadhoo Island

The 2-D freshwater lens distribution density maps produced with GIS software for visualization of the spatial and volume extents are also presented below in Figure 7-18 to Figure 7-20.
