Assessing Groundwater Resources and Design of Aquifer
Recharge Systems in Selected 17 Islands of Maldives - L1

BASELINE ASSESSMENT REPORT

Ha Filladhoo, Ha Maarandhoo, Ha Muraidhoo
Ha Uligan, and Ha Molhadhoo

Assignment: Assessing Groundwater Resources and Design of Aquifer Recharge Systems in Selected 17 Islands of Maldives (Lot 1)

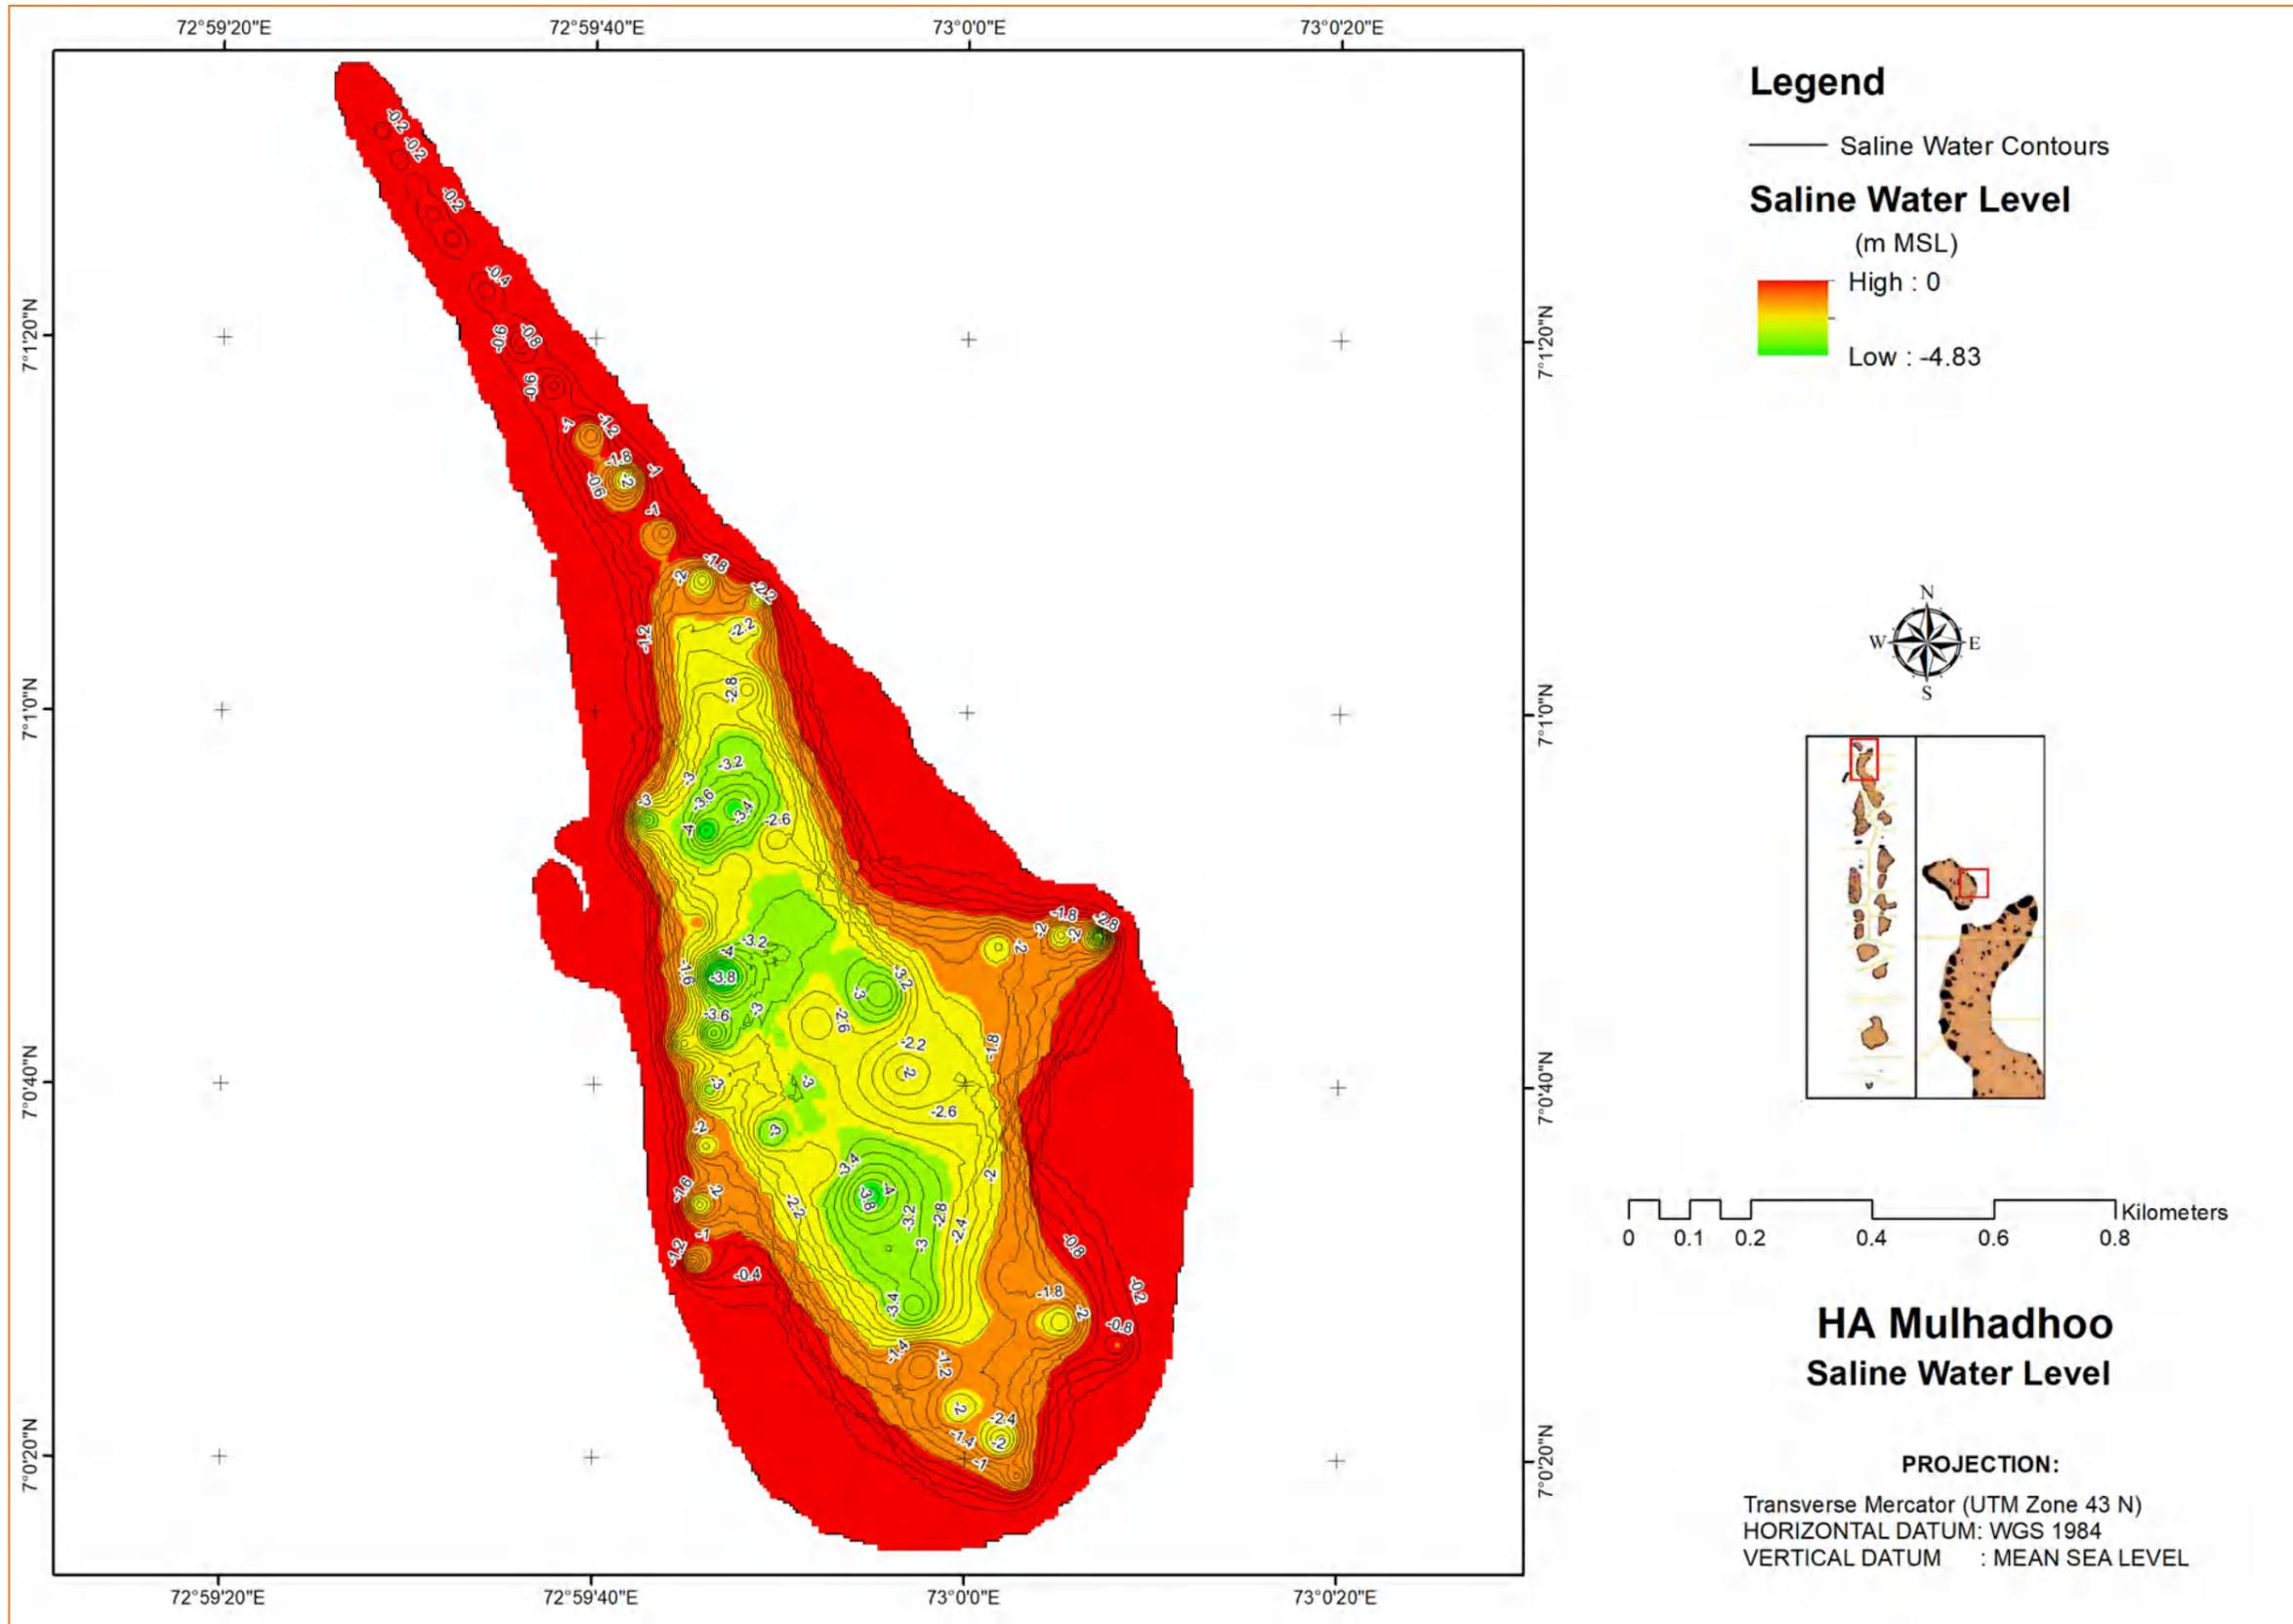
Figure 7-19: Saline water Level in Molhadhoo Island

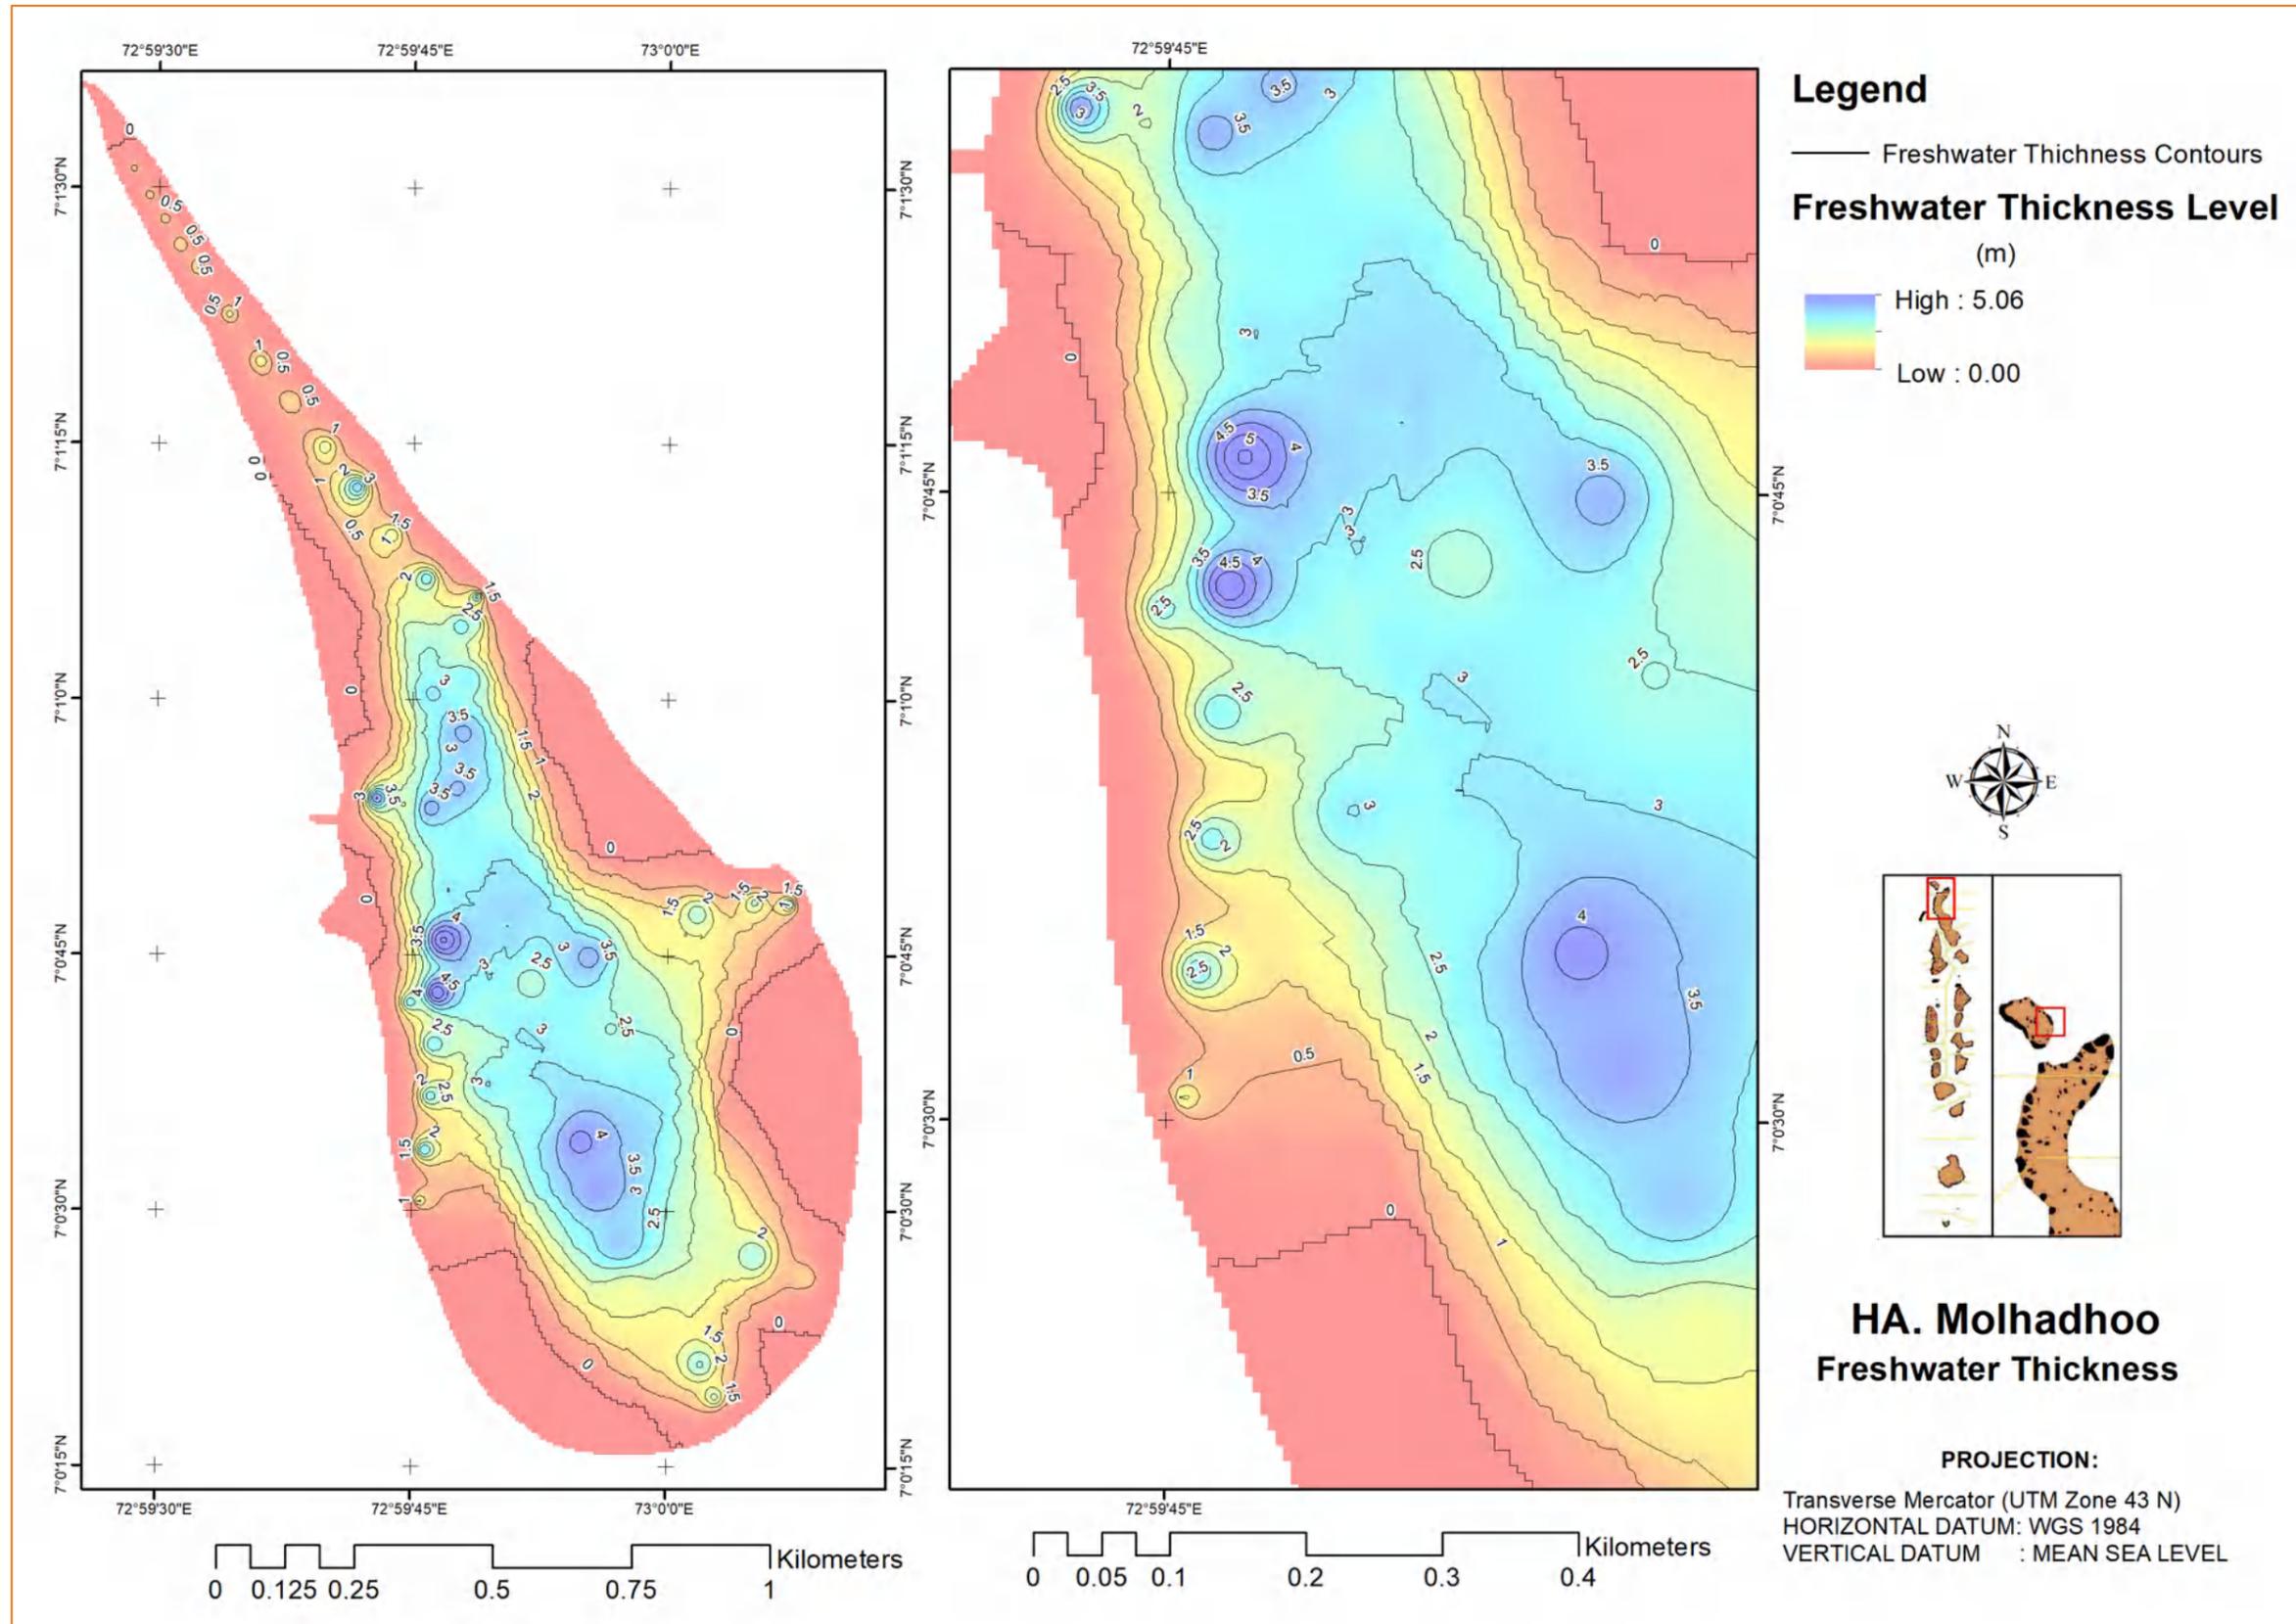
Figure 7-20: Freshwater thickness in Molhadhoo Island

The maximum freshwater thickness of the island is 1.85 m (It is noted here that these readings were taken in October, which is the wet season and the with a reasonably higher number of wet days per month of the year).

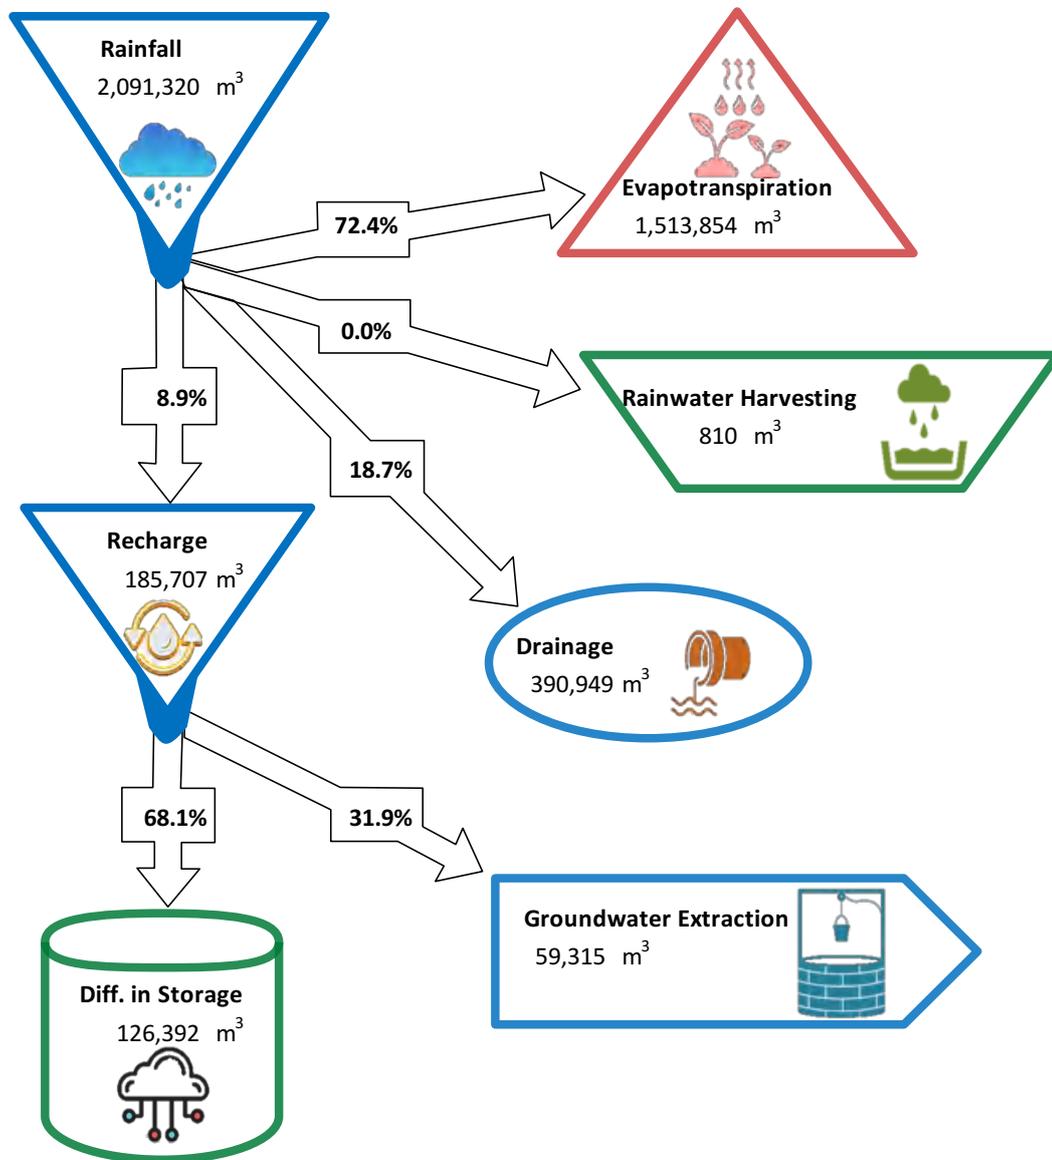
Figure 7-21: Schematic of water balance in Molhadhoo Island

An annual estimation is carried out based on the water balance method (Falkland, 2000). Rainwater harvesting is calculated using the number of rainwater harvesting units on the island. According to the spatial mean annual rainfall of the Maldives, the annual average rainfall of Molhadhoo Island is reported as 1,750 mm/year. Evapotranspiration was estimated using crop water requirements for different land use. Then, the rainfall was subtracted from rainwater harvesting, evapotranspiration, drainage to get the recharge volume. Drainage or the surface runoff was calculated by considering an aggregate runoff coefficient for the island based on the land usage (roof cover, bare land, farmland, roads, playgrounds, wetlands). The groundwater extractions were estimated from the amount of water usage in different sectors (residential, resorts, restaurants, agriculture and farming). The difference between recharge and groundwater extraction is taken to estimate the difference in storage.
