Assessing Groundwater Resources and Design of Aquifer Recharge Systems in Selected Islands of Maldives

BASELINE ASSESSMENT REPORT

Th. Gaadhiffushi, Th. Omadhoo, Th. Vandhoo,
Th. Kandoodhoo, Sh. Foakaidhoo, and Th. Dhiyamigili

Assignment: Assessing Groundwater Resources and Design of Aquifer Recharge Systems in Maldives (Lot 2)

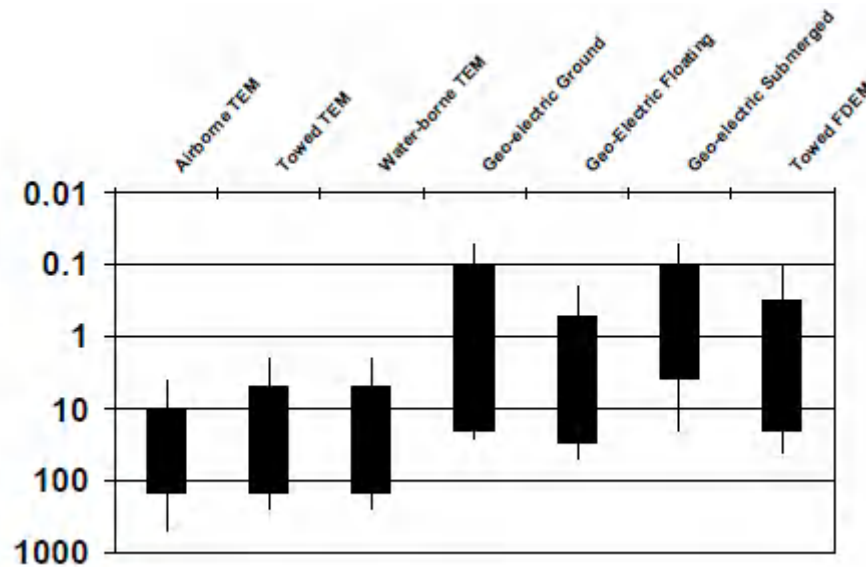
Figure 1-2: Ranges of detectable depths of various ER/EC imaging devices (in metres). Note that airborne FDEM (not shown) has a range similar to but shallower than airborne TEM (Source: Allen, 2007)

The emerging EM methods are based on the electrical properties of sub-surface layers while it overcomes the problem of establishing good galvanic (electrical) contact between the source of current and (earth) media, such as encountered in resistivity measurements. This enables the use of airborne EM technologies which are relatively faster and easier in application over wider areas. With presently available helicopter-borne and drone mounted sensors, groundwater studies can be designed to obtain a high resolution three-dimensional (3-D) view of the internal resistivity structure. However, the choice of method is entirely dependent on the availability of time and funds and the degree of accuracy required. Further, the relatively small dimensions and extents of the islands involved in comparison to the ranges of detectable depths (Fig. 1-2) and the specific need for differentiating saline groundwater from fresh groundwater to identify saline-freshwater interphase to detect lens thickness in this project exclude the use of EM methodologies in the present study. The ER based equipment and methodologies have been adopted in the first part of the project focusing on the assessment of baseline conditions in selected 13 islands (Min Env, 2020).

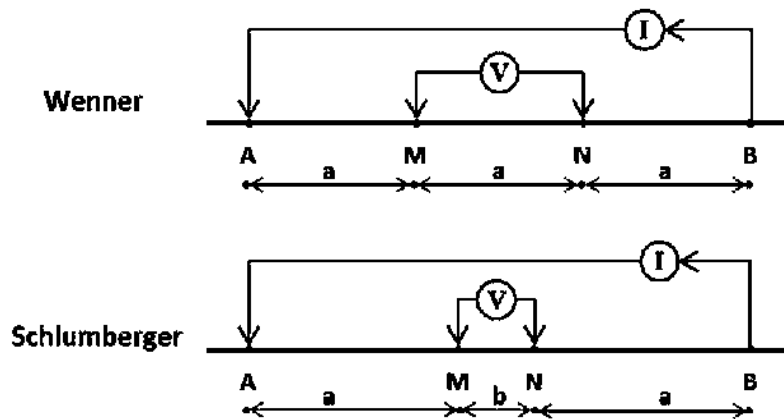
Figure 1-3: Electrode configurations -- Wenner and Schlumberger Arrays (Garofalo, 2014)

There are several standard electrode configurations used in resistivity surveys such as Wenner array and Schlumberger array. The Wenner array is mostly used for profiling to investigate the lateral resistivity variation whereas the Schlumberger array is used for vertical profiling. Schlumberger array is the method used in this study. Figure 1-3 shows the two different electrode arrays.

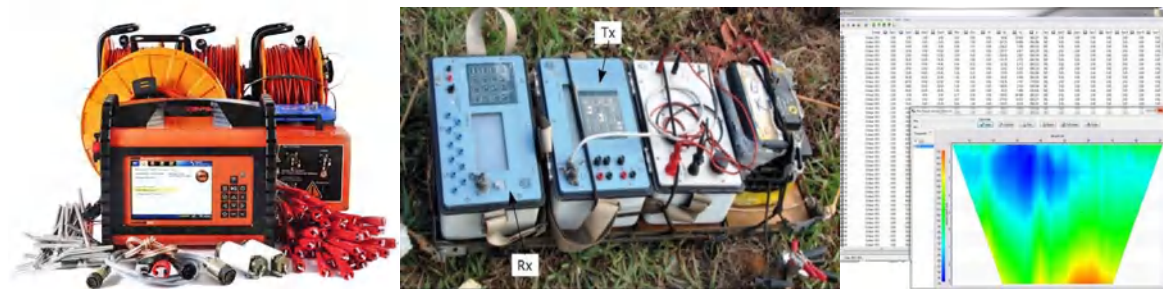
Figure 1-4: Electrical Resistivity (ER) equipment used for the field pilot tests (Sources: Left - ABEM Terrameter LS 2 - User Manual, 2017/ Center, Right - Siqueira Neto & Elis)

An ABEM Terrameter (Model SAS 1000) and an IRIS Resistivity Instrument (Model SYSCAL Pro) were used to carry out the island wide ER surveys in selected atoll islands.

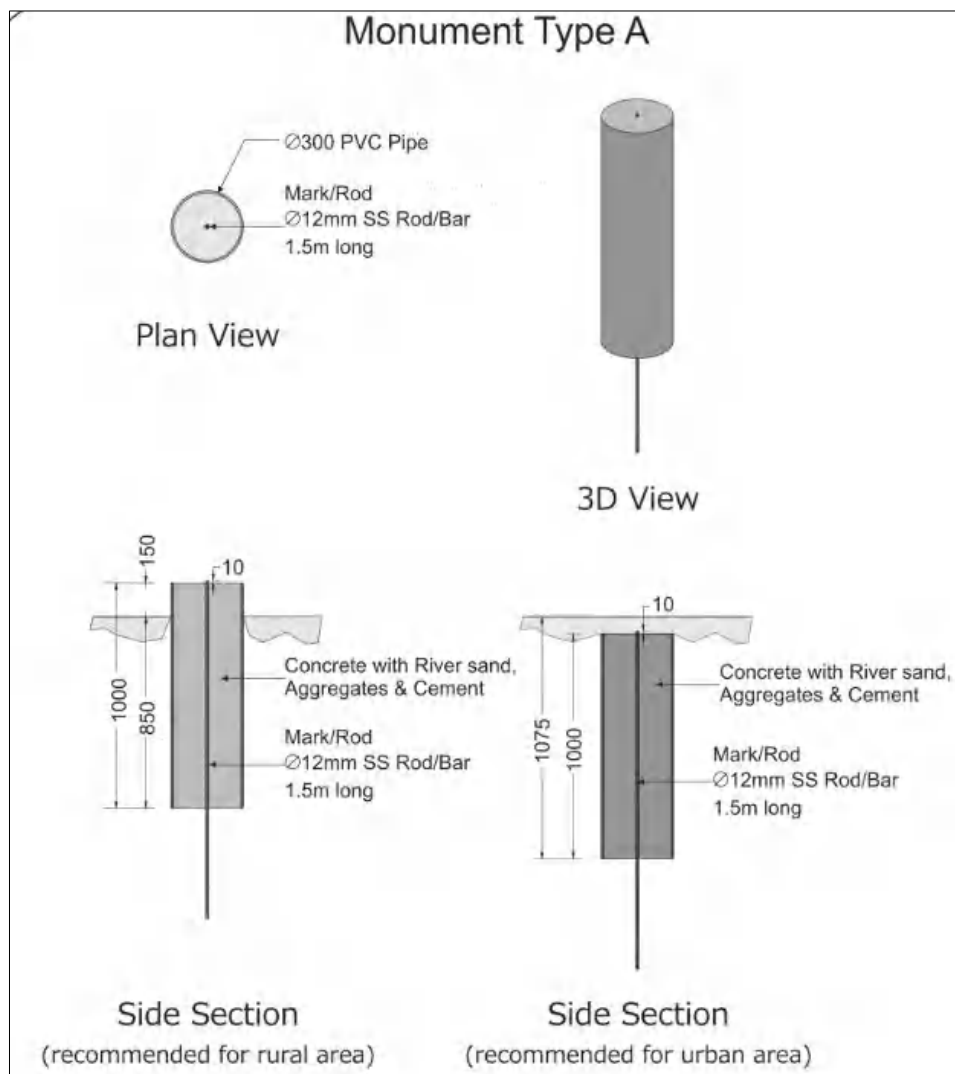
Figure 1-5: Type A PSM design (source: Maldives Land and Survey Authority, Guideline on establishment of Permanent Survey Mark)

The PSMs have been established where necessary (project sites where PSMs are not registered at Maldives Land and Survey Authority - MLSA) as per the MLSA guideline of establishing PSMs. Three PSMs were cast on-site as per MLSA guideline (Type A PSM design), while the PSMs were spaced such that best triangulation is achieved (depending on availability of space). The PSMs were placed 10 cm below ground level as recommended in Control Survey Guidelines by MLSA. The PSMs horizontal coordinates were established using Topcon GNSS receivers using the static survey method with horizontal and vertical error within 10mm. The data was processed using the Magnate Tools Office (TOPCON Inc., USA) software. The vertical level was established using predicted tidal data of the nearest tide station and established using the difference of ellipsoid height method (Figure 1-5 to Figure 1-7).

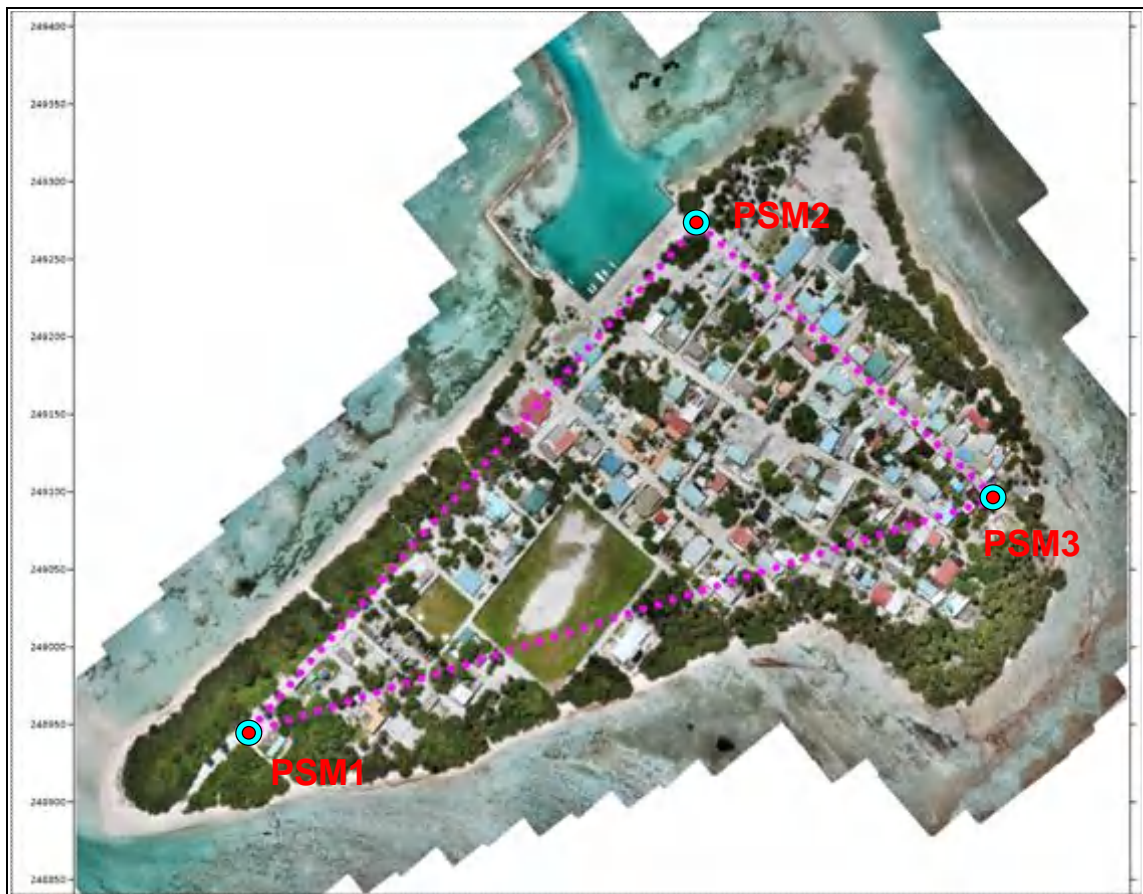
Figure 1-7: Example of spacing of PSMs

Two PSMs were located such that both are intervisible to each other while the 3rd was located at a maximum available distance away from intervisible PSMs (and intervisible to both above) as illustrated in Fig. 1-7.

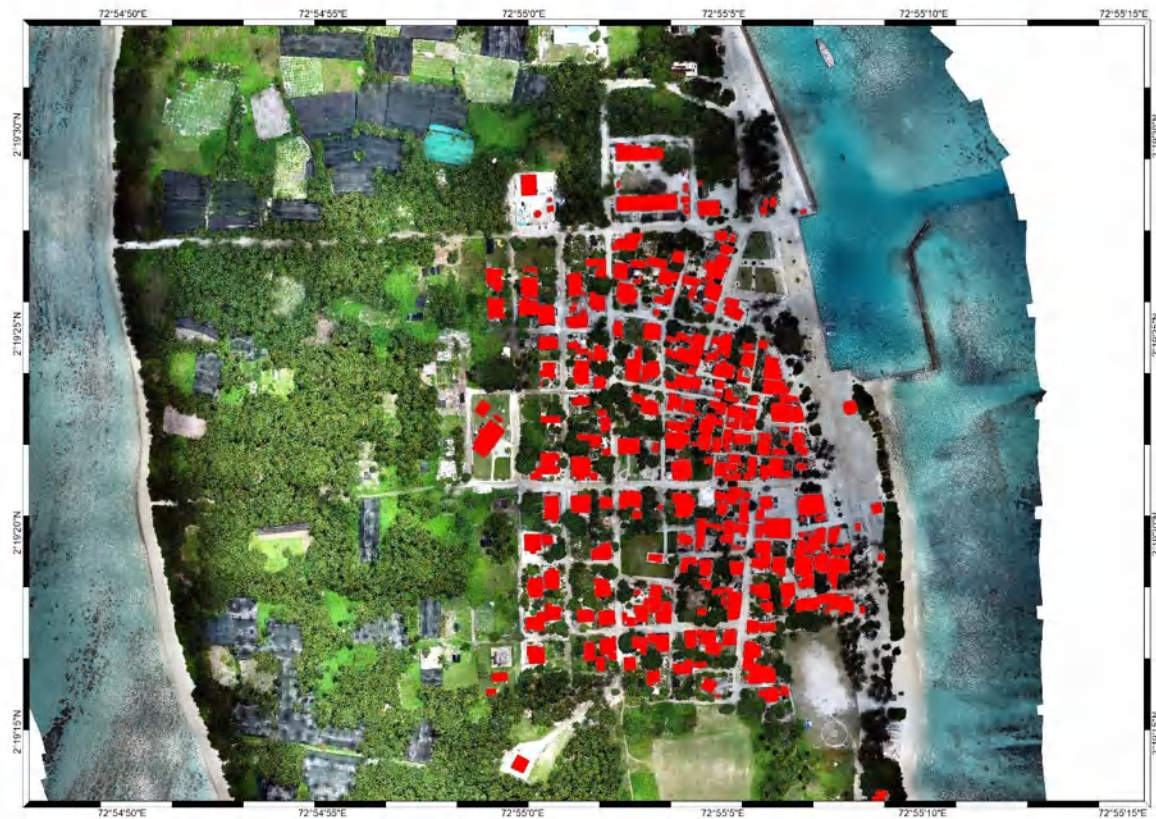
Figure 1-9: Calculation of Roof Cover in an island using UAV survey in the Maldives

Similarly, all empty areas, vegetated areas and other similar land use and terrain features can be extracted. These data will help hydrogeologists to accurately model rainfall runoff, rainwater infiltration and provide vital estimates on groundwater recharge.

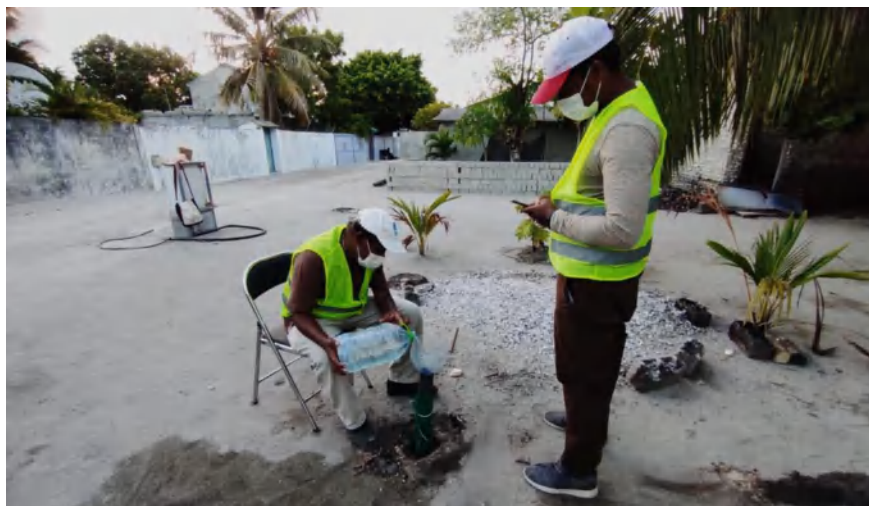
Figure 1-10: Methodology for Constant Head Gravity Permeability Tests

- K = coefficient of permeability;
- Q = constant rate of flow into the hole;
- r = internal radius of casing; and
- H = differential head of water = H_1 (gravity head) - H_f (head loss due to friction).

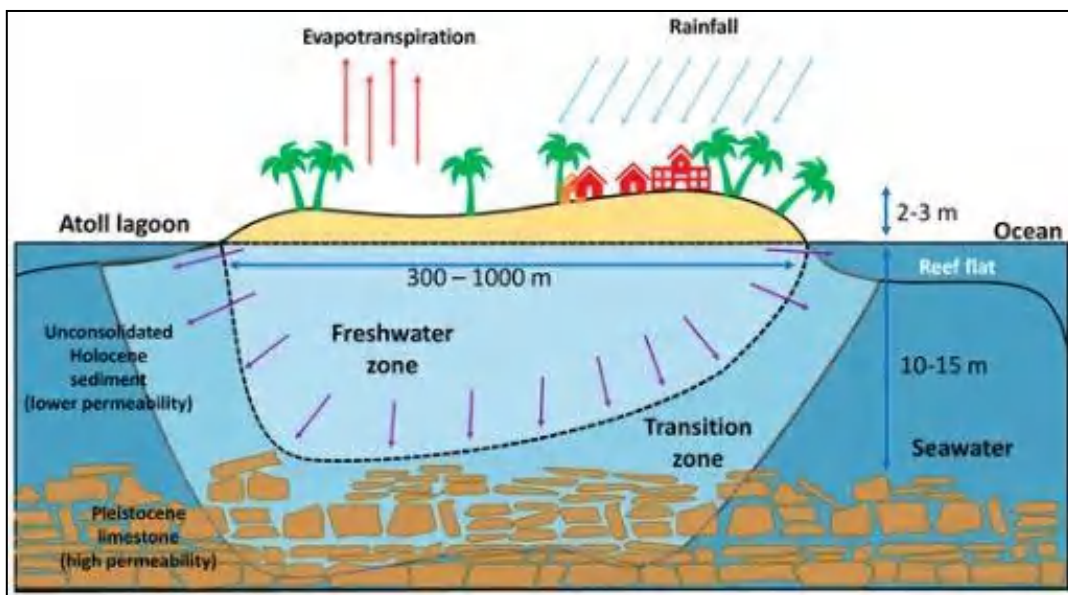
Figure 2-1: Cross section through a small coral island showing main features of a freshwater lens (exaggerated vertical scale) (Source: Jaleel et al., 2020)

The base of the freshwater zone can be accurately determined by establishing a recognisable salinity limit for freshwater and drilling through the lens to find where the limit occurs. The salinity limit adopted for freshwater (suitable for drinking water) is often taken as the WHO guideline value for chloride ion of 250 mg/L (WHO, 1993). This is approximately equivalent to electrical conductivity (EC) of 1,500 $\mu\text{S}/\text{cm}$. In some islands, a higher value of EC (e.g. 2,500 $\mu\text{S}/\text{cm}$) has been used as an upper limit, noting that the WHO guidelines are based on taste and not health considerations.

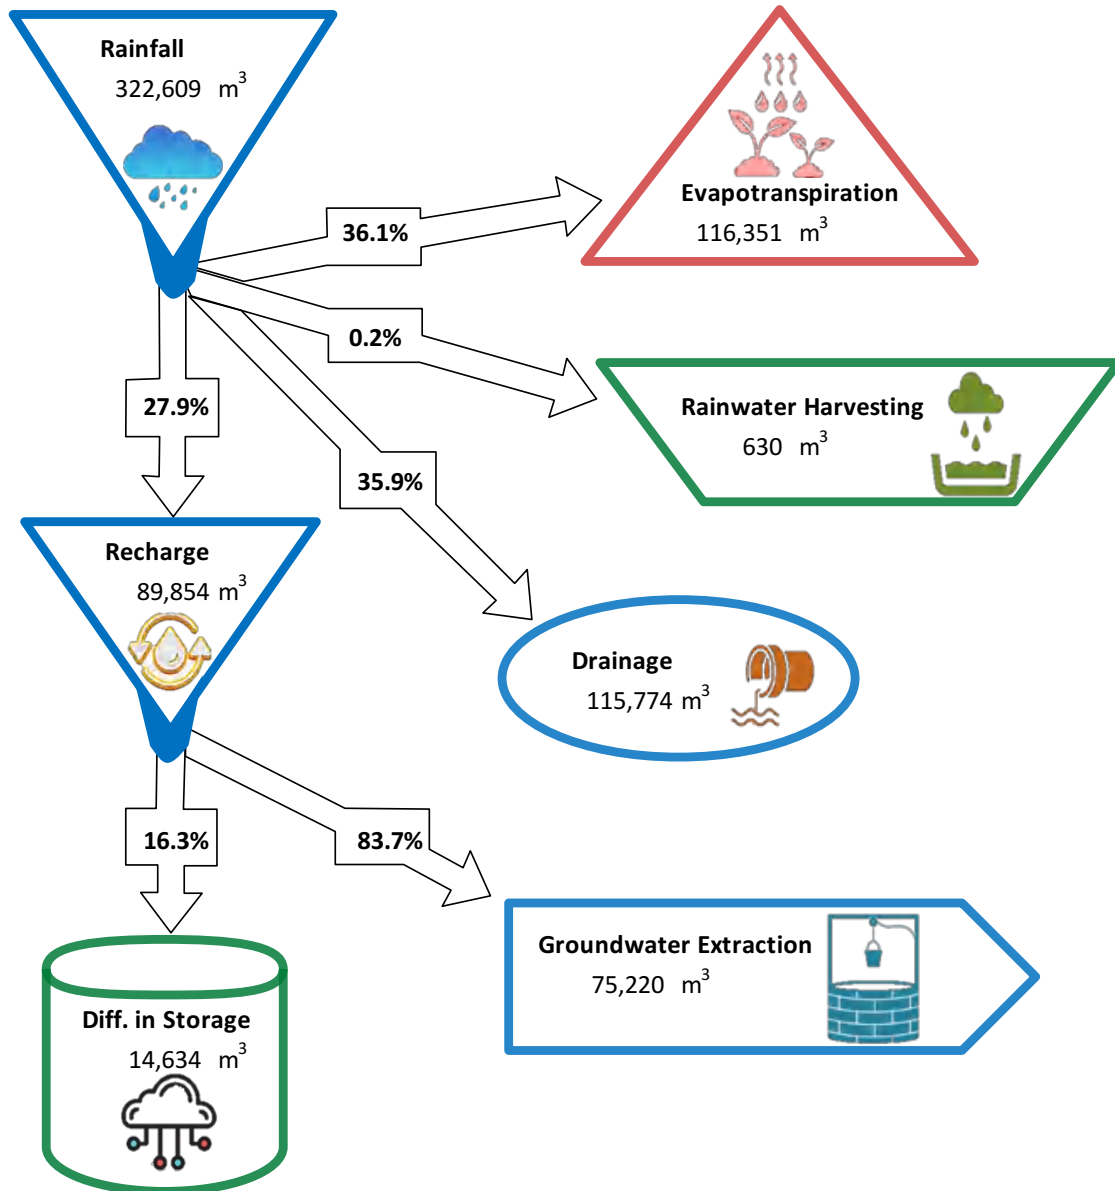
Figure 6-23: Schematic of water balance in Gaadhiffushi Island

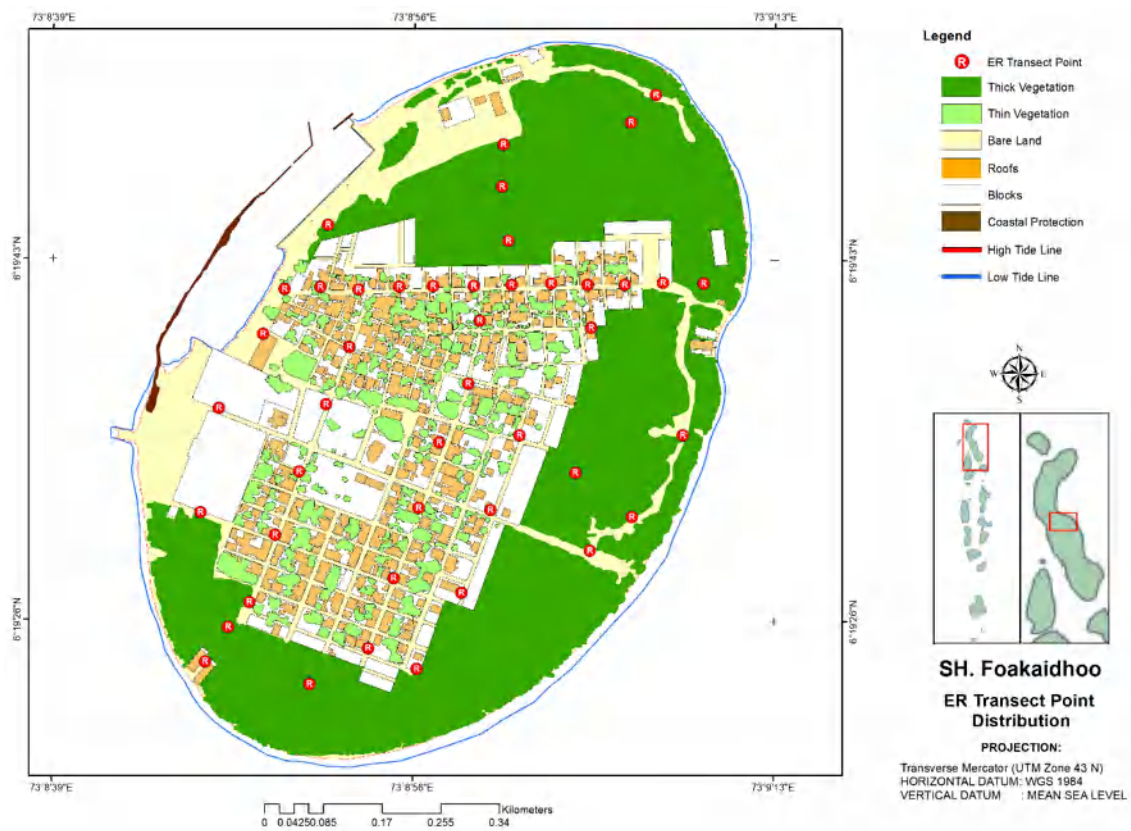
Figure 7-16: Location of ER points in Foakaidhoo Island

The Electrical Resistivity (ER) tests were carried out in the locations as outlined in Figure 7-16 below. The ER survey included test points along 9 transects selected representatively based on reconnaissance surveys to adequately characterise different land uses and island cross-sections. The main transects were aligned along existing roads to maintain consistency and uniformity.

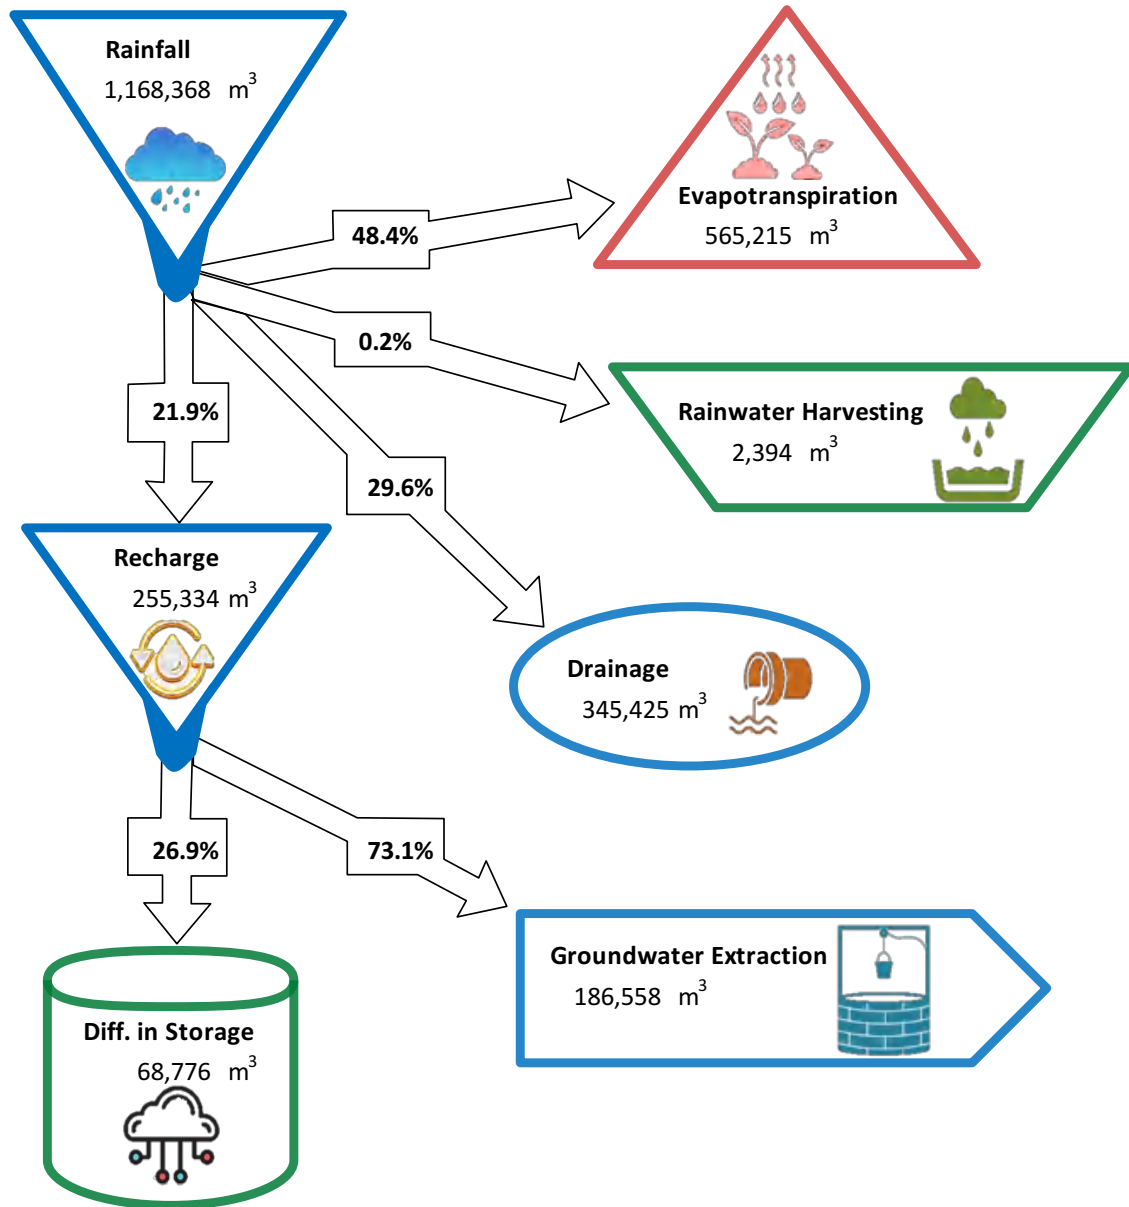
Figure 7-22: Schematic of water balance in Foakaidhoo Island
