Environmental Impact Assessment

Document Stage: Updated
Number: 51077-003
August 2023

Maldives: Greater Malé Waste-to-Energy Project – Waste to Energy Plant (Part I)

Appendices

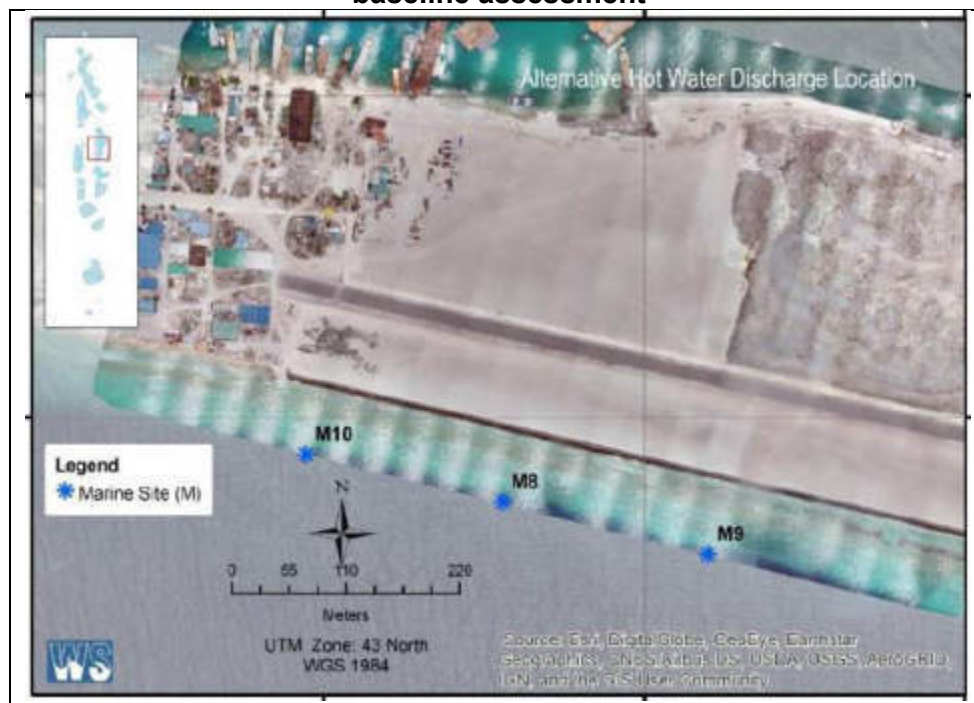
Figure 1: Underwater Marine Survey Locations M8,M9 and M10 for pre-construction baseline assessment

For the pre-construction site environmental baseline assessment reef benthic survey was conducted on 16 June 2022 in locations M10, M9 and M8 Figure 1. Following establishment of GPS locations, transects surveys conducted at two depths: 5m and 10m at each station following the methods established by Hodgson et.al (2006) in Reef Check Instruction Manual: A Guide to Reef Check Coral Reef Monitoring. Three transects of 20 m length were laid, one after the other along the reef ensuring transect falls to the specific depth. A quadrat of size 0.5 x 0.5 m was laid sequentially on the transect and photo images were taken with the quadrat in middle making sure the quadrat in the center of the frame. In this way every transect would have at least 10 images. Three such transects would around 60 images from each depth.

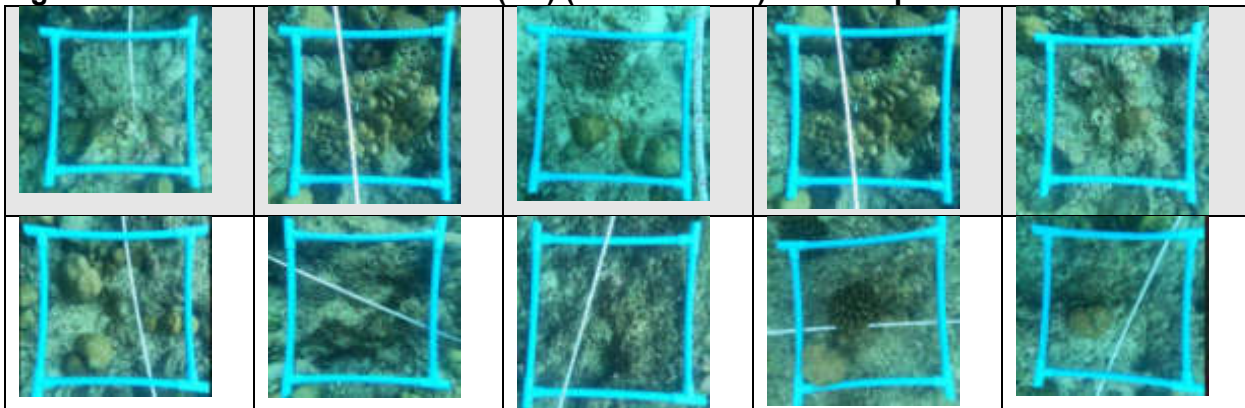
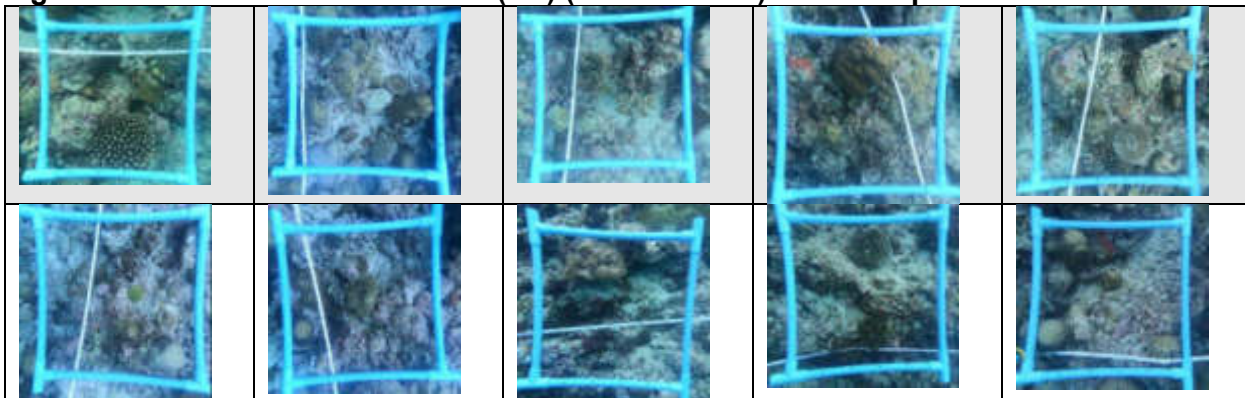
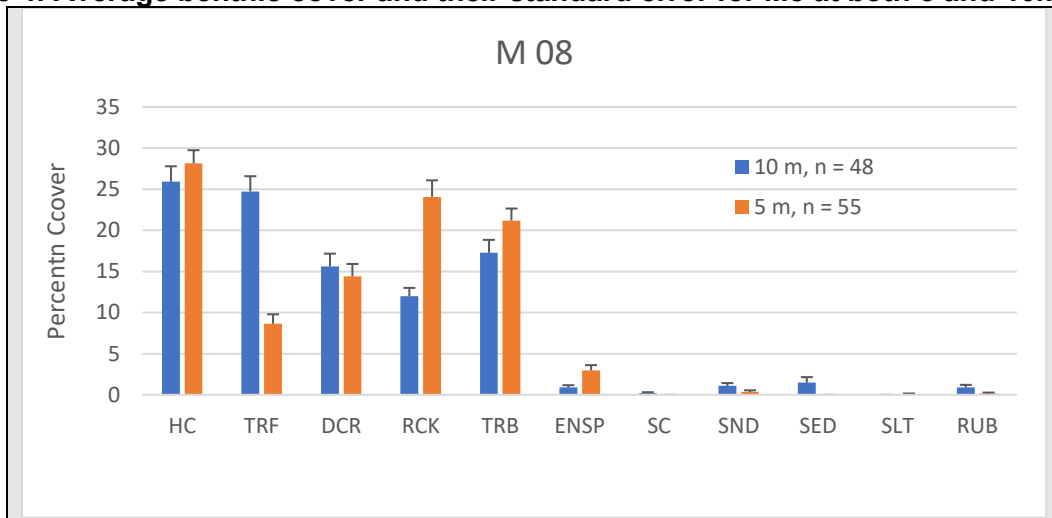
Status of Site M8: This site was selected because it is the one of the locations that will be used for the discharge of waste water and brine outfall in the EIA report. Substrate cover at both 5m and 10 m depths shows hard coral cover within 26-28%, turf is higher at 10m depth (25%) than the 5-meter depth (9%). and dead coral cover is similar at both depth (14-15%). Rock and turf rubble cover are higher at 5m depth (24-21% respectively), Rubble and turf rubble cover are less at 10m depth (12-17% respectively). Encrusting corals and sponges are slightly higher at 5m depth but the overall cover in both depths are less than 5%. Massive porites were the dominating group of hard coral observed at the site. Trigger fish, surgeon fish (Powder blue), wrasse (labridae) basslets were common. Grazers (Acanthurids or Scarids) were not seen and this results is consistent with what was obtained with earlier assessment. Photographs of the transect quadrats are shown in 2 and 3. Benthic composition of M8 at both 5 and 10m depth is in 4.

Figure 2: Photos Taken from Site 8 (M8) (16 June 2022) at 5m depth

Figure 3: Photos Taken from Site 8 (M8) (16 June 2022) at 10m depth

Figure 4: Average benthic cover and their standard error for M8 at both 5 and 10m depth

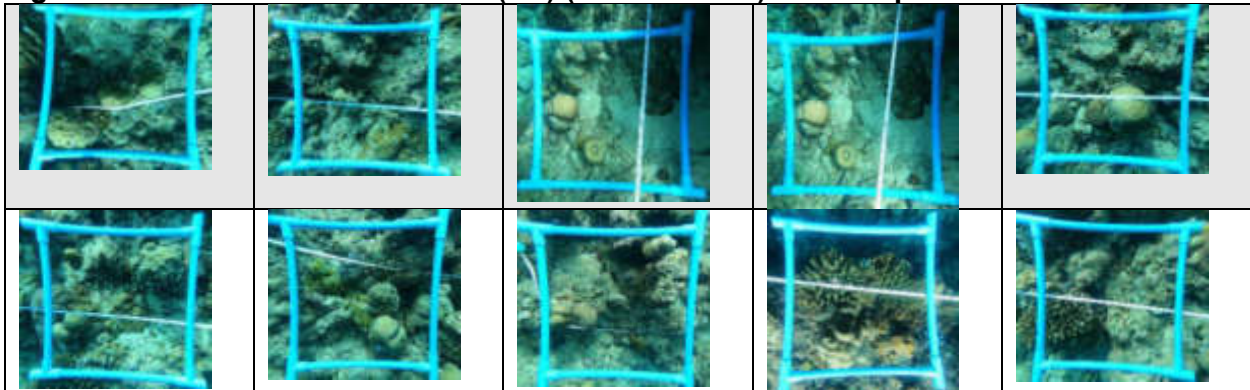
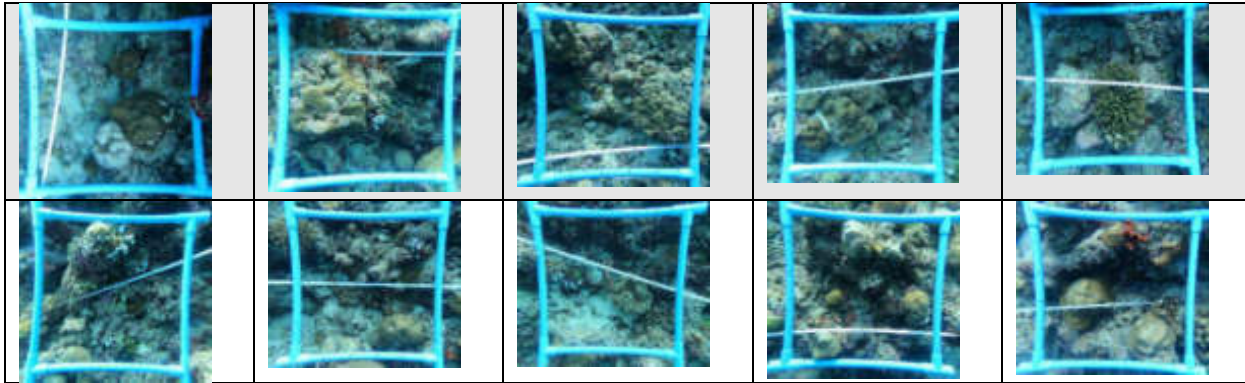
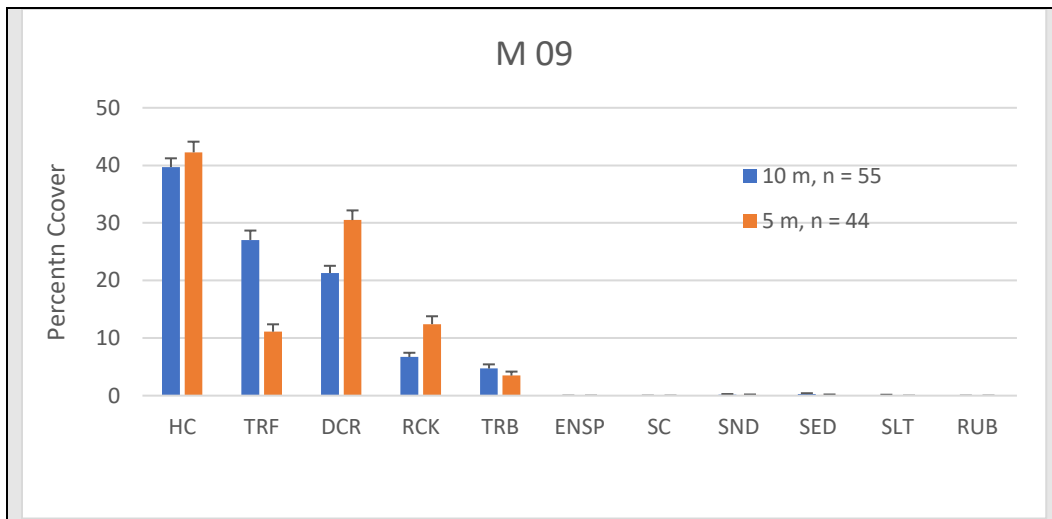
Status of Site M9: This location was identified as an alternative for brine discharge and wastewater outfall. This is close to the WtE site at the southern reef of Thilafushi Island. Substrate survey shows hard coral cover over 40% at both depths. Similar to M9, turf cover is higher at 10m (27%) than 5m depth (11%) while dead coral rock is higher at 5m (31%) than 10m depth (21%). Porities are the dominant hard live coral encountered in the area in the transects and fairly large amount table corals were found on the reef flat at about 2m depth. Trigger fish, surgeon fish (Powder blue), wrasse (labridae) basslets were common. Grazers (Acanthurids or Scarids) were not seen and this result is consistent with what was obtained with earlier assessment. Photographs of the transect quadrats are shown in Figure 5 and

Figure 5: Photos Taken from Site 9 (M9) (16 June 2022) at 5m depth

Figure 6: Photos Taken from Site 9 (M9) (16 June 2022) at 10m depth

Figure 7: Average benthic cover and their standard error for M9 at both 5 and 10m depth

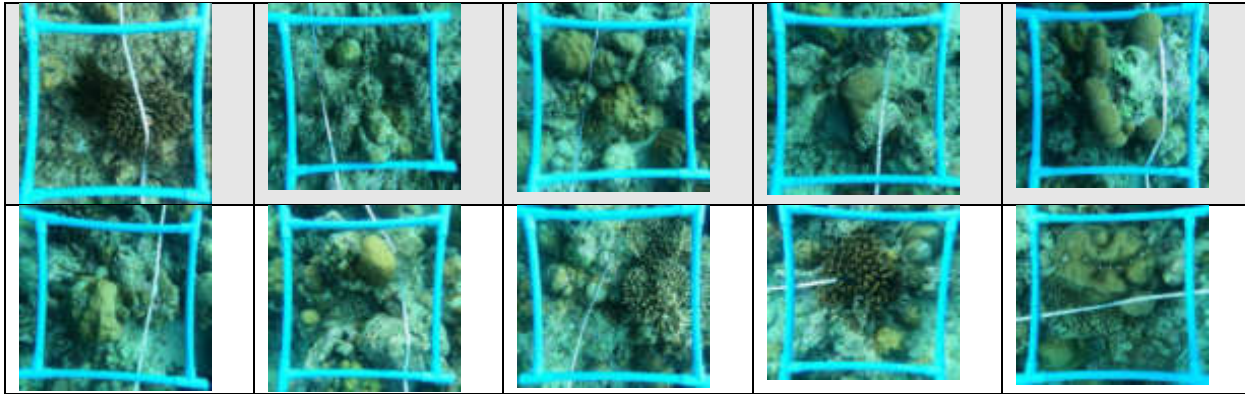
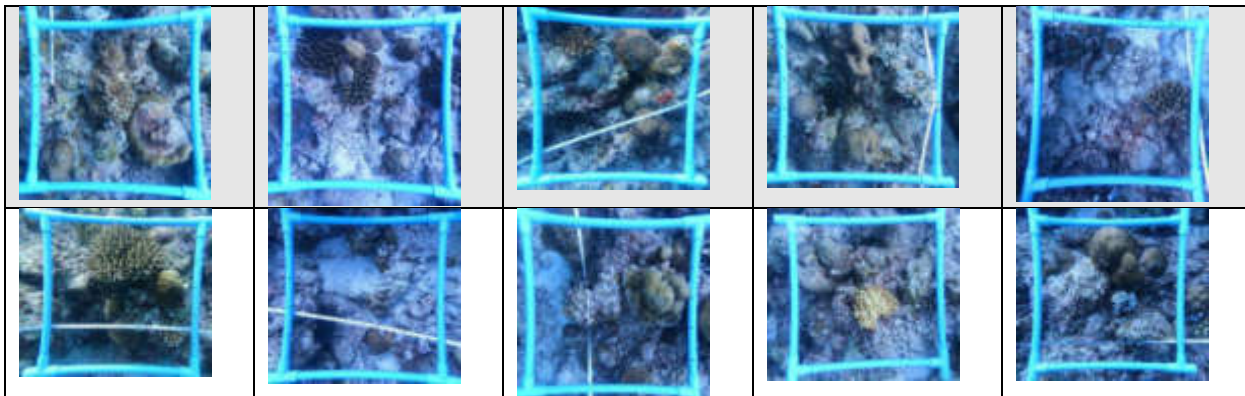
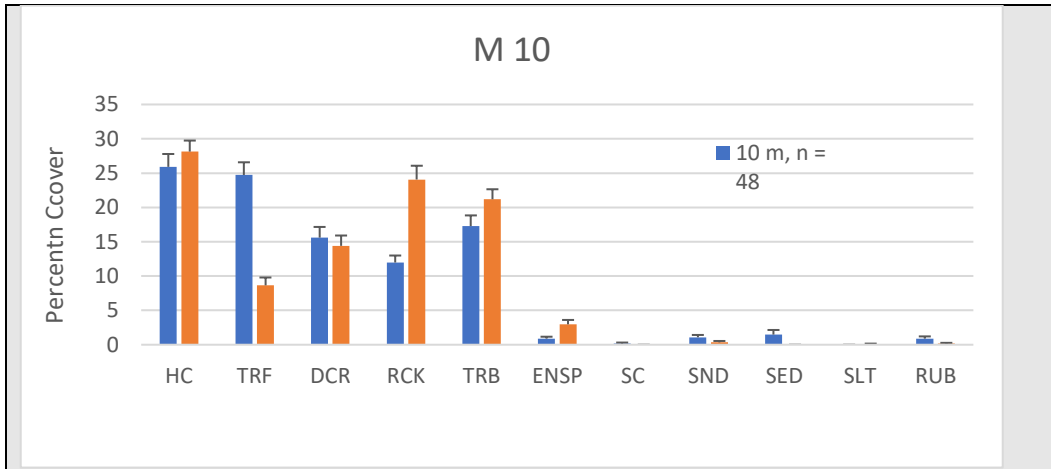
Status of Site M10: This location has been identified in the EIA report as a potential alternative for the discharge of brine water and waste water. The location is very close to the WtE facility, and it is on the southern reef of Thilafushi Island. In the substrates the cover at both 5m and 10 m depths include hard corals 38% turf and dead coral 24 and 26% respectively. Rock and turf rubble are less than 10% silt and sand are less than 2%. Massive Porites were the dominating group of hard coral observed at the site. Trigger fish, surgeon fish (Powder blue), wrasse (labridae) basslets were common. Grazers (Acanthurids or Scarids) were not seen, and this result is consistent with what was obtained with earlier assessment. Photographs of the transect quadrats are shown in Figure 8 and Figure 9. Benthic composition of M8 at both 5 and 10m depth is in the graph in Figure 20 .

Figure 1: Photos Taken from Site 10 (M10) (16 June 2022) at 5m depth

Figure 9: Photos Taken from Site 10 (M10) (16 June 2022) at 10m depth

Figure 20: Average benthic cover and their standard error for M9 at both 5 and 10m depth

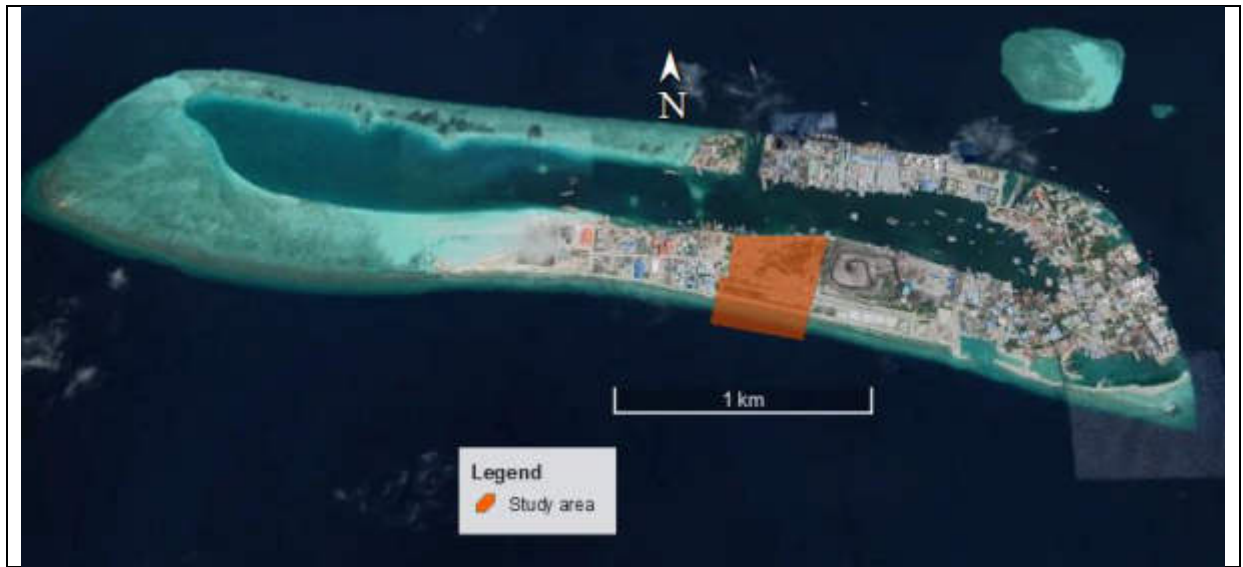
Figure 1: Location of map of Proposed WTE facility development Project at Thilafushi and location of STP within the WTE site boundary.

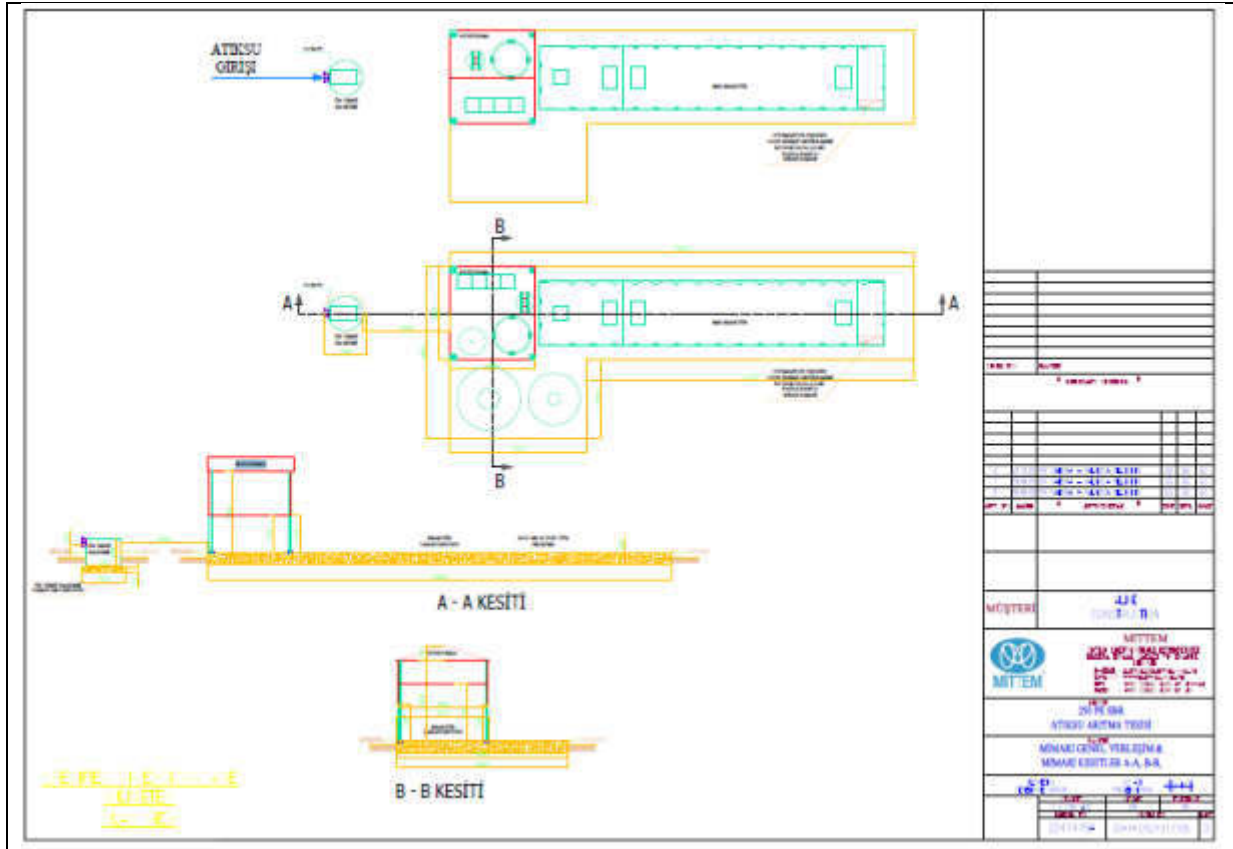
A single-story standard building will be constructed for services and facilities required for the operation of the plant. The land area allocated for the facility is approximately 16 m x 18 m. This building will consist of an inlet chamber, grit chamber, oil and grease chamber, equalization tank, SBR reactors basins, centrifuge house, DWPE dosing tank, sludge sump and Pump and effluent sump well. *Figure 4* shows the layout works of the facility building

Figure 4. STP Building layout at WTE facility , Thilafushi. A magnified view is attached in the Annex

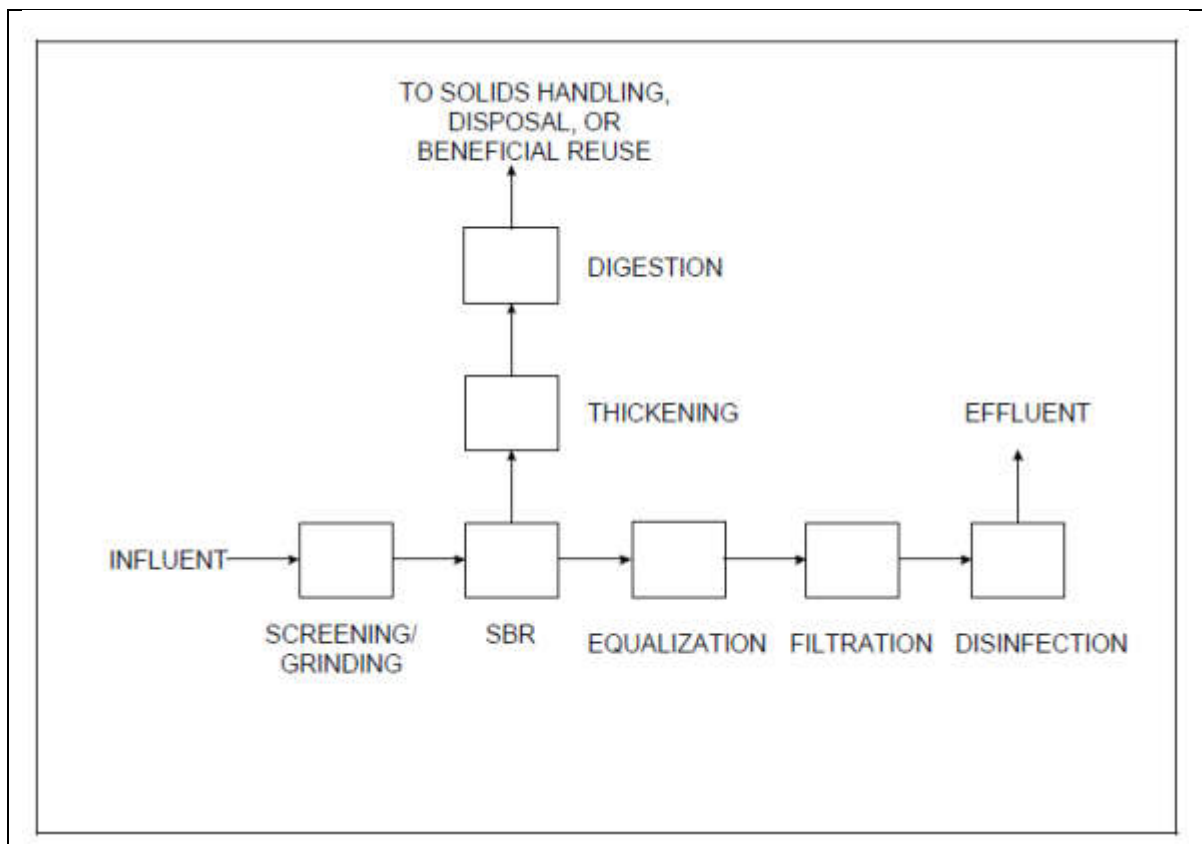
Figure 6 Process flow diagram for a typical SBR.

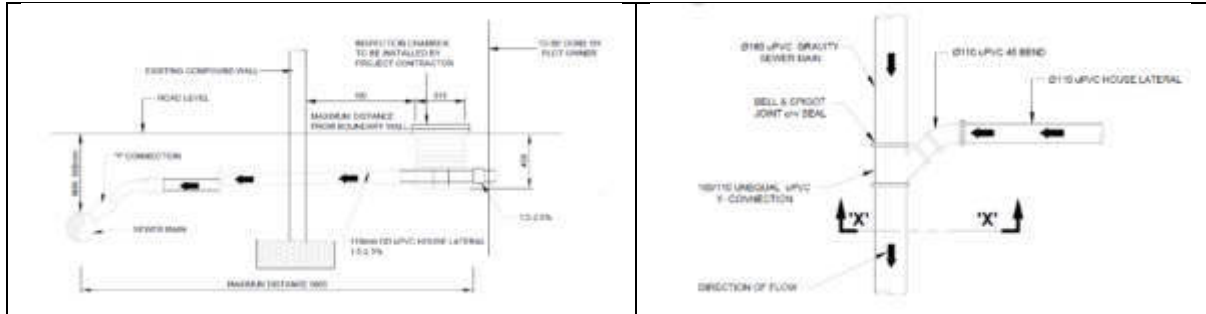
The facilities and buildings inside the WtE facility will be connected to the sewer main with uPVC pipe of 110mm OD gravity sewer laid at a minimum grade of 1.5-2.5% to facilitate the flow of solids. A pre-fabricated corrugated HDPE inspection chamber will be placed at the boundary of each building connection prior to downstream connection with a 'Y' fixture, lateral connection (See *Figure 7*)

Figure 7. Sewer connection. Section view of the building connection (left) , Plane view of the building (Right)

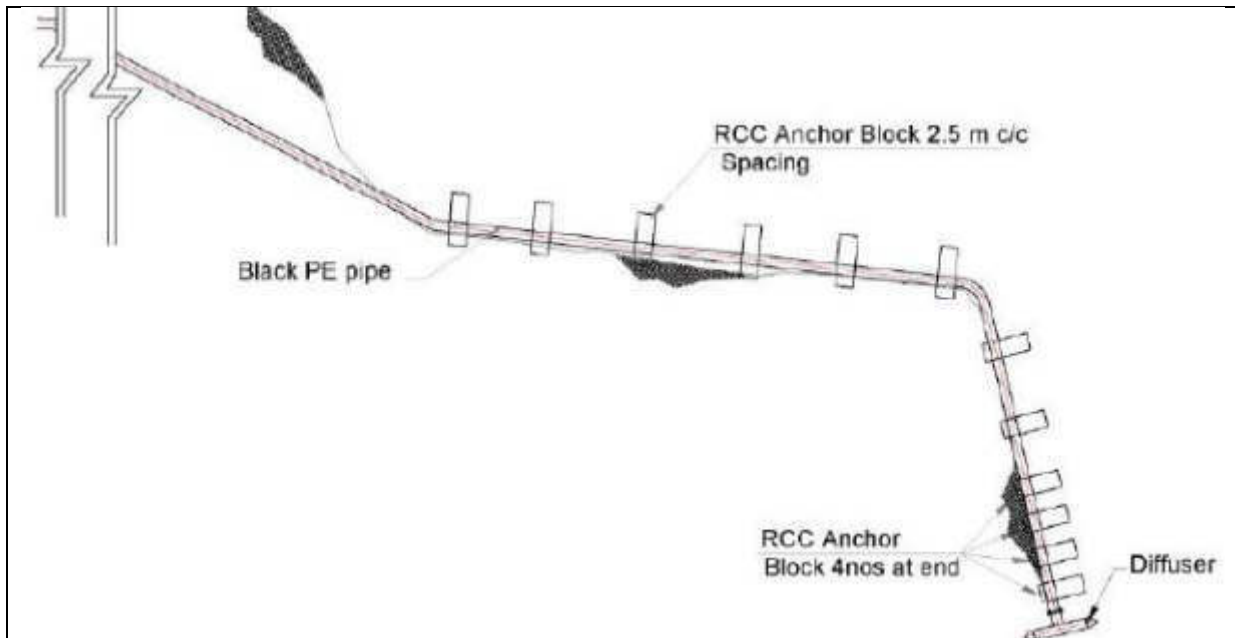
The sewage pipe will be laid underground at about 1.1.5m in the land until it reaches the existing rock-boulder seawall. Once it reached the rock boulder seawall it will be fixed on top of it into the reef flat/lagoon. On the reef flat the pipeline will be ballasted with anchored block to the seabed. Anchor blocks will be 1 to 2 tons of reinforced concrete (Precast U-blocks to be bolted in place to form one complete block) at 4 m intervals as shown in the drawing, to prevent displacement at rough weather conditions Figure 8.

Figure 8. Schematic showing the methodology for laying sewerage outfall pipe on the reef to the discharge location

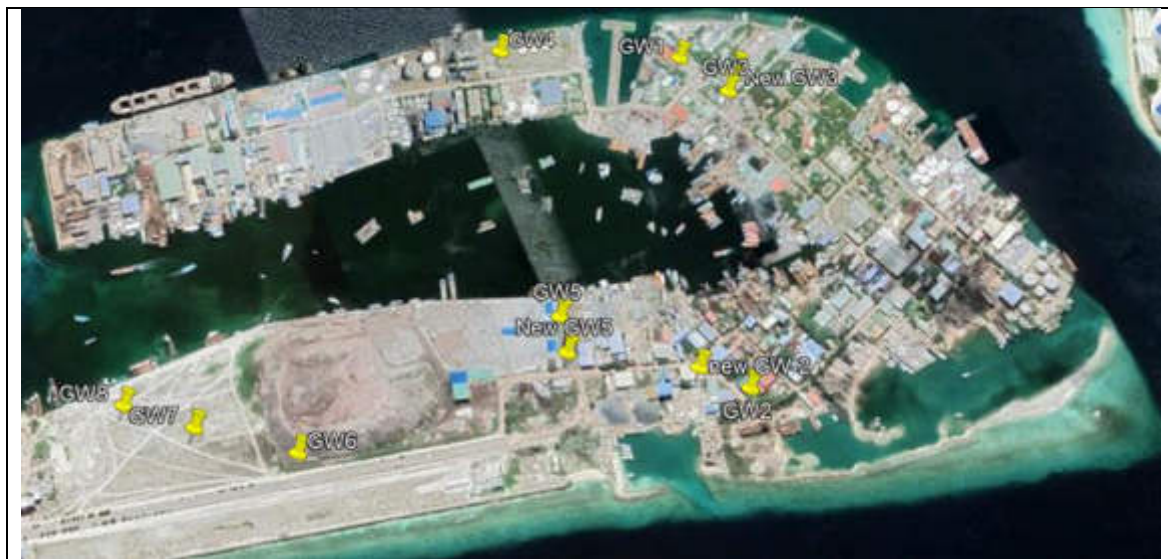
Figure 9: Ground water sampling locations

In-situ recording of pH, Temperature DO and EC for each sample conducted by using a handheld Hach SensION +MM156 water quality measurement meter

Ground water assessment was conducted on 30th November 2022. Water samples were collected from 6 monitoring stations Figure 9. For each location, the samples were collected from mid-water level carried for laboratory testing in Sri Lanka. General sampling procedure involves washing the sampling bottle glass/ with water from the sampling points. For microbial tests, samples were collected in sterile glass bottles and tested in the MWSC laboratory.

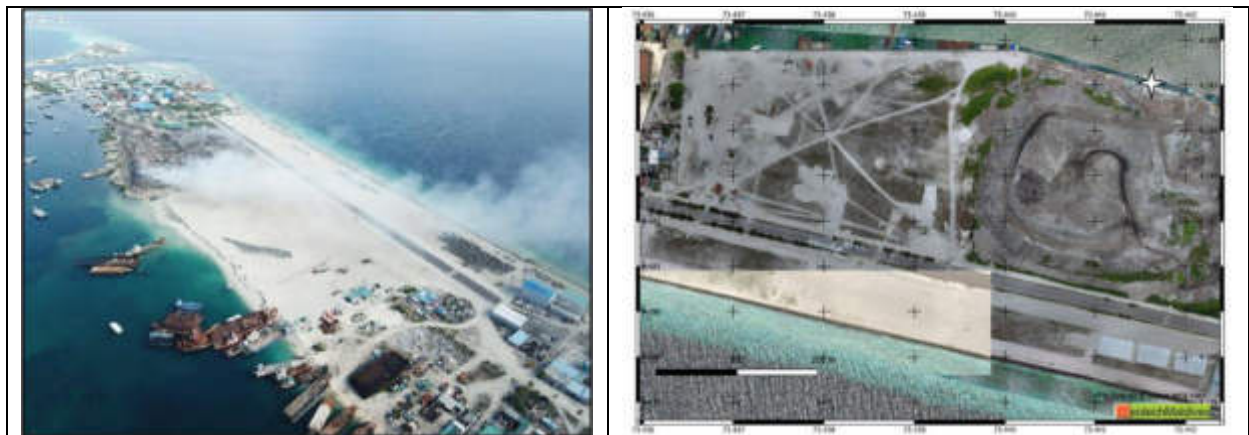
Figure 12: WtE Site in 2019 (left) and in 2022 (right)

The project is located on the southern side of Thilafushi. The island has been reclaimed since December 1992 by dumping of wastes on the submerged “Thilafalhu” lagoon area. 15 hectares of land has been allocated by the Government to construct the WtE facility in the island. Pre construction work has been going on the site since April 2022 and this includes fencing of boundary of site, construction of various buildings and facilities required for construction camp. Geotechnical studies water quality, Ambient air and noise monitoring activities as well as other site clearance activities as removal of garbage pile discarded boats and vehicles from land and sea boundaries of the site (*Figure 12*). At present workers are transported to the site on daily basis and only the security staff remains in the site at night The following presents pectoral representation of the site .

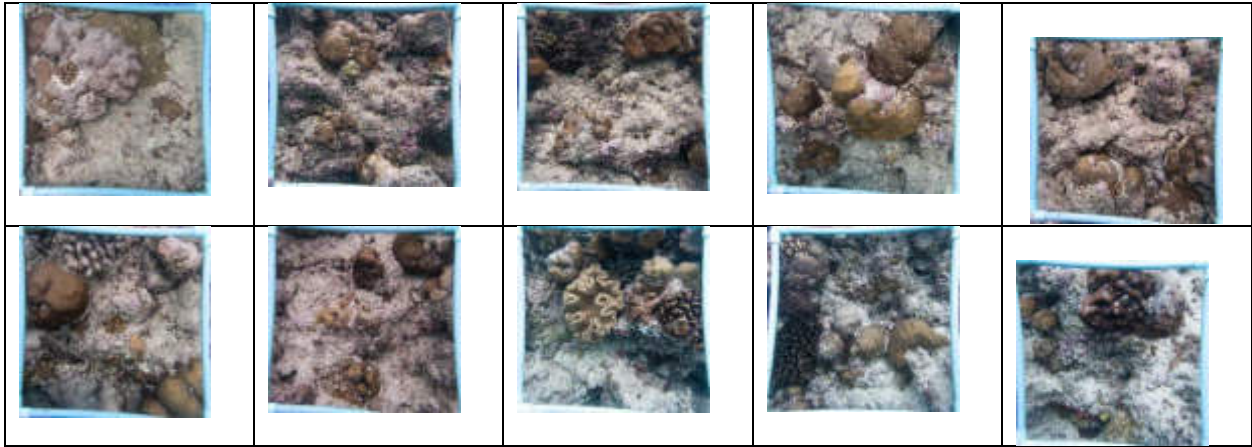
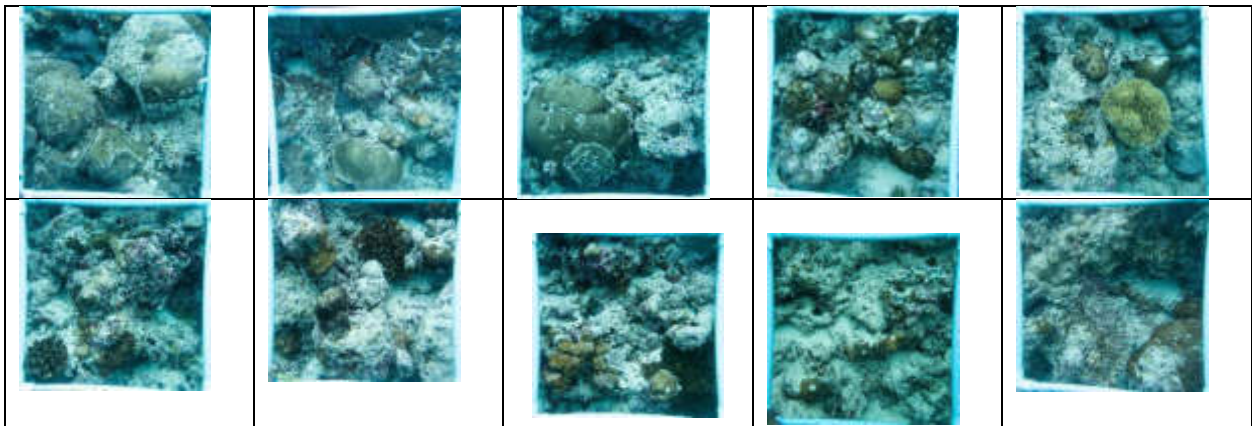
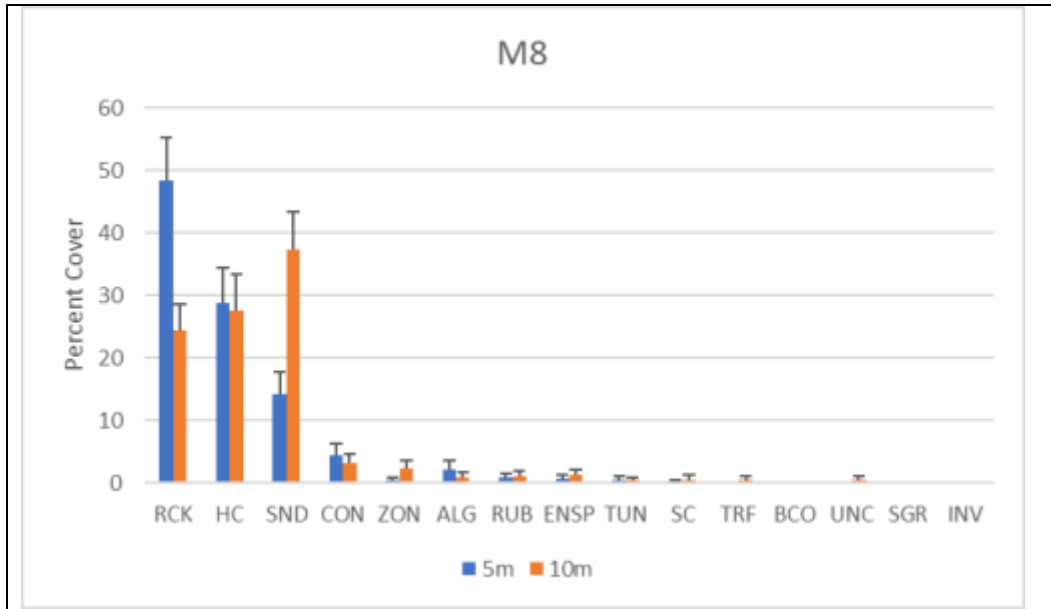
Figure 16: Photos Taken from Site 8 (M8) (24th December 2022) at 5m depth

Figure 17: Photos Taken from Site 8 (M8) (24th December 2022) at 10m depth

Figure 18: Average benthic cover and their standard error for M8 at both 5 and 10m depth

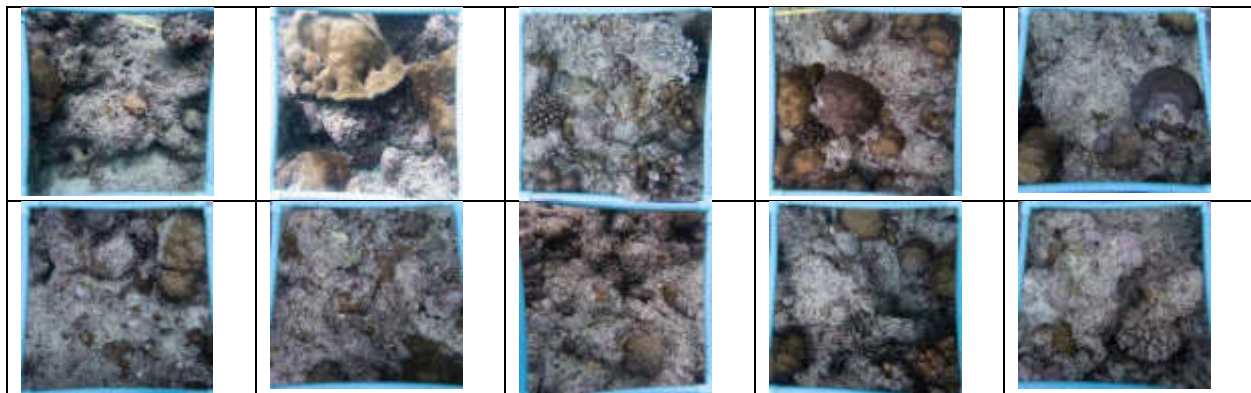
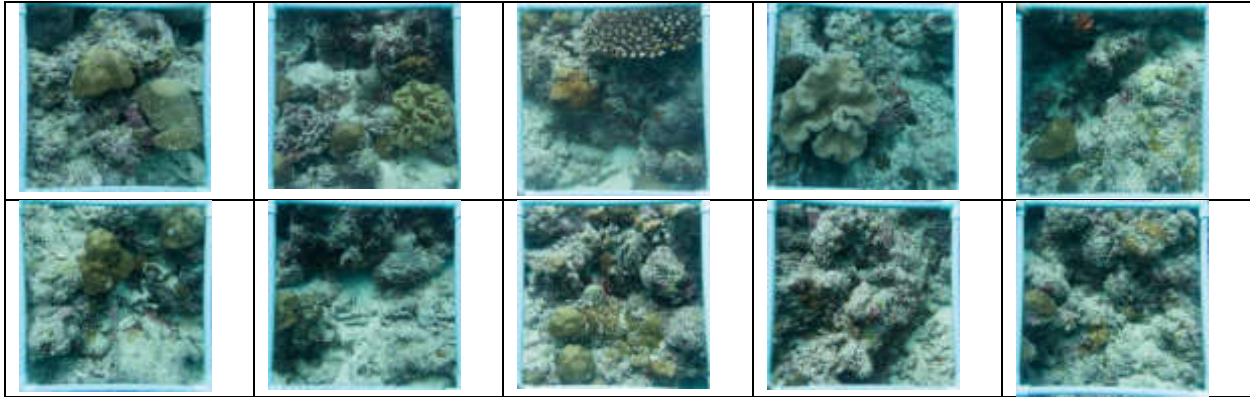
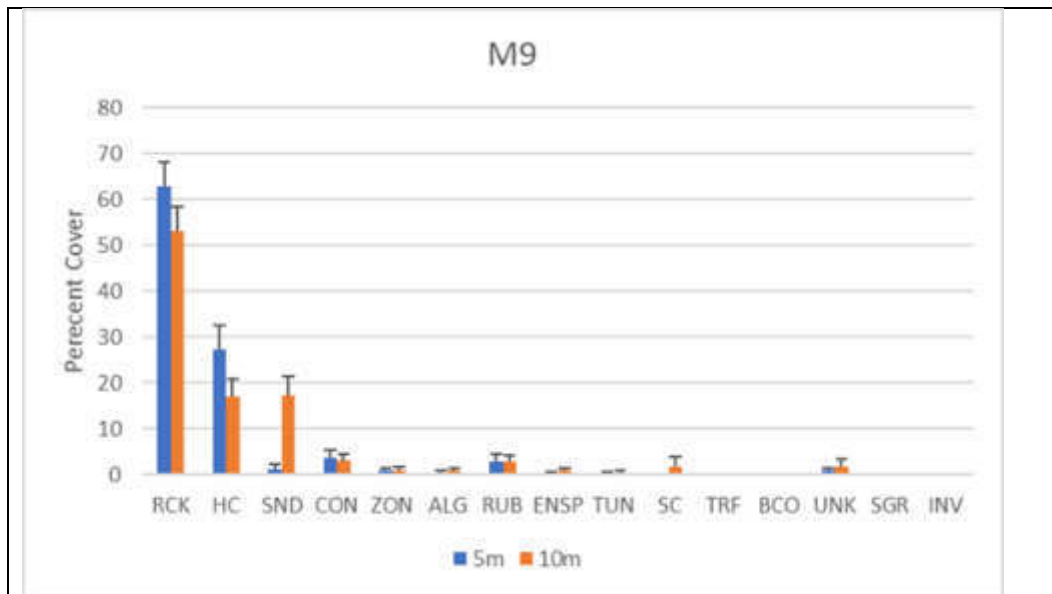
Status of Site M9: This location was identified as an alternative for brine discharge and wastewater outfall. This is close to the WtE site at the southern reef of Thilafushi Island. Substrate cover was qualitatively similar to the results obtained for the survey conducted in June. Like Site 8, the highest substrate cover was rock, some 50-60% of the 0.5 x 05 m quadrat, followed by live coral. Live coral cover was also qualitatively like M8. Sand cover was around 5-15%, much lower at 5m. Rubble cover also was low.

With regards to fish *Chormis dimidiata* was abundant, occurring > 40 individuals along 20 meters transect. Also, the *Pomecentrid philippinus* and *Pterocaesio* tile were common at site. Photographs of the transect quadrats are shown in Figure 19 and Figure 20. Benthic composition of M9 at both 5 and 10m depth is in Figure 21.

Figure 19: Photos Taken from Site 9 (M9) (24th December 2022) at 5m depth

Figure 20: Photos Taken from Site 9 (M9) (24th December 2022) at 10m depth

Figure 21: Average benthic cover and their standard error for M9 at both 5 and 10m depth

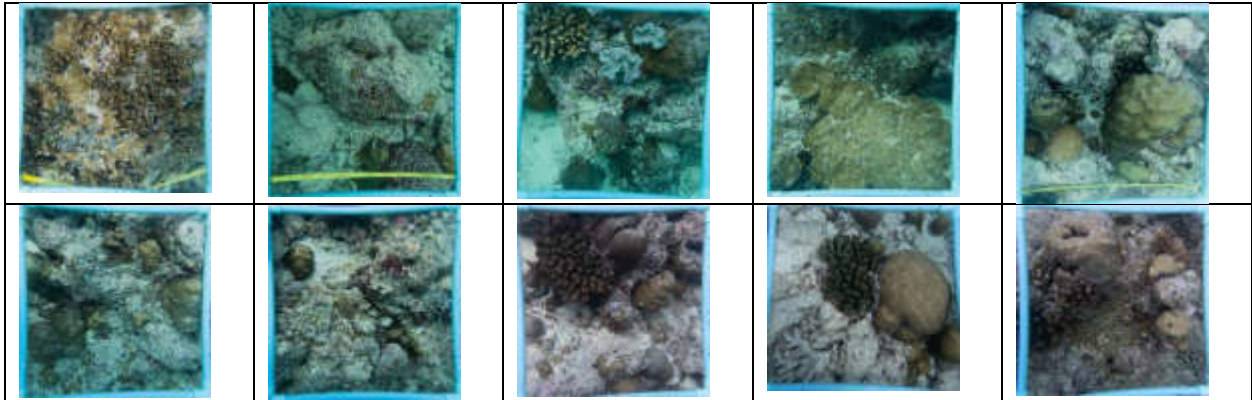
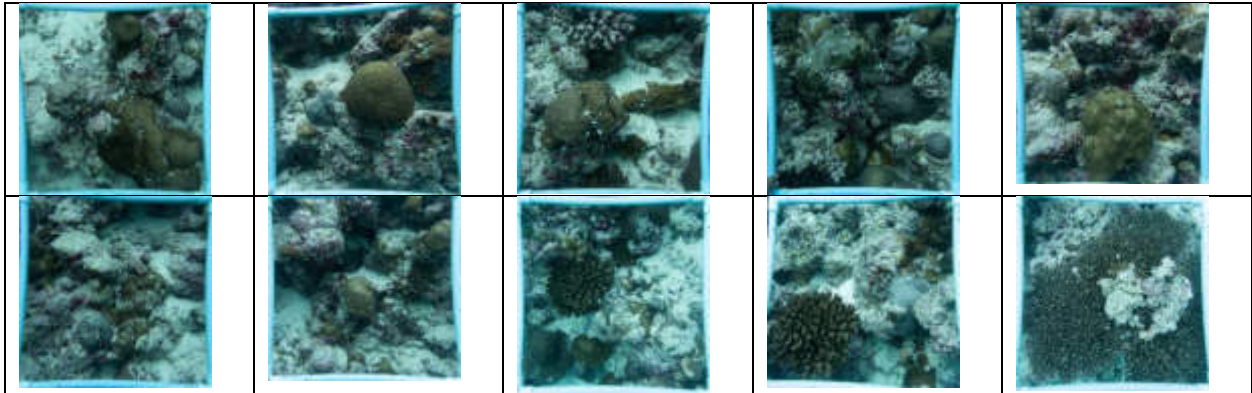
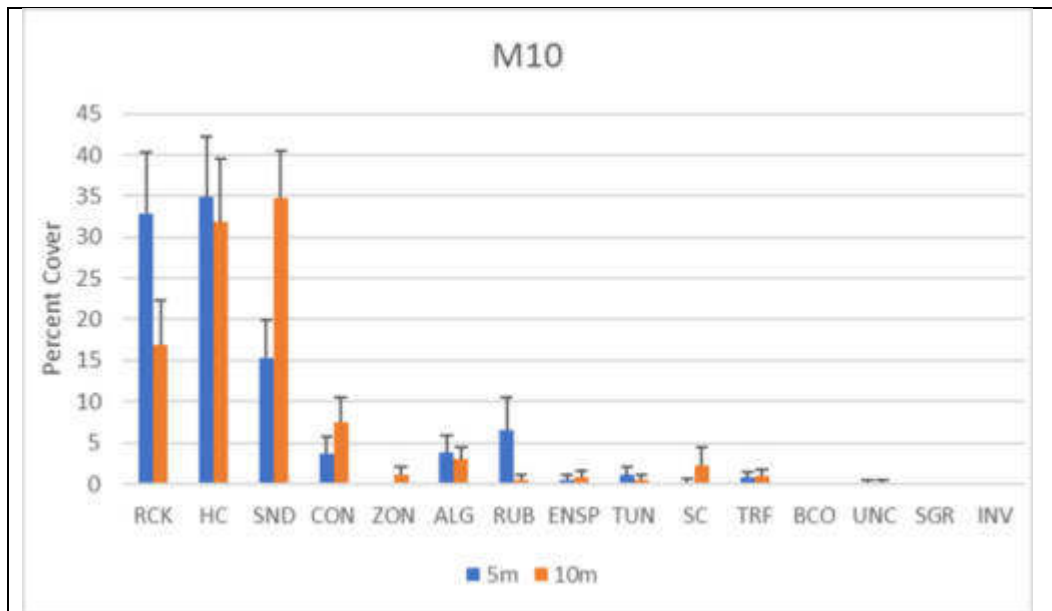
Status of Site M10: This location has been identified in the EIA report as a potential alternative for the discharge of brine water and waste water. The location is very close to the WtE facility and it is on the southern reef of Thilafushi Island. Site M10 had largest cover for rock, hard coral and sand (around 40-40%) although rock was significantly lower at 10m depth, while sand cover was lower about 15% at 5m and slightly over 30% at 10m depth. Corallinaceae cover is slightly higher at 10m than 5m depth 8% and 3 % respectively. Mirco Algae and rubble cover on the substrates are higher at 5m than 10m at 5m depth micro algae cover does not exceeds 5% of substrate while rubble content is over 5% at 5m depth at 10 m depth both Micro Algae and rubble content is below 3%.

With regard to fish *Chormis dimidiata* was the only abundant fish found in the area. Common occurrence of any species was not recorded at this location. Photographs of the transect quadrats are shown in Figure 22 and Figure 23. Benthic composition of M10 at both 5 and 10m depth is in the graph in Figure 24 .

Figure 22: Photos Taken from Site 10 (M10) (24th December 2022) at 5m depth

Figure 23: Photos Taken from Site 10 (M10) (24th December 2022) at 10m depth

Figure 24: Average benthic cover and their standard error for M9 at both 5 and 10m depth

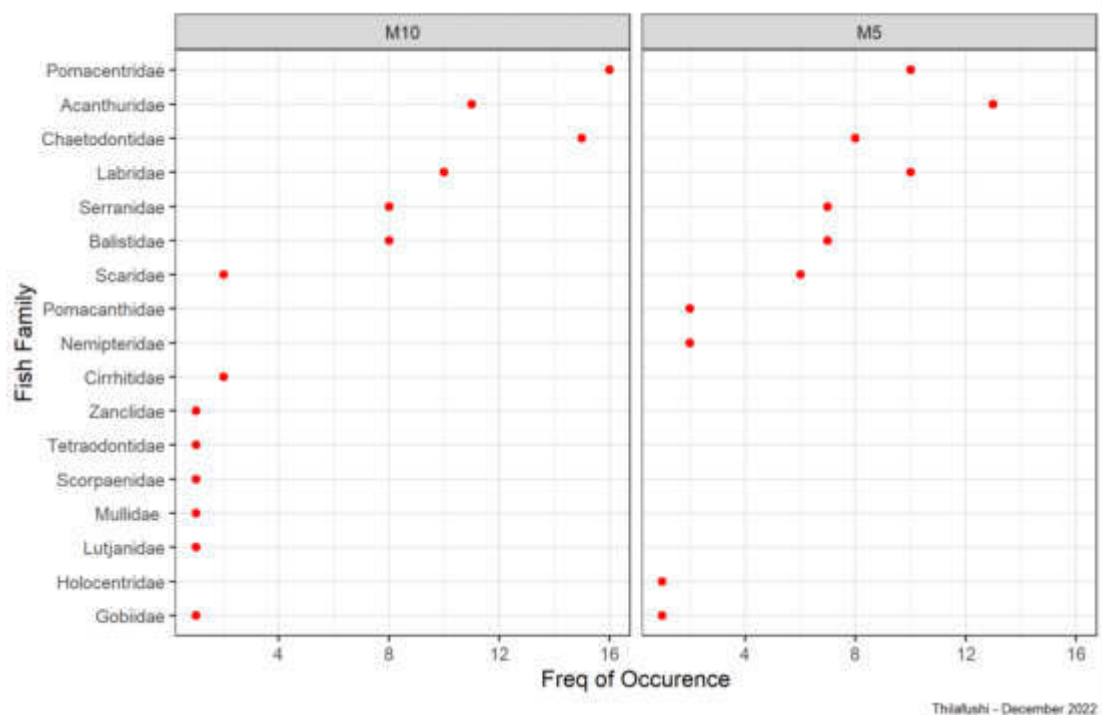
Figure 25: Fish Families ordered with frequency of occurrence. Pomacentridae is most common family

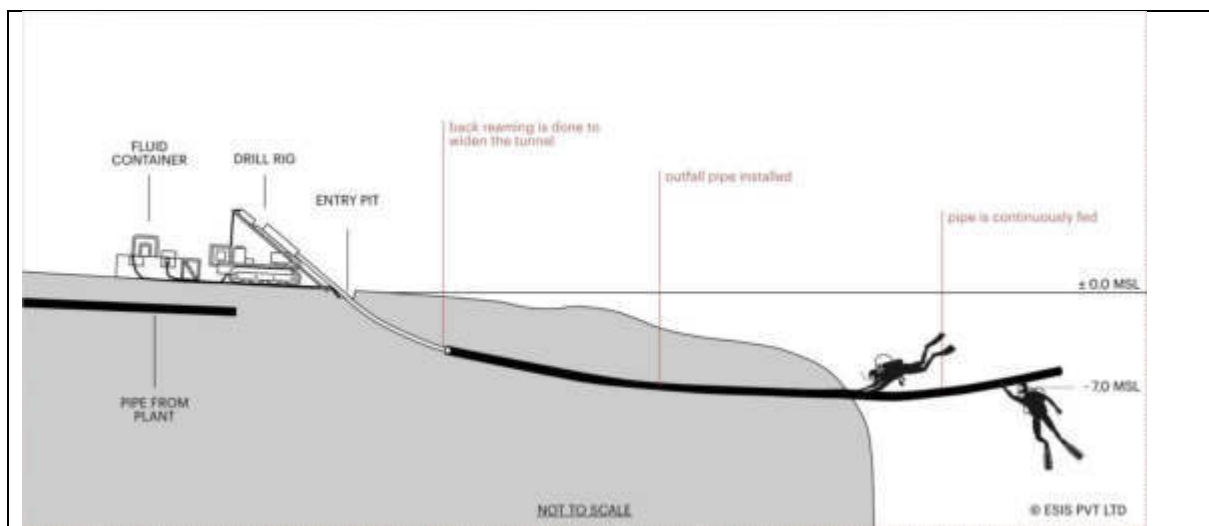
Horizontal Directional Drilling is commonly is trenchless construction method for installing pipes under sensitive area such as coral reefs where open-trench installation would be disruptive or difficult to construct. The directional drilling or guided boring process begins by drilling into undisturbed surface at this 10- 25-degree angle. As the tool penetrates the ground, the second drill pipe is added. The process continues with the steering controlled so that the drilling tool will enter the first pit level at the proper depth. The success of horizontal directional drilling lies on the construction of the drill head and reamers *Figure 26*.

Figure 26. Schematics of the sea outfall installation using HDD method

Major disadvantage of HDD is that it is very expensive, fairly sophisticated technology. Also large amount of drilling fluid is used and a large land clearance is required at the entrance point.
